Profile/Photo Observation Report

Date:	09/15/2021	Weather:		Coding:	PACP 7.0
Pipe Length (ft):	255.2	Owner:	City of Hobart	Pre Clean:	Light Cleaning
P.O.#:	YES502259	Surveyor:	S. Bucklin	PSR:	P-504-134-050
Customer:	City of Hobart	Clean Date:	09/10/2021	Shape:	C

Street:	North Cavender Street	Flow Control:	Not Controlled
City:	Hobart, IN	Year Renewed:	
Location:	Alley	Tape/Media #:	
Purpose:	Routine Assessment	Dia/Height:	10"
Use:	Sanitary Sewage Pipe	Material:	VCP
Drain Area:		Lining:	None
Category:	NA		
Comment:			
Location Details:		Direction of Survey:	Upstream
US MH:	M-504-050	DS MH:	M-504-134
		Total Length Surveyed (ft):	255.2

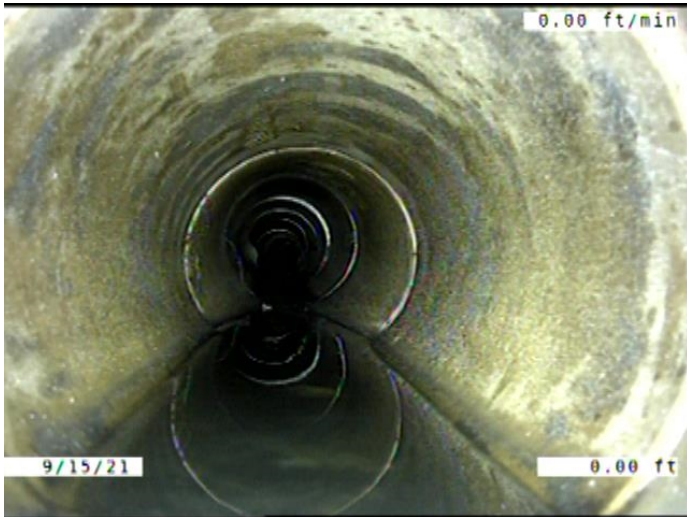
Code: **MWL**
 Description: **Miscellaneous Water Level**

Distance (ft): **.0**
 Structural Grade: **0**
 O&M Grade: **0**
 Clock Start/From:
 Clock To:
 1st Value:
 2nd Value:
 Value Percent: **5.000**
 Continuous Index:
 Within 8" of Joint: **NO**
 Remarks:

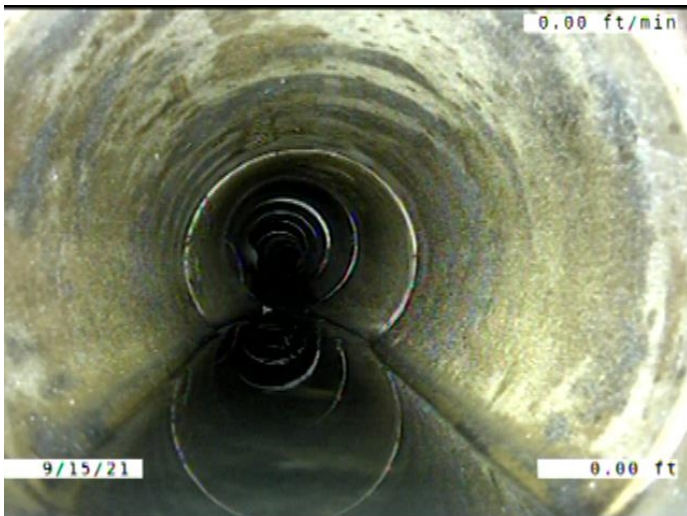
Code: **MGO**
 Description: **Miscellaneous General Observation**

Distance (ft): **1.5**
 Structural Grade: **0**
 O&M Grade: **0**
 Clock Start/From:
 Clock To:
 1st Value:
 2nd Value:
 Value Percent:
 Continuous Index:
 Within 8" of Joint: **NO**
 Remarks: **DROP INTO THE MANHOLE. HAD TO START IN THE PIPE.**

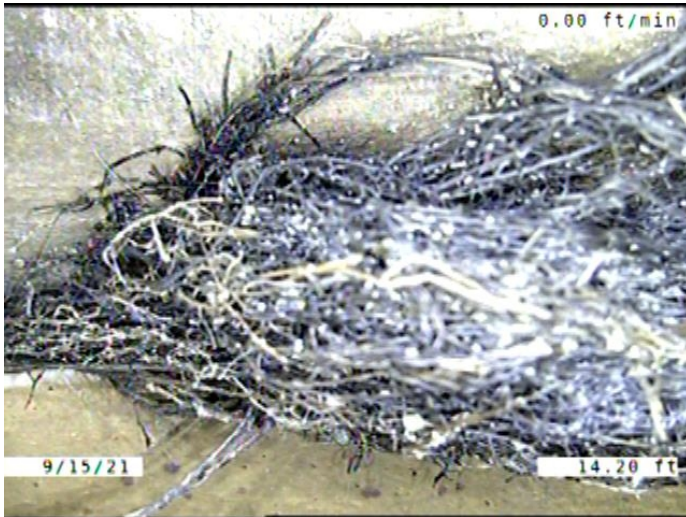
Code: **RMJ**
 Description: **Roots Medium Joint**

Distance (ft): **14.2**
 Structural Grade: **0**
 O&M Grade: **3**
 Clock Start/From: **9**
 Clock To: **4**
 1st Value:
 2nd Value:
 Value Percent: **5.000**
 Continuous Index: **S01**
 Within 8" of Joint: **YES**
 Remarks:

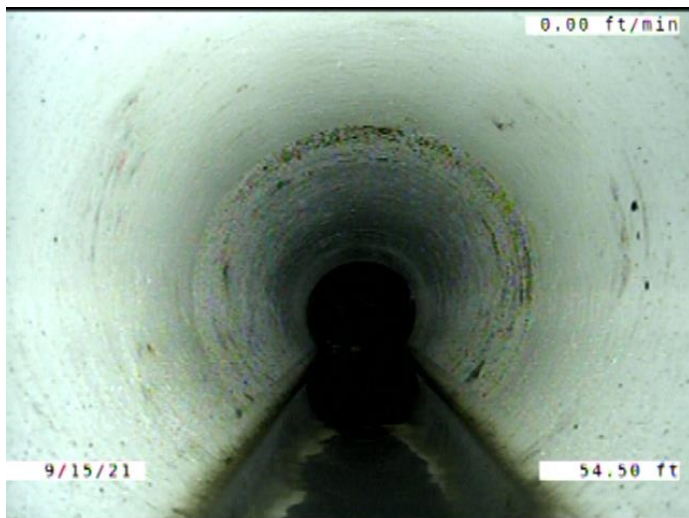
Code: **MWLS**
Description: **Miscellaneous Water Level Sag**

Distance (ft): **54.5**
Structural Grade: **2**
O&M Grade: **0**
Clock Start/From:
Clock To:
1st Value:
2nd Value:
Value Percent: **5.000**
Continuous Index: **F03**
Within 8" of Joint: **NO**
Remarks:

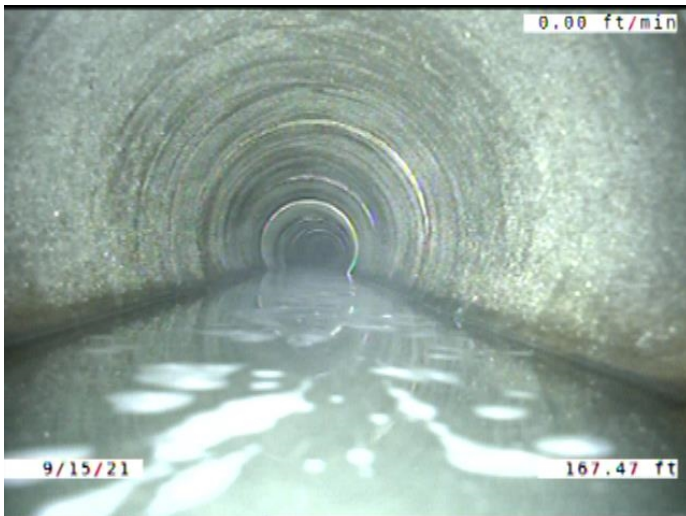
Code: **DAE**
 Description: **Deposits Attached Encrustation**

Distance (ft): **167.5**
 Structural Grade: **0**
 O&M Grade: **2**
 Clock Start/From: **12**
 Clock To: **4**
 1st Value:
 2nd Value:
 Value Percent: **5.000**
 Continuous Index: **F05**
 Within 8" of Joint: **YES**
 Remarks:

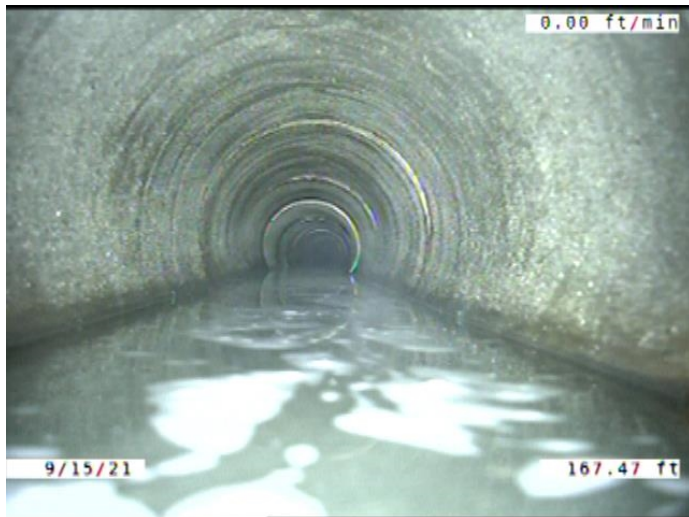
Code: **DAE**
 Description: **Deposits Attached Encrustation**

Distance (ft): **167.5**
 Structural Grade: **0**
 O&M Grade: **2**
 Clock Start/From: **8**
 Clock To: **10**
 1st Value:
 2nd Value:
 Value Percent: **5.000**
 Continuous Index: **F06**
 Within 8" of Joint: **YES**
 Remarks:

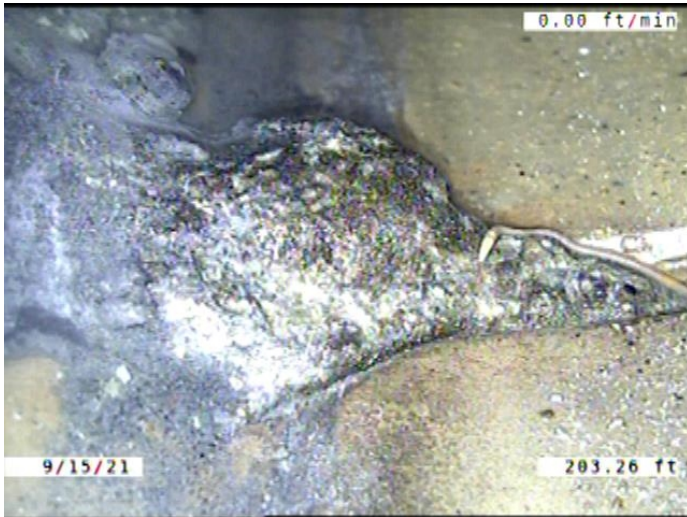
Code: **DAE**
 Description: **Deposits Attached Encrustation**

Distance (ft): **203.3**
 Structural Grade: **0**
 O&M Grade: **2**
 Clock Start/From: **4**
 Clock To: **5**
 1st Value:
 2nd Value:
 Value Percent: **5.000**
 Continuous Index:
 Within 8" of Joint: **YES**
 Remarks:

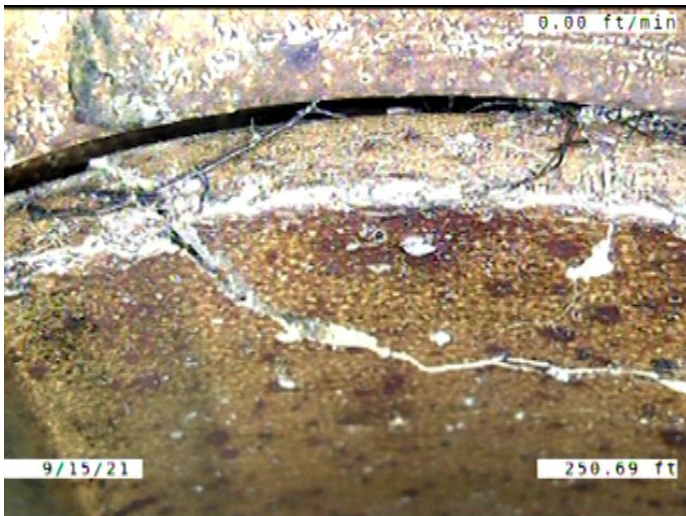
Code: **B**
 Description: **Broken**
