Profile/Photo Observation Report

Street:	Old Ridge Road	Flow Control:	Not Controlled
City:	Hobart, IN	Year Renewed:	
Location:	Light Highway	Tape/Media #:	DEP 20
Purpose:	Routine Assessment	Dia/Height:	24"
Use:	Sanitary	Material:	CP
Drain Area:		Lining:	
Category:	NA		
Comment:			
Location Details:		Direction of Survey:	Upstream
US MH:	M-504-065	DS MH:	M-504-064
		Total Length Surveyed (ft):	315.8

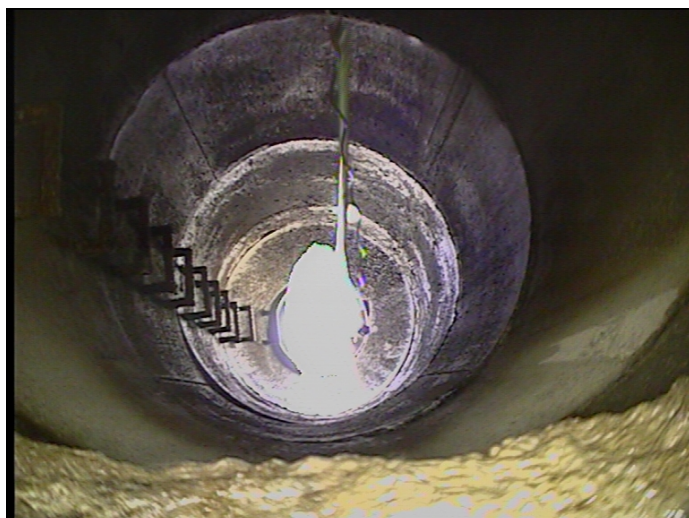
Code: **AMH**
Description: **Manhole**

Distance (ft): **.0**
Structural Grade: **0**
O&M Grade: **0**
Clock Start/From:
Clock To:
1st Value:
2nd Value:
Value Percent:
Continuous Index:
Within 8" of Joint: **NO**
Remarks: **M-504-064**

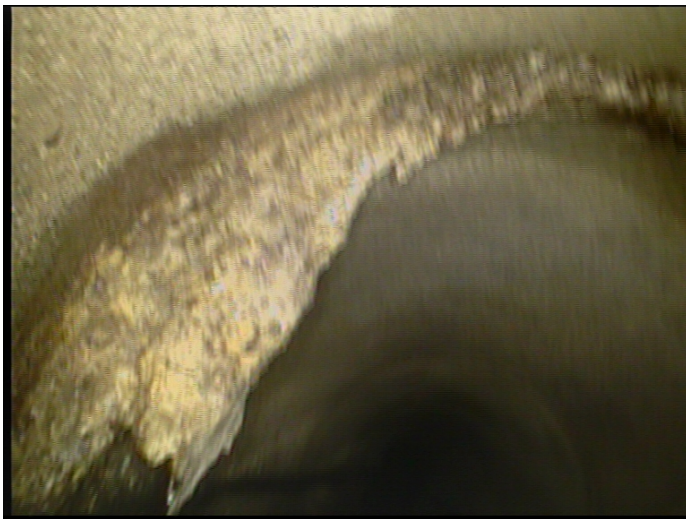
Code:	DAE
Description:	Deposits Attached Encrustation
Distance (ft):	278.9
Structural Grade:	0
O&M Grade:	2
Clock Start/From:	8
Clock To:	4
1st Value:	
2nd Value:	
Value Percent:	5.000
Continuous Index:	F02
Within 8" of Joint:	NO
Remarks:

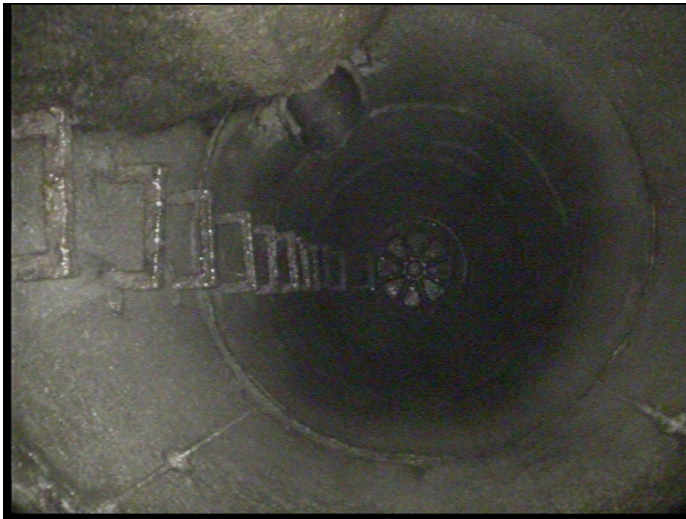
Code:	AMH
Description:	Manhole
Distance (ft):	315.8
Structural Grade:	0
O&M Grade:	0
Clock Start/From:	
Clock To:	
1st Value:	
2nd Value:	
Value Percent:	
Continuous Index:	
Within 8" of Joint:	NO
Remarks:	M-504-065
