Profile/Photo Observation Report

Date:	04/19/2018	Weather:		Coding:	PACP 6.0
Pipe Length (ft):	161.5	Owner:	NA	Pre Clean:	Not Known
P.O.#:		Surveyor:	Byrd Fitzgerald	PSR:	P-504-065.2-065.1
Customer:		Clean Date:	01/01/1900	Shape:	C

Street:	N GUYER ST	Flow Control:	Not Controlled
City:	Hobart, IN	Year Renewed:	
Location:	Light Highway	Tape/Media #:	
Purpose:	Not Known	Dia/Height:	8"
Use:	Sanitary	Material:	CP
Drain Area:	NA	Lining:	
Category:	NA		
Comment:			
Location Details:		Direction of Survey:	Downstream
US MH:	M-504-065.1	DS MH:	M-504-065.2
		Total Length Surveyed (ft):	124.1

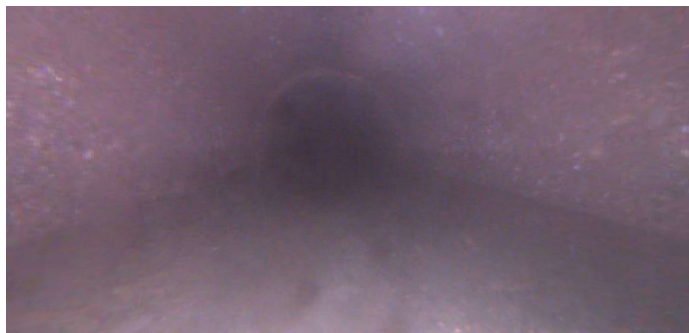
Code: **AMH**
Description: **Manhole**

Distance (ft): **.0**
Structural Grade: **0**
O&M Grade: **0**
Clock Start/From:
Clock To:
1st Value:
2nd Value:
Value Percent:
Continuous Index:
Within 8" of Joint: **NO**
Remarks: **M-504-065.1**

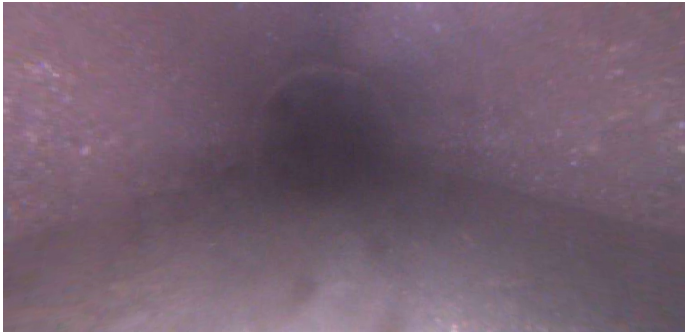
Code:	MWL
Description:	Water Level

Distance (ft):	.0
Structural Grade:	0
O&M Grade:	0
Clock Start/From:	
Clock To:	
1st Value:	
2nd Value:	
Value Percent:	25.000
Continuous Index:	
Within 8" of Joint:	NO
Remarks:

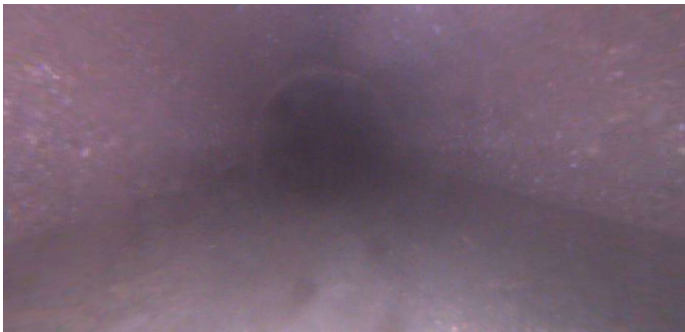
Code:	MGO
Description:	General Observation

Distance (ft):	.0
Structural Grade:	0
O&M Grade:	0
Clock Start/From:	
Clock To:	
1st Value:	
2nd Value:	
Value Percent:	
Continuous Index:	
Within 8" of Joint:	NO
Remarks:	steam

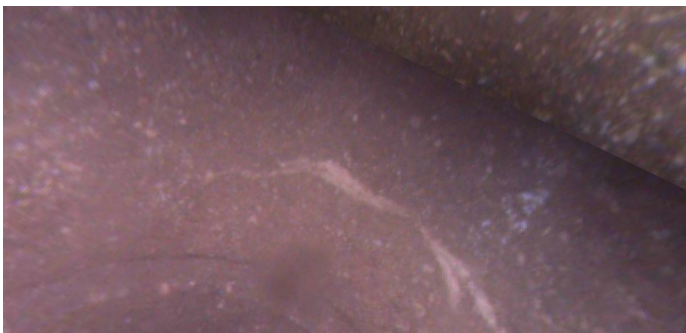
Code: **CC**
Description: **Crack Circumferential**

Distance (ft): **17.6**
Structural Grade: **1**
O&M Grade: **0**
Clock Start/From: **8**
Clock To: **4**
1st Value:
2nd Value:
Value Percent:
Continuous Index:
Within 8" of Joint:
Remarks:

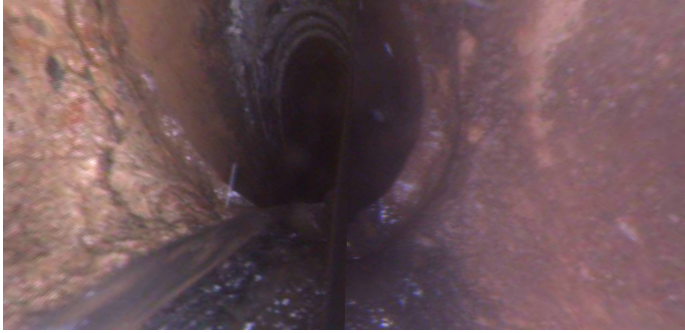
Code: **TBA**
Description: **Tap Break-in Active**

Distance (ft): **20.4**
Structural Grade: **0**
O&M Grade: **0**
Clock Start/From: **10**
Clock To:
1st Value: **4.000**
2nd Value:
Value Percent:
Continuous Index:
Within 8" of Joint: **YES**
Remarks:

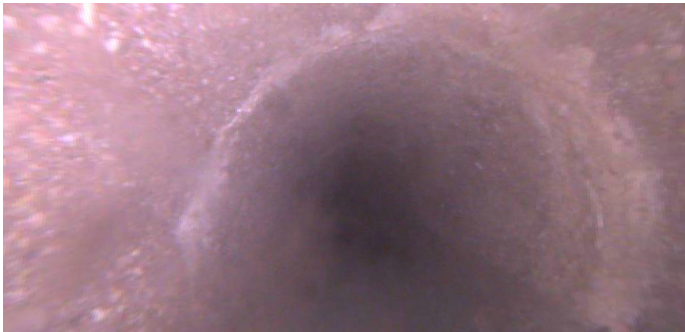
Code: **CC**
Description: **Crack Circumferential**

Distance (ft): **30.9**
Structural Grade: **1**
O&M Grade: **0**
Clock Start/From: **8**
Clock To: **4**
1st Value:
2nd Value:
Value Percent:
Continuous Index: **S01**
Within 8" of Joint:
Remarks: **thru out pipe**

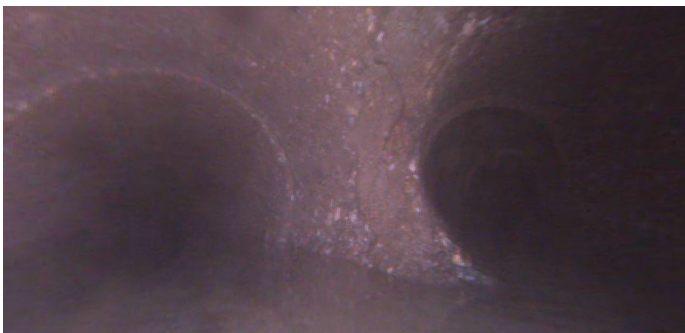
Code: **TF**
Description: **Tap Factory**

Distance (ft): **65.4**
Structural Grade: **0**
O&M Grade: **0**
Clock Start/From: **3**
Clock To:
1st Value: **4.000**
2nd Value:
Value Percent:
Continuous Index:
Within 8" of Joint: **YES**
Remarks:

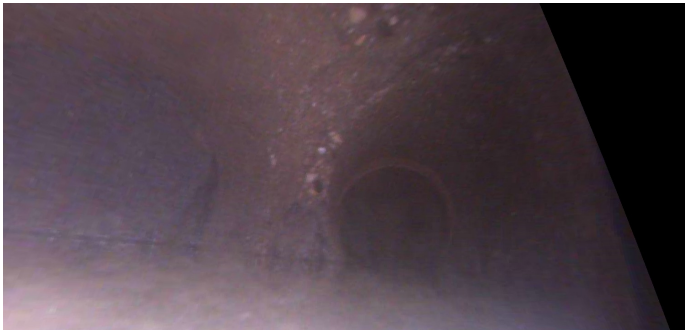
Code: **TF**
Description: **Tap Factory**

Distance (ft): **122.6**
Structural Grade: **0**
O&M Grade: **0**
Clock Start/From: **3**
Clock To:
1st Value: **4.000**
2nd Value:
Value Percent:
Continuous Index:
Within 8" of Joint: **YES**
Remarks:
