Profile/Photo Observation Report

Date:	09/13/2021	Weather:		Coding:	PACP 7.0
Pipe Length (ft):	124.0	Owner:	City of Hobart	Pre Clean:	Light Cleaning
P.O.#:	YES502259	Surveyor:	S. Bucklin	PSR:	P-504-065.2-065.1
Customer:	City of Hobart	Clean Date:	09/09/2021	Shape:	C

Street:	North Guyer Street	Flow Control:	Not Controlled
City:	Hobart, IN	Year Renewed:	
Location:	Local rural streets with light traffic, t	Tape/Media #:	
Purpose:	Routine Assessment	Dia/Height:	8"
Use:	Sanitary Sewage Pipe	Material:	CP
Drain Area:		Lining:	None
Category:	NA		
Comment:			
Location Details:		Direction of Survey:	Upstream
US MH:	M-504-065.1	DS MH:	M-504-065.2
		Total Length Surveyed (ft):	124.0

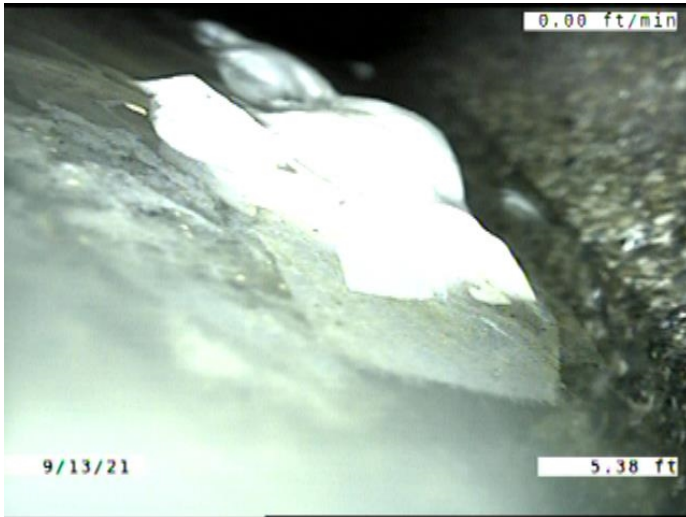
Code: **DAR**
 Description: **Deposits Attached Ragging**

Distance (ft): **5.4**
 Structural Grade: **0**
 O&M Grade: **2**
 Clock Start/From: **5**
 Clock To: **7**
 1st Value:
 2nd Value:
 Value Percent: **5.000**
 Continuous Index:
 Within 8" of Joint: **YES**
 Remarks:

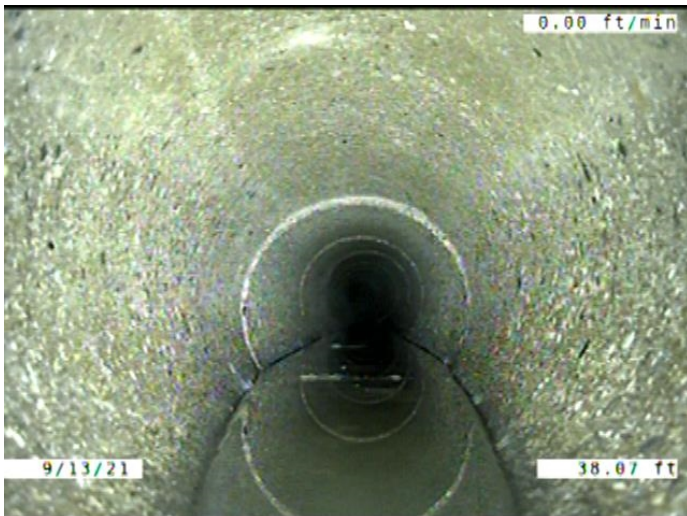
Code: **MWLS**
 Description: **Miscellaneous Water Level Sag**

Distance (ft): **38.1**
 Structural Grade: **2**
 O&M Grade: **0**
 Clock Start/From:
 Clock To:
 1st Value:
 2nd Value:
 Value Percent: **10.000**
 Continuous Index: **S02**
 Within 8" of Joint: **NO**
 Remarks:

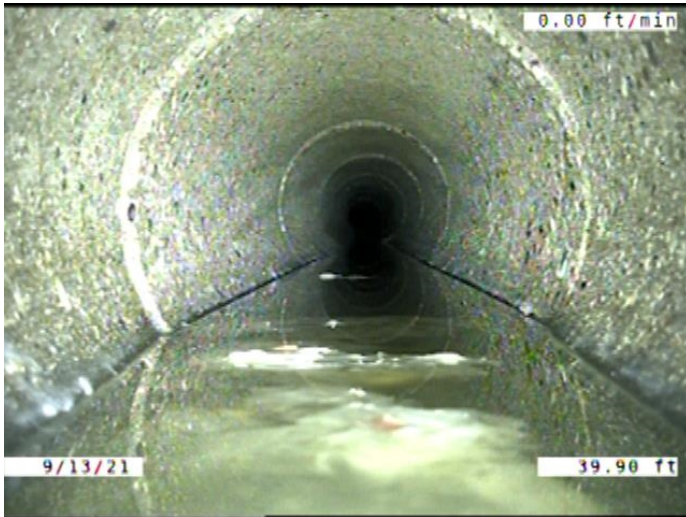
Code: **DSF**
Description: **Deposits Settled Fine**

Distance (ft): **39.9**
Structural Grade: **0**
O&M Grade: **2**
Clock Start/From: **5**
Clock To: **7**
1st Value:
2nd Value:
Value Percent: **5.000**
Continuous Index: **S03**
Within 8" of Joint: **YES**
Remarks:

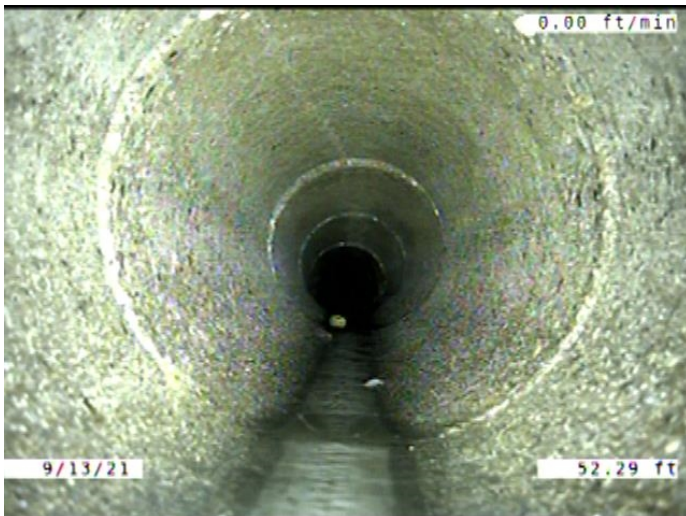
Code: **MWLS**
Description: **Miscellaneous Water Level Sag**

Distance (ft): **52.3**
Structural Grade: **2**
O&M Grade: **0**
Clock Start/From:
Clock To:
1st Value:
2nd Value:
Value Percent: **10.000**
Continuous Index: **F02**
Within 8" of Joint: **NO**
Remarks:

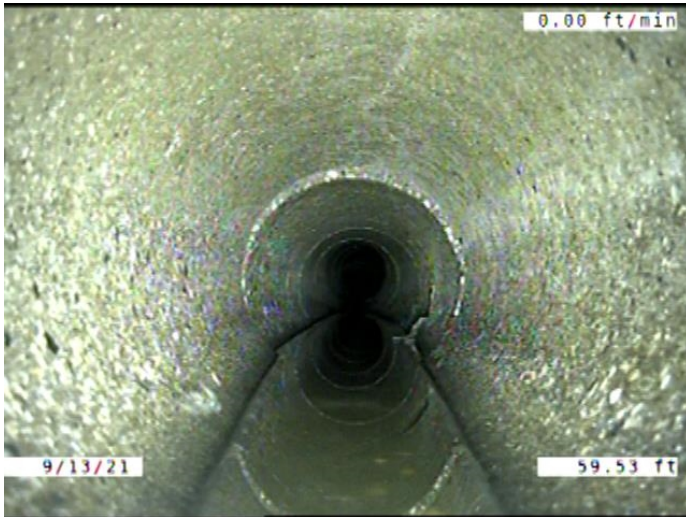
Code: **MWLS**
Description: **Miscellaneous Water Level Sag**

Distance (ft): **59.5**
Structural Grade: **2**
O&M Grade: **0**
Clock Start/From:
Clock To:
1st Value:
2nd Value:
Value Percent: **10.000**
Continuous Index: **S04**
Within 8" of Joint: **NO**
Remarks:

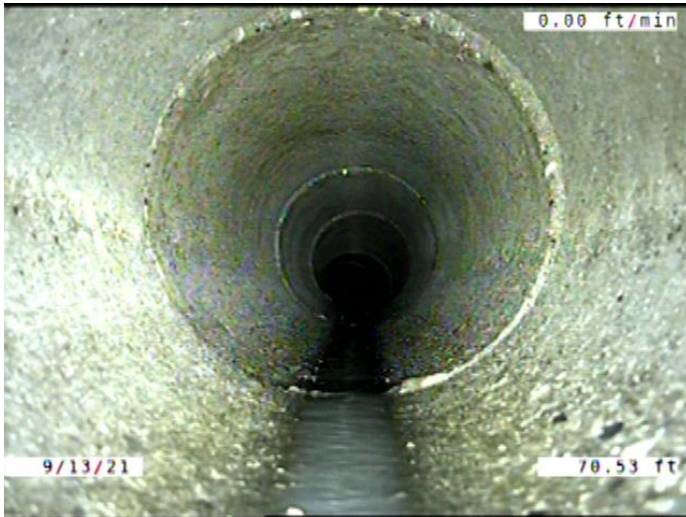
Code: **MWLS**
Description: **Miscellaneous Water Level Sag**

Distance (ft): **70.5**
Structural Grade: **2**
O&M Grade: **0**
Clock Start/From:
Clock To:
1st Value:
2nd Value:
Value Percent: **10.000**
Continuous Index: **F04**
Within 8" of Joint: **NO**
Remarks:

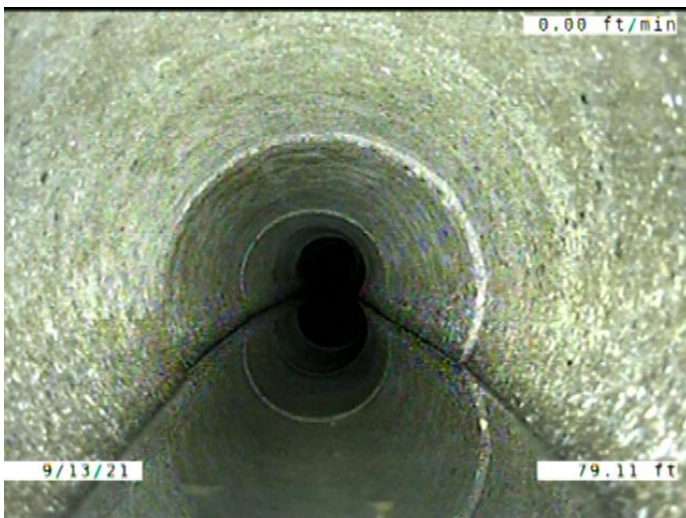
Code: **MWLS**
Description: **Miscellaneous Water Level Sag**

Distance (ft): **79.1**
Structural Grade: **2**
O&M Grade: **0**
Clock Start/From:
Clock To:
1st Value:
2nd Value:
Value Percent: **10.000**
Continuous Index: **S05**
Within 8" of Joint: **NO**
Remarks:

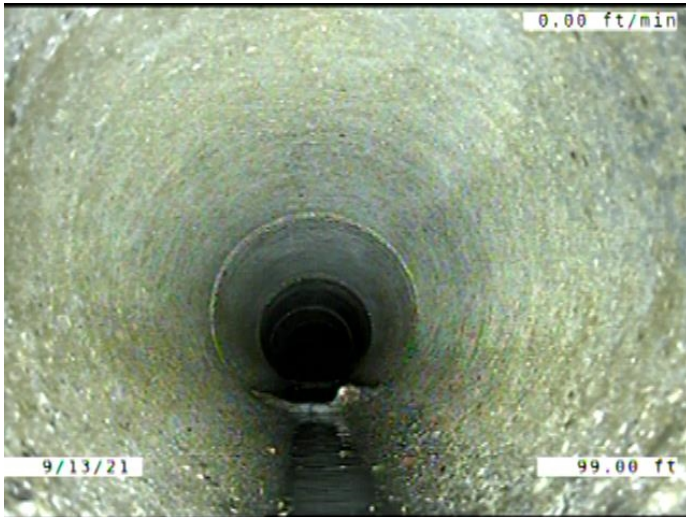
Code: **MWLS**
 Description: **Miscellaneous Water Level Sag**

Distance (ft): **99.0**
 Structural Grade: **2**
 O&M Grade: **0**
 Clock Start/From:
 Clock To:
 1st Value:
 2nd Value:
 Value Percent: **10.000**
 Continuous Index: **F05**
 Within 8" of Joint: **NO**
 Remarks:

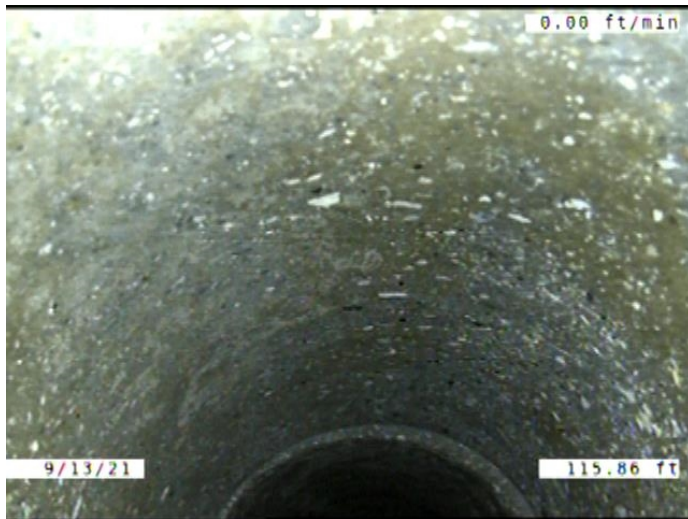
Code: **MWL**
Description: **Miscellaneous Water Level**

Distance (ft): **115.9**
Structural Grade: **0**
O&M Grade: **0**
Clock Start/From:
Clock To:
1st Value:
2nd Value:
Value Percent: **15.000**
Continuous Index:
Within 8" of Joint: **NO**
Remarks:

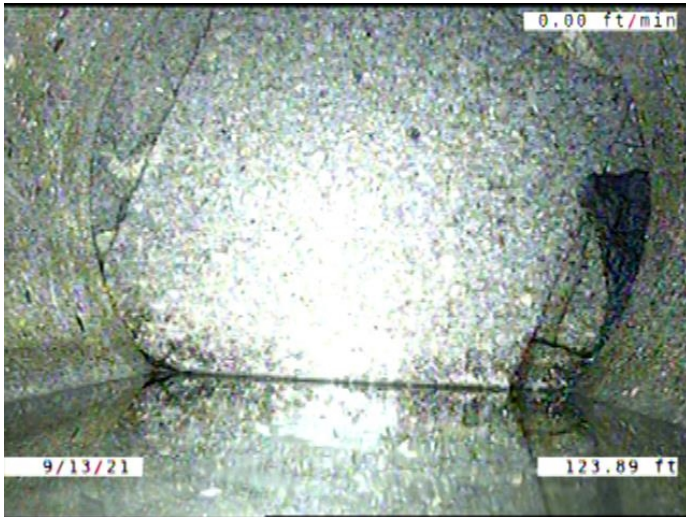
Code: **DSF**
Description: **Deposits Settled Fine**

Distance (ft): **123.9**
Structural Grade: **0**
O&M Grade: **2**
Clock Start/From: **5**
Clock To: **7**
1st Value:
2nd Value:
Value Percent: **5.000**
Continuous Index: **F03**
Within 8" of Joint: **YES**
Remarks:

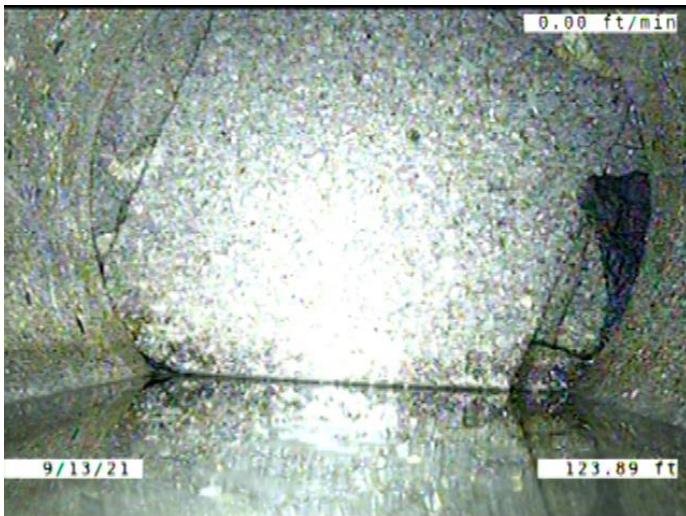
Code: **DAE**
Description: **Deposits Attached Encrustation**

Distance (ft): **123.9**
Structural Grade: **0**
O&M Grade: **2**
Clock Start/From: **3**
Clock To: **9**
1st Value:
2nd Value:
Value Percent: **5.000**
Continuous Index: **F01**
Within 8" of Joint: **YES**
Remarks:
