## Profile/Photo Observation Report

Date:	<b>09/13/2021</b>	Weather:		Coding:	<b>PACP 7.0</b>
Pipe Length (ft):	<b>191.0</b>	Owner:	<b>City of Hobart</b>	Pre Clean:	<b>Light Cleaning</b>
P.O.#:	<b>YES502259</b>	Surveyor:	<b>S. Bucklin</b>	PSR:	<b>P-504-065-065.1</b>
Customer:	<b>City of Hobart</b>	Clean Date:	<b>09/09/2021</b>	Shape:	<b>C</b>

Street:	<b>North Guyer Street</b>	Flow Control:	<b>Not Controlled</b>
City:	<b>Hobart, IN</b>	Year Renewed:	
Location:	<b>Local rural streets with light traffic, t</b>	Tape/Media #:	
Purpose:	<b>Routine Assessment</b>	Dia/Height:	<b>10"</b>
Use:	<b>Sanitary Sewage Pipe</b>	Material:	<b>VCP</b>
Drain Area:		Lining:	<b>None</b>
Category:	<b>NA</b>		
Comment:			
Location Details:		Direction of Survey:	<b>Downstream</b>
US MH:	<b>M-504-065.1</b>	DS MH:	<b>M-504-065</b>
		Total Length Surveyed (ft):	<b>191.0</b>

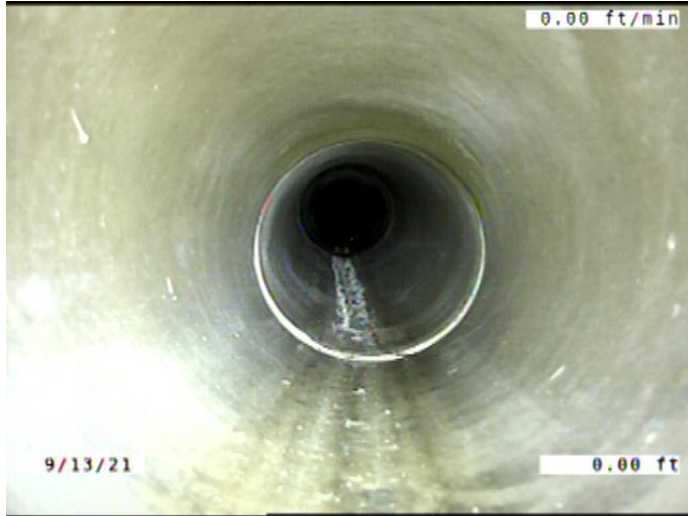
Code:	<b>MWL</b>
Description:	<b>Miscellaneous Water Level</b>
Distance (ft):	<b>.0</b>
Structural Grade:	<b>0</b>
O&M Grade:	<b>0</b>
Clock Start/From:	
Clock To:	
1st Value:	
2nd Value:	
Value Percent:	<b>5.000</b>
Continuous Index:	
Within 8" of Joint:	<b>NO</b>
Remarks:

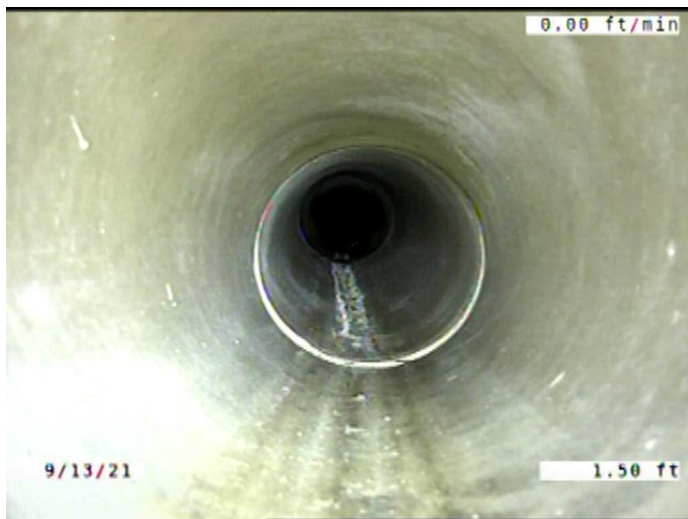
Code:	<b>MGO</b>
Description:	<b>Miscellaneous General Observation</b>
Distance (ft):	<b>1.5</b>
Structural Grade:	<b>0</b>
O&M Grade:	<b>0</b>
Clock Start/From:	
Clock To:	
1st Value:	
2nd Value:	
Value Percent:	
Continuous Index:	
Within 8" of Joint:	<b>NO</b>
Remarks:	<b>DROP INTO THE MANHOLE. HAD TO START IN THE PIPE.</b>

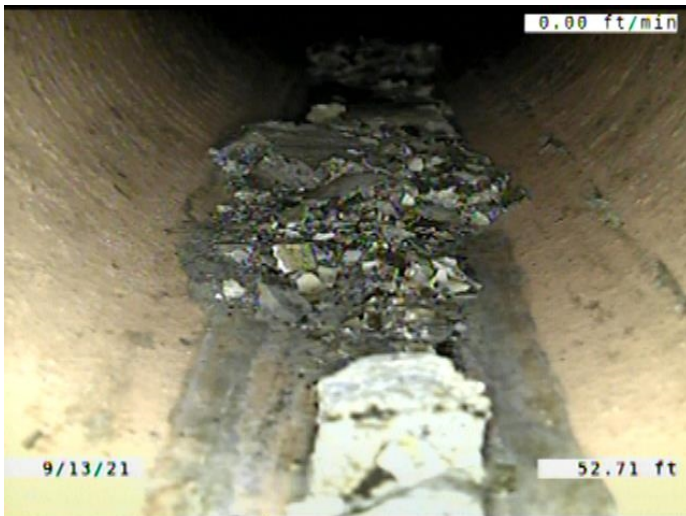
Code: **DSGV**  
 Description: **Deposits Settled Gravel**

Distance (ft): **52.7**  
 Structural Grade: **0**  
 O&M Grade: **2**  
 Clock Start/From: **5**  
 Clock To: **7**  
 1st Value:  
 2nd Value:  
 Value Percent: **5.000**  
 Continuous Index: **S01**  
 Within 8" of Joint: **YES**  
 Remarks:

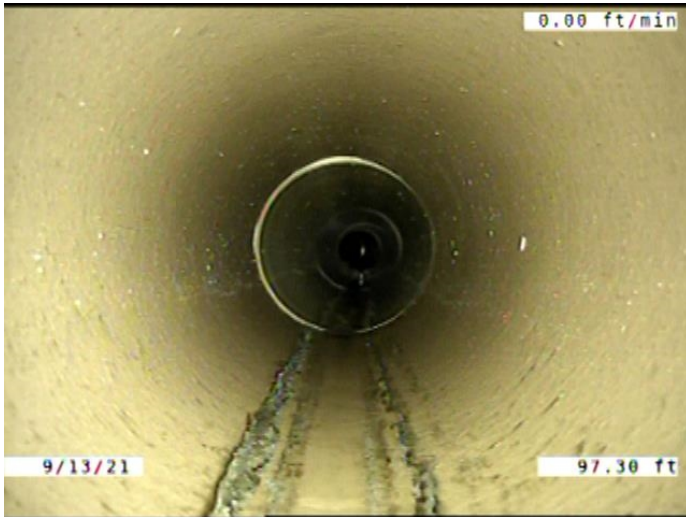
Code: **DSGV**  
Description: **Deposits Settled Gravel**

Distance (ft): **97.3**  
Structural Grade: **0**  
O&M Grade: **2**  
Clock Start/From: **5**  
Clock To: **7**  
1st Value:  
2nd Value:  
Value Percent: **5.000**  
Continuous Index: **F01**  
Within 8" of Joint: **YES**  
Remarks:

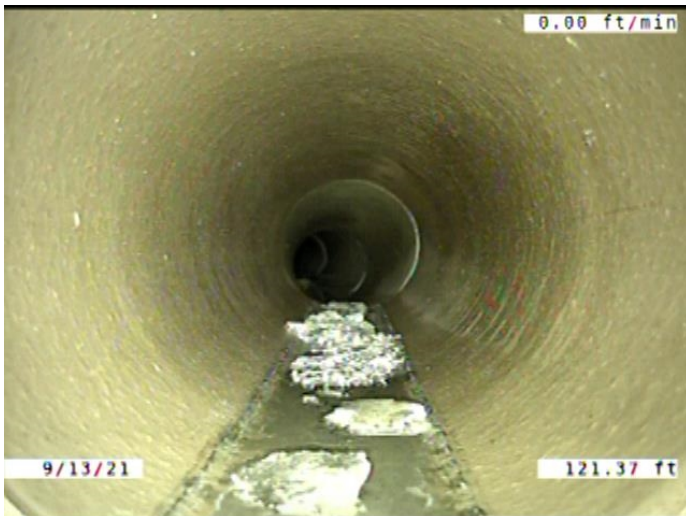
Code: **DSF**  
Description: **Deposits Settled Fine**

Distance (ft): **121.4**  
Structural Grade: **0**  
O&M Grade: **2**  
Clock Start/From: **5**  
Clock To: **7**  
1st Value:  
2nd Value:  
Value Percent: **5.000**  
Continuous Index: **S02**  
Within 8" of Joint: **YES**  
Remarks:

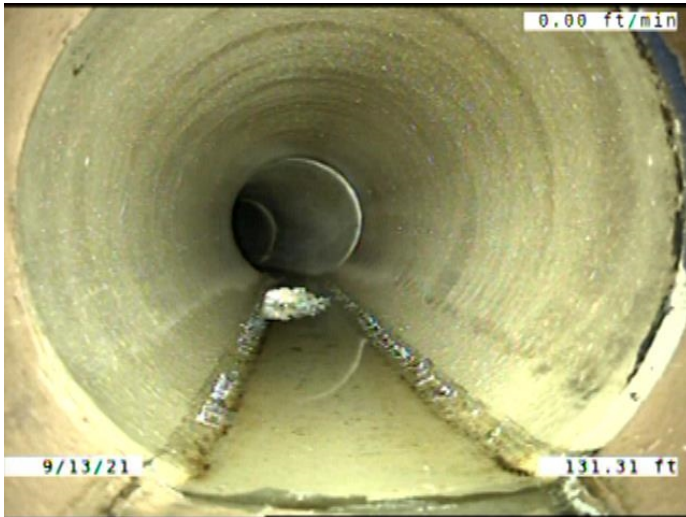
Code:	<b>MWLS</b>
Description:	<b>Miscellaneous Water Level Sag</b>
Distance (ft):	<b>131.3</b>
Structural Grade:	<b>2</b>
O&M Grade:	<b>0</b>
Clock Start/From:	
Clock To:	
1st Value:	
2nd Value:	
Value Percent:	<b>5.000</b>
Continuous Index:	
Within 8" of Joint:	<b>NO</b>
Remarks:

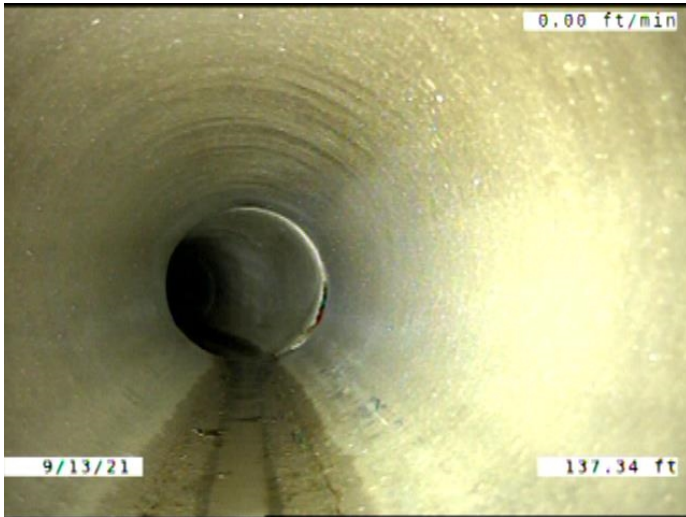
Code: **DSF**  
Description: **Deposits Settled Fine**

Distance (ft): **137.3**  
Structural Grade: **0**  
O&M Grade: **2**  
Clock Start/From: **5**  
Clock To: **7**  
1st Value:  
2nd Value:  
Value Percent: **5.000**  
Continuous Index: **F02**  
Within 8" of Joint: **YES**  
Remarks:

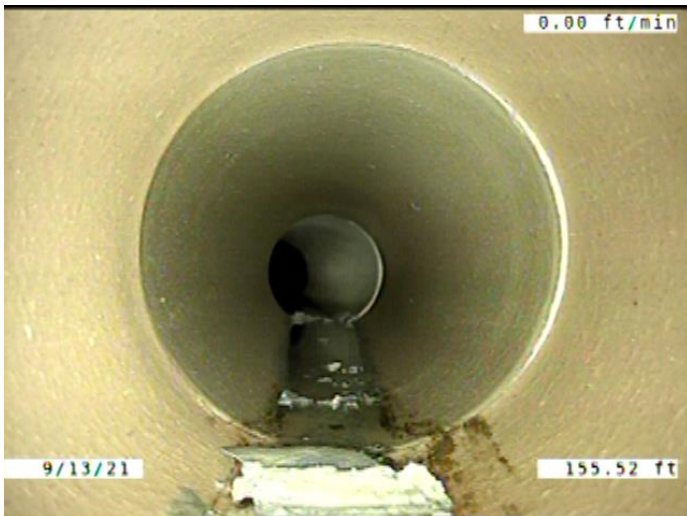
Code: **DSF**  
 Description: **Deposits Settled Fine**

Distance (ft): **155.5**  
 Structural Grade: **0**  
 O&M Grade: **2**  
 Clock Start/From: **5**  
 Clock To: **7**  
 1st Value:  
 2nd Value:  
 Value Percent: **5.000**  
 Continuous Index: **S03**  
 Within 8" of Joint: **YES**  
 Remarks:

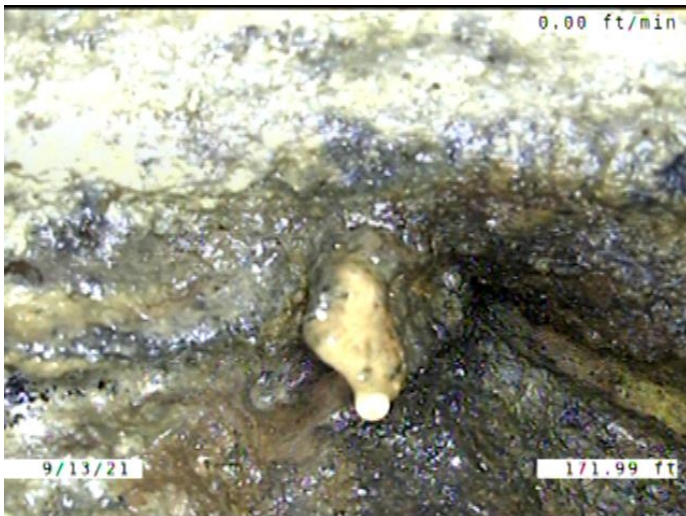
Code: **IWJ**  
 Description: **Infiltration Weeper Joint**

Distance (ft): **172.0**  
 Structural Grade: **0**  
 O&M Grade: **2**  
 Clock Start/From: **12**  
 Clock To:  
 1st Value:  
 2nd Value:  
 Value Percent:  
 Continuous Index:  
 Within 8" of Joint: **YES**  
 Remarks:

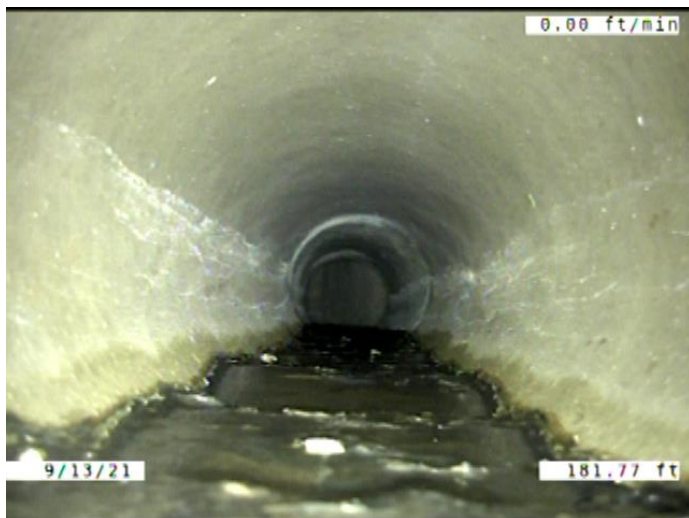
Code: **LD**  
 Description: **Line Down**

Distance (ft): **181.8**  
 Structural Grade: **0**  
 O&M Grade: **2**  
 Clock Start/From:  
 Clock To:  
 1st Value:  
 2nd Value:  
 Value Percent: **20.000**  
 Continuous Index:  
 Within 8" of Joint: **NO**  
 Remarks:
