Profile/Photo Observation Report

Date:	09/13/2021	Weather:		Coding:	PACP 7.0
Pipe Length (ft):	191.0	Owner:	City of Hobart	Pre Clean:	Light Cleaning
P.O.#:	YES502259	Surveyor:	S. Bucklin	PSR:	P-504-065-065.1
Customer:	City of Hobart	Clean Date:	09/09/2021	Shape:	C

Street:	North Guyer Street	Flow Control:	Not Controlled
City:	Hobart, IN	Year Renewed:	
Location:	Local rural streets with light traffic, t	Tape/Media #:	
Purpose:	Routine Assessment	Dia/Height:	10"
Use:	Sanitary Sewage Pipe	Material:	VCP
Drain Area:		Lining:	None
Category:	NA		
Comment:			
Location Details:		Direction of Survey:	Downstream
US MH:	M-504-065.1	DS MH:	M-504-065
		Total Length Surveyed (ft):	191.0

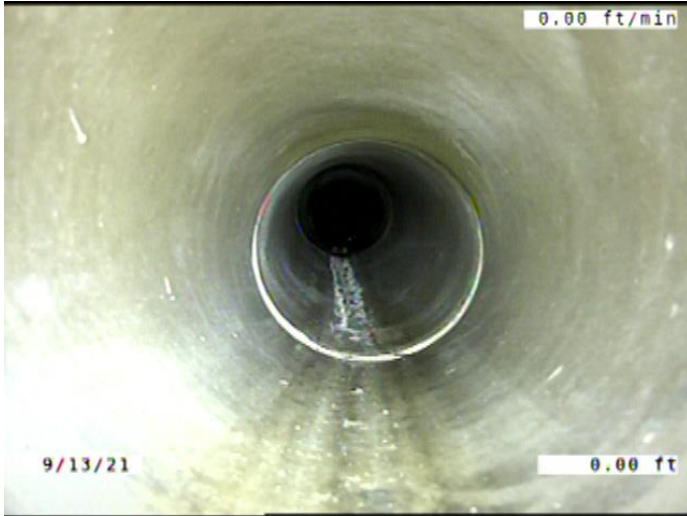
Code: **MWL**
Description: **Miscellaneous Water Level**

Distance (ft): **.0**
Structural Grade: **0**
O&M Grade: **0**
Clock Start/From:
Clock To:
1st Value:
2nd Value:
Value Percent: **5.000**
Continuous Index:
Within 8" of Joint: **NO**
Remarks:

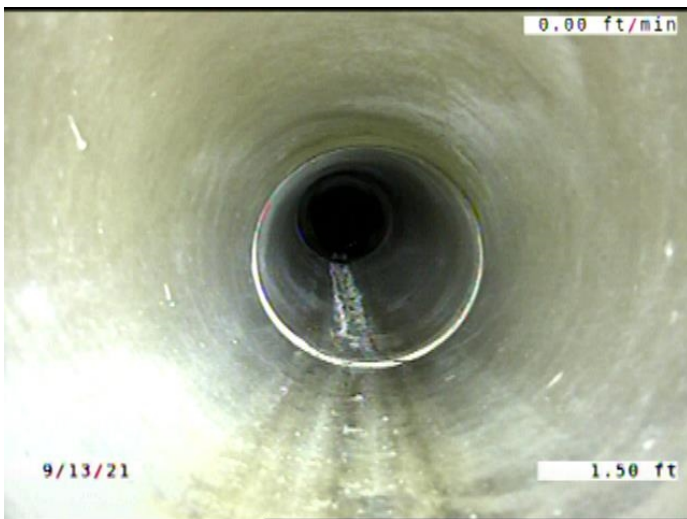
Code: **MGO**
Description: **Miscellaneous General Observation**

Distance (ft): **1.5**
Structural Grade: **0**
O&M Grade: **0**
Clock Start/From:
Clock To:
1st Value:
2nd Value:
Value Percent:
Continuous Index:
Within 8" of Joint: **NO**
Remarks: **DROP INTO THE MANHOLE. HAD TO START IN THE PIPE.**

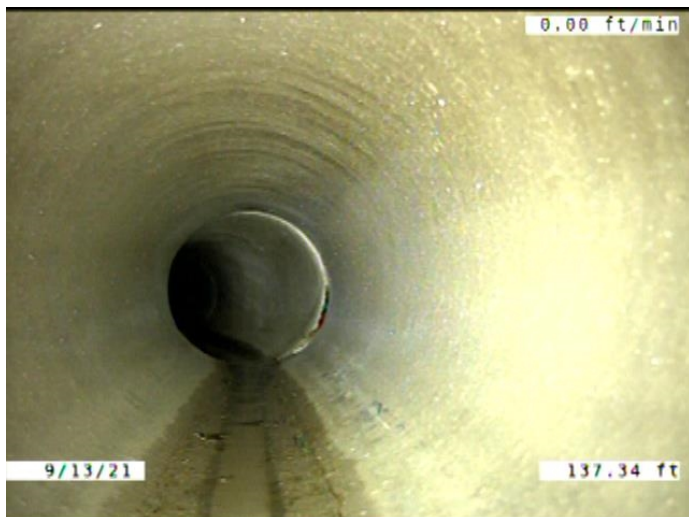
Code: **DSF**
 Description: **Deposits Settled Fine**

Distance (ft): **137.3**
 Structural Grade: **0**
 O&M Grade: **2**
 Clock Start/From: **5**
 Clock To: **7**
 1st Value:
 2nd Value:
 Value Percent: **5.000**
 Continuous Index: **F02**
 Within 8" of Joint: **YES**
 Remarks:

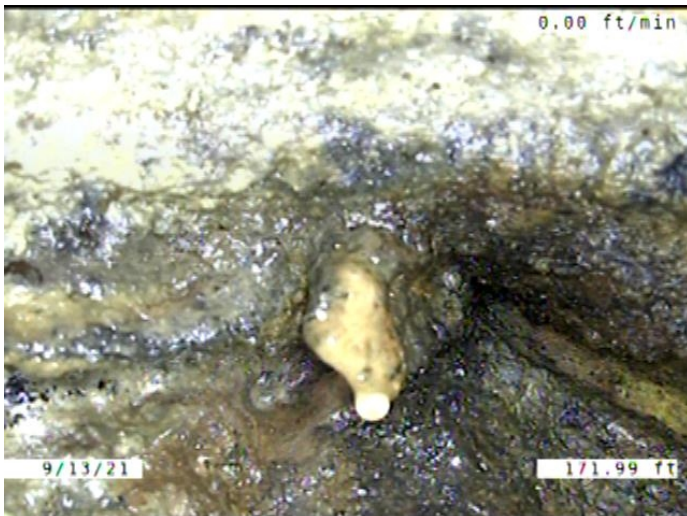
Code: **IWJ**
 Description: **Infiltration Weeper Joint**

Distance (ft): **172.0**
 Structural Grade: **0**
 O&M Grade: **2**
 Clock Start/From: **12**
 Clock To:
 1st Value:
 2nd Value:
 Value Percent:
 Continuous Index:
 Within 8" of Joint: **YES**
 Remarks:
