Profile/Photo Observation Report

Date:	04/11/2018	Weather:		Coding:	PACP 6.0
Pipe Length (ft):		Owner:	City of Hobart	Pre Clean:	No Pre-Cleaning
P.O.#:	29-2	Surveyor:	M. Pielacha	PSR:	M-504-067-M-504-060
Customer:	City of Hobart	Clean Date:		Shape:	C

US MH: **M-504-067** DS MH: **M-504-060** Total Length Surveyed (ft): **156.7**

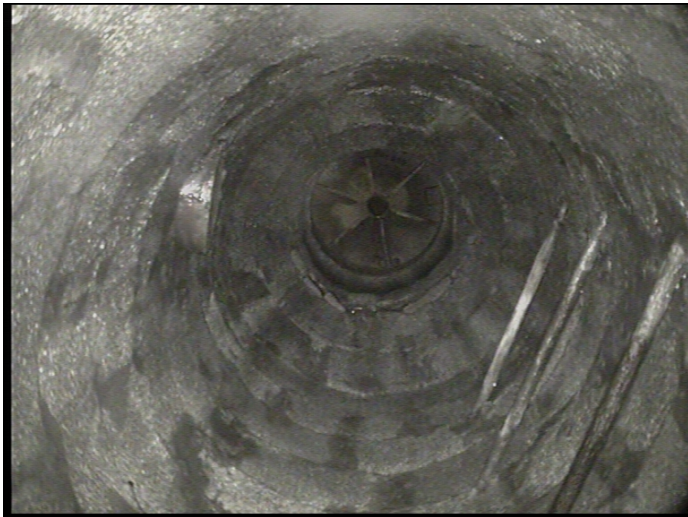
Code: **AMH**
Description: **Manhole**

Distance (ft): **.0**
Structural Grade: **0**
O&M Grade: **0**
Clock Start/From:
Clock To:
1st Value:
2nd Value:
Value Percent:
Continuous Index:
Within 8" of Joint: **NO**
Remarks: **M-504-067**

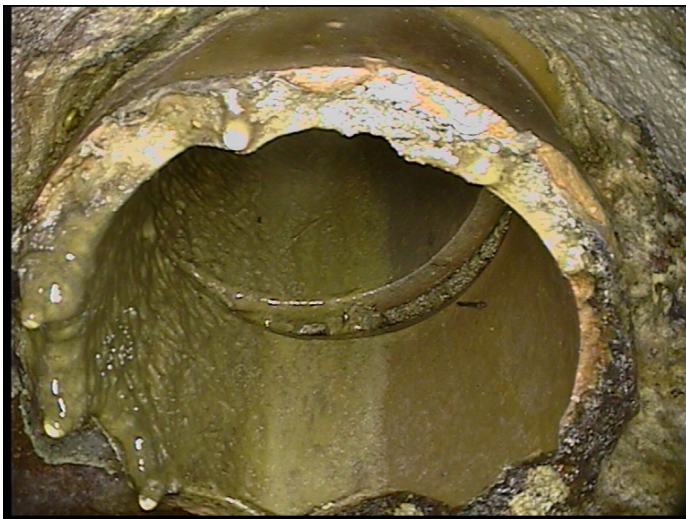
Code: **TB**
Description: **Tap Break-in**

Distance (ft): **75.7**
Structural Grade: **0**
O&M Grade: **0**
Clock Start/From: **12**
Clock To:
1st Value: **4.000**
2nd Value:
Value Percent:
Continuous Index:
Within 8" of Joint: **NO**
Remarks:
