Profile/Photo Observation Report

Street:	Off Wisconsin Street	Flow Control:	Not Controlled
City:	Hobart, IN	Year Renewed:	
Location:	Light Highway	Tape/Media #:	DEP 29
Purpose:	Routine Assessment	Dia/Height:	18"
Use:	Sanitary	Material:	VCP
Drain Area:		Lining:

US MH: **M-504-067** DS MH: **M-504-060** Total Length Surveyed (ft): **156.7**

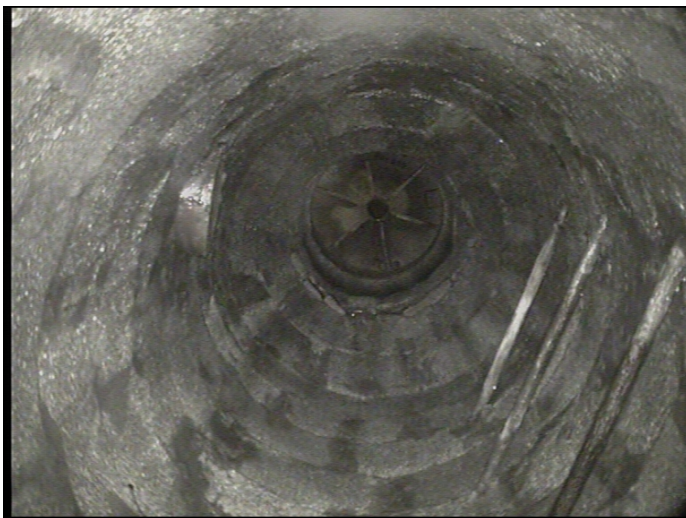
Code: **AMH**
 Description: **Manhole**

Distance (ft): **.0**
 Structural Grade: **0**
 O&M Grade: **0**
 Clock Start/From:
 Clock To:
 1st Value:
 2nd Value:
 Value Percent:
 Continuous Index:
 Within 8" of Joint: **NO**
 Remarks: **M-504-067**

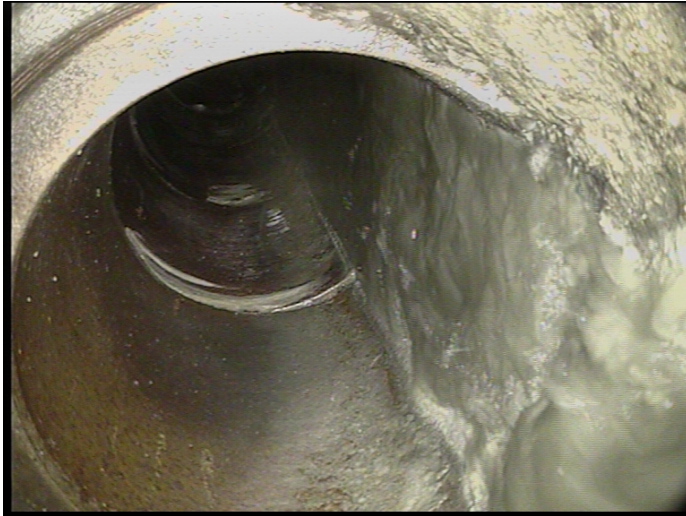
Code: **MWL**
Description: **Water Level**

Distance (ft): **.0**
Structural Grade: **0**
O&M Grade: **0**
Clock Start/From:
Clock To:
1st Value:
2nd Value:
Value Percent: **10.000**
Continuous Index:
Within 8" of Joint: **NO**
Remarks:

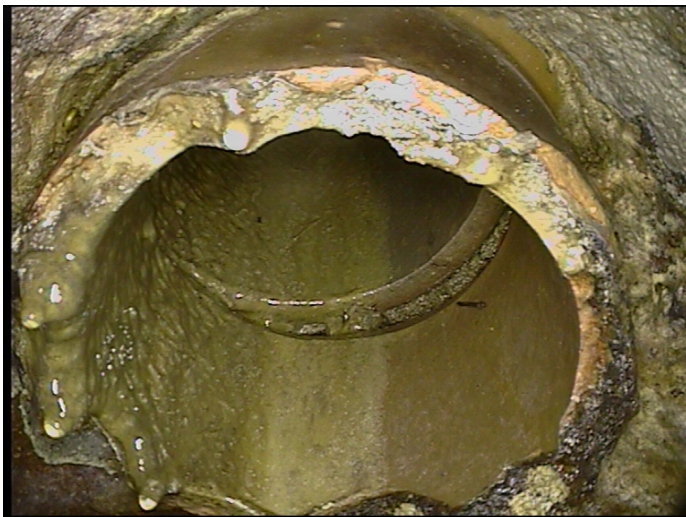
Code: **TB**
Description: **Tap Break-in**

Distance (ft): **75.7**
Structural Grade: **0**
O&M Grade: **0**
Clock Start/From: **12**
Clock To:
1st Value: **4.000**
2nd Value:
Value Percent:
Continuous Index:
Within 8" of Joint: **NO**
Remarks:

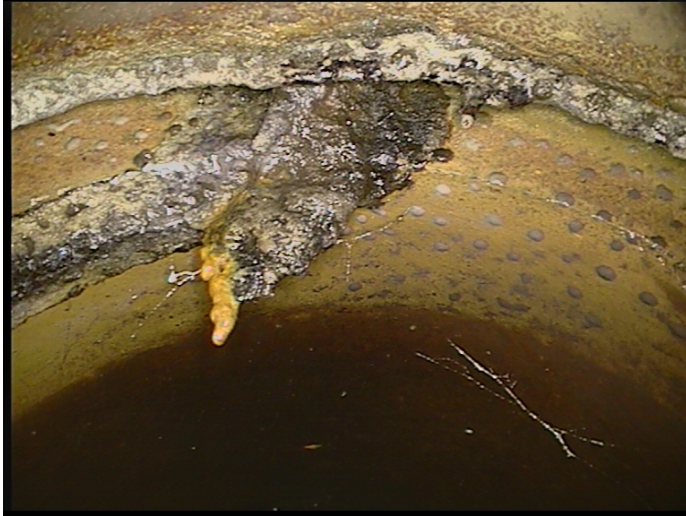
Code: **ID**
Description: **Infil Dripper**

Distance (ft): **153.9**
Structural Grade: **0**
O&M Grade: **3**
Clock Start/From: **11**
Clock To:
1st Value:
2nd Value:
Value Percent:
Continuous Index:
Within 8" of Joint: **YES**
Remarks:

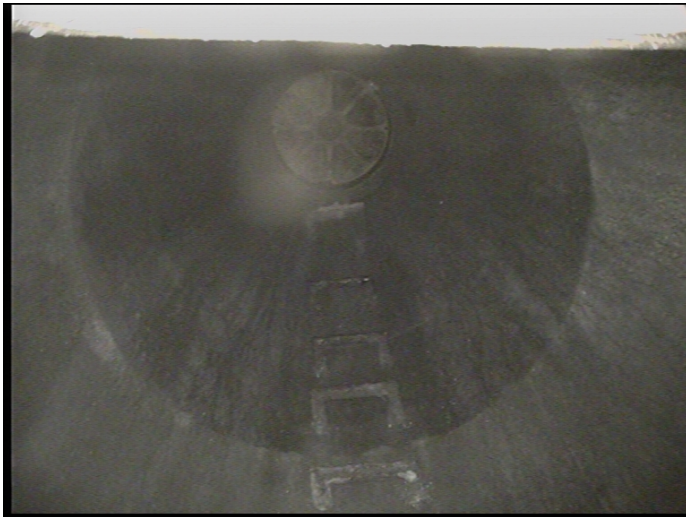
Code: **AMH**
Description: **Manhole**

Distance (ft): **156.7**
Structural Grade: **0**
O&M Grade: **0**
Clock Start/From:
Clock To:
1st Value:
2nd Value:
Value Percent:
Continuous Index:
Within 8" of Joint: **NO**
Remarks: **M-504-060**
