Profile/Photo Observation Report

Date:	04/11/2018	Weather:		Coding:	PACP 6.0
Pipe Length (ft):		Owner:	City of Hobart	Pre Clean:	No Pre-Cleaning
P.O.#:	29-1	Surveyor:	M. Pielacha	PSR:	M-504-068-M-504-067
Customer:	City of Hobart	Clean Date:		Shape:	C

Street:	Off Wisconsin Street	Flow Control:	Not Controlled
City:	Hobart, IN	Year Renewed:	
Location:	Light Highway	Tape/Media #:	DEP 29
Purpose:	Routine Assessment	Dia/Height:	18"
Use:	Sanitary	Material:	VCP
Drain Area:		Lining:	
Category:	NA		
Comment:			
Location Details:		Direction of Survey:	Downstream
US MH:	M-504-068	DS MH:	M-504-067
		Total Length Surveyed (ft):	152.8

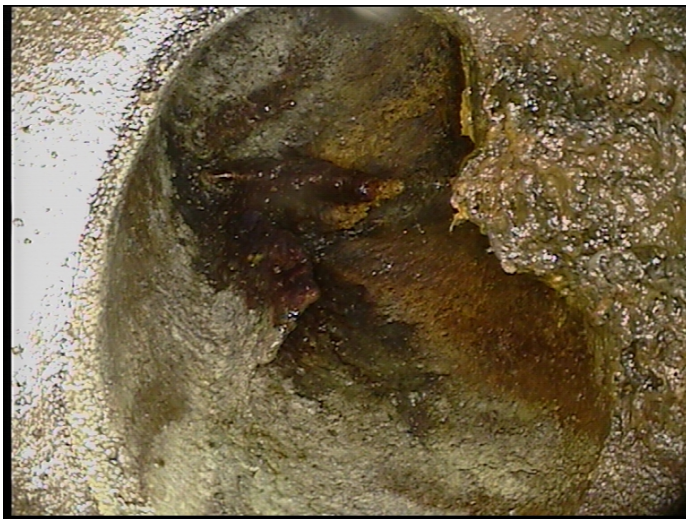
Code: **TFC**
Description: **Tap Factory Capped**

Distance (ft): **47.8**
Structural Grade: **0**
O&M Grade: **0**
Clock Start/From: **2**
Clock To:
1st Value: **4.000**
2nd Value:
Value Percent:
Continuous Index:
Within 8" of Joint: **NO**
Remarks:

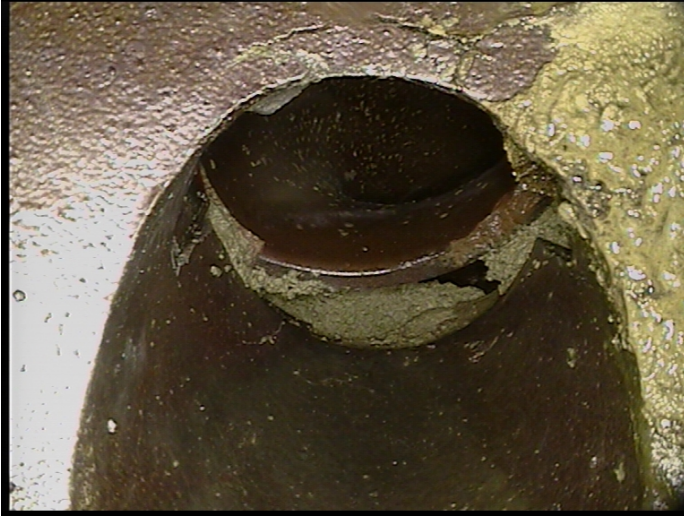
Code: **TF**
Description: **Tap Factory**

Distance (ft): **73.8**
Structural Grade: **0**
O&M Grade: **0**
Clock Start/From: **2**
Clock To:
1st Value: **4.000**
2nd Value:
Value Percent:
Continuous Index:
Within 8" of Joint: **NO**
Remarks:

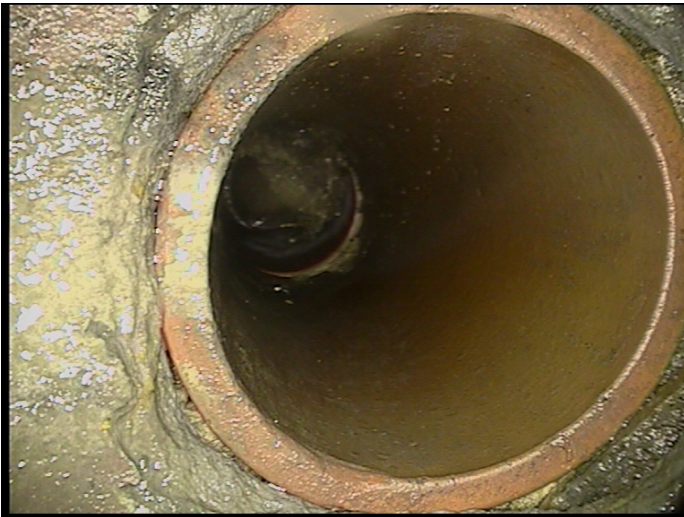
Code: **TB**
Description: **Tap Break-in**

Distance (ft): **74.4**
Structural Grade: **0**
O&M Grade: **0**
Clock Start/From: **11**
Clock To:
1st Value: **4.000**
2nd Value:
Value Percent:
Continuous Index:
Within 8" of Joint: **NO**
Remarks:

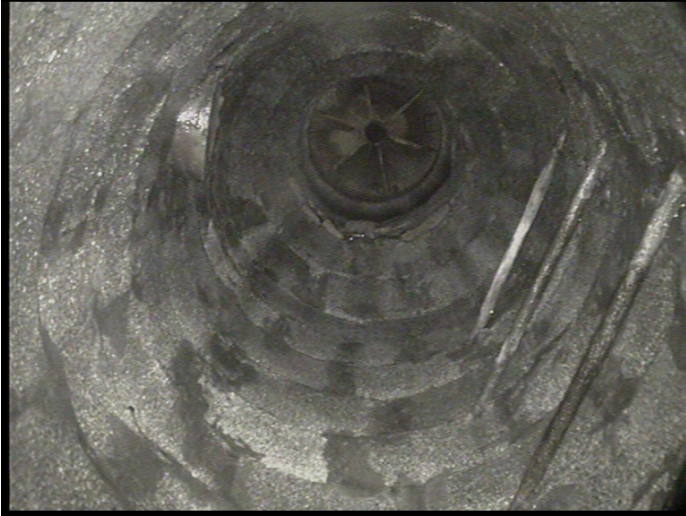
Code:	AMH
Description:	Manhole
Distance (ft):	152.8
Structural Grade:	0
O&M Grade:	0
Clock Start/From:	
Clock To:	
1st Value:	
2nd Value:	
Value Percent:	
Continuous Index:	
Within 8" of Joint:	NO
Remarks:	M-504-067
