## Profile/Photo Observation Report

Date:	<b>04/11/2018</b>	Weather:		Coding:	<b>PACP 6.0</b>
Pipe Length (ft):		Owner:	<b>City of Hobart</b>	Pre Clean:	<b>No Pre-Cleaning</b>
P.O.#:	<b>29-1</b>	Surveyor:	<b>M. Pielacha</b>	PSR:	<b>M-504-068-M-504-067</b>
Customer:	<b>City of Hobart</b>	Clean Date:		Shape:	<b>C</b>

Street:	<b>Off Wisconsin Street</b>	Flow Control:	<b>Not Controlled</b>
City:	<b>Hobart, IN</b>	Year Renewed:	
Location:	<b>Light Highway</b>	Tape/Media #:	<b>DEP 29</b>
Purpose:	<b>Routine Assessment</b>	Dia/Height:	<b>18"</b>
Use:	<b>Sanitary</b>	Material:	<b>VCP</b>
Drain Area:		Lining:

US MH: **M-504-068** DS MH: **M-504-067** Total Length Surveyed (ft): **152.8**

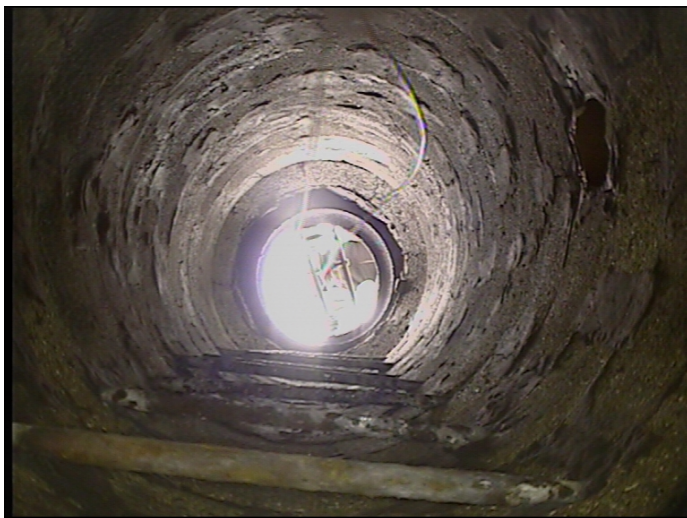
Code: **AMH**  
 Description: **Manhole**

Distance (ft): **.0**  
 Structural Grade: **0**  
 O&M Grade: **0**  
 Clock Start/From:  
 Clock To:  
 1st Value:  
 2nd Value:  
 Value Percent:  
 Continuous Index:  
 Within 8" of Joint: **NO**  
 Remarks: **M-504-068**

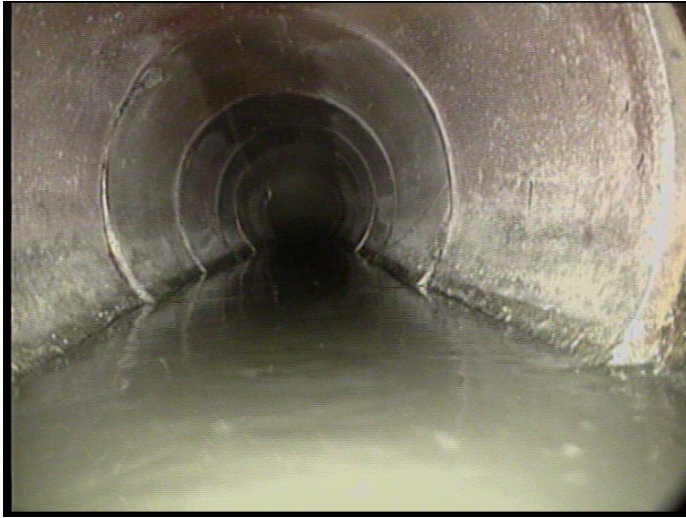
Code:	<b>MWL</b>
Description:	<b>Water Level</b>
Distance (ft):	<b>.0</b>
Structural Grade:	<b>0</b>
O&M Grade:	<b>0</b>
Clock Start/From:	
Clock To:	
1st Value:	
2nd Value:	
Value Percent:	<b>10.000</b>
Continuous Index:	
Within 8" of Joint:	<b>NO</b>
Remarks:

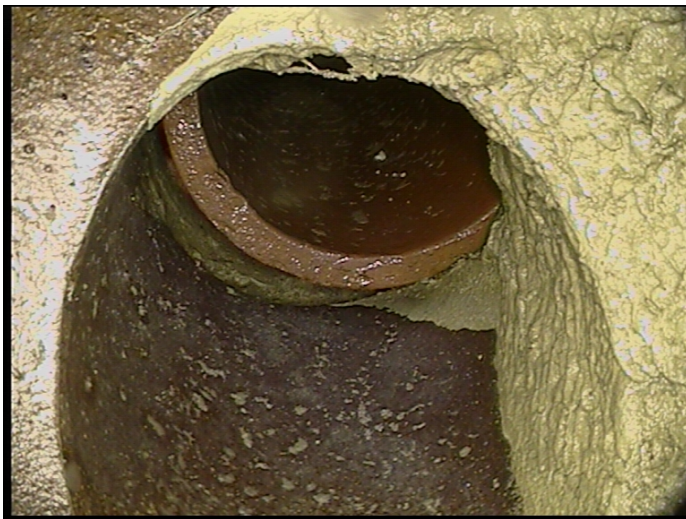
Code:	<b>TF</b>
Description:	<b>Tap Factory</b>
Distance (ft):	<b>25.3</b>
Structural Grade:	<b>0</b>
O&M Grade:	<b>0</b>
Clock Start/From:	<b>2</b>
Clock To:	
1st Value:	<b>4.000</b>
2nd Value:	
Value Percent:	
Continuous Index:	
Within 8" of Joint:	<b>NO</b>
Remarks:

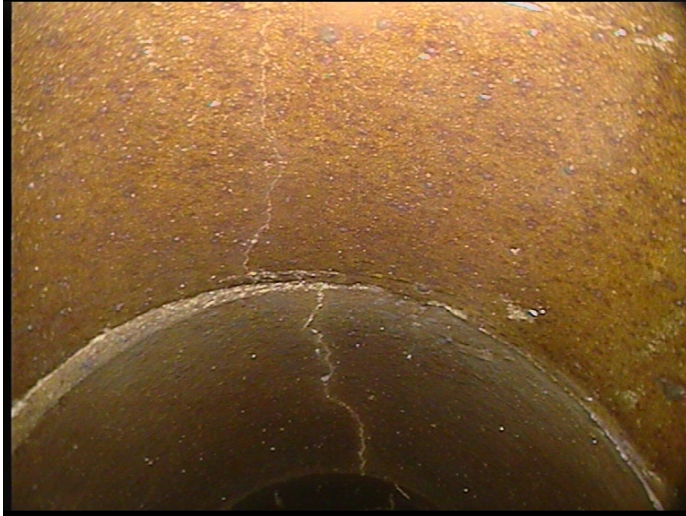
Code: **CL**  
Description: **Crack Longitudinal**

Distance (ft): **26.8**  
Structural Grade: **2**  
O&M Grade: **0**  
Clock Start/From: **12**  
Clock To:  
1st Value:  
2nd Value:  
Value Percent:  
Continuous Index: **S01**  
Within 8" of Joint: **YES**  
Remarks:

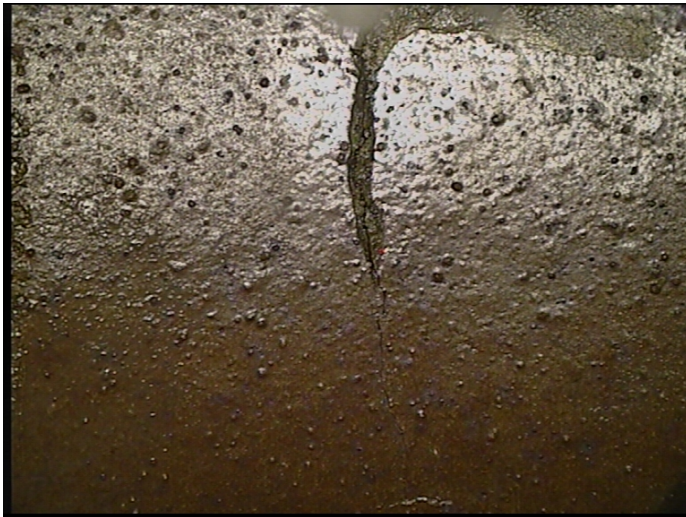
Code: **CL**  
Description: **Crack Longitudinal**

Distance (ft): **37.3**  
Structural Grade: **2**  
O&M Grade: **0**  
Clock Start/From: **12**  
Clock To:  
1st Value:  
2nd Value:  
Value Percent:  
Continuous Index: **F01**  
Within 8" of Joint: **NO**  
Remarks:

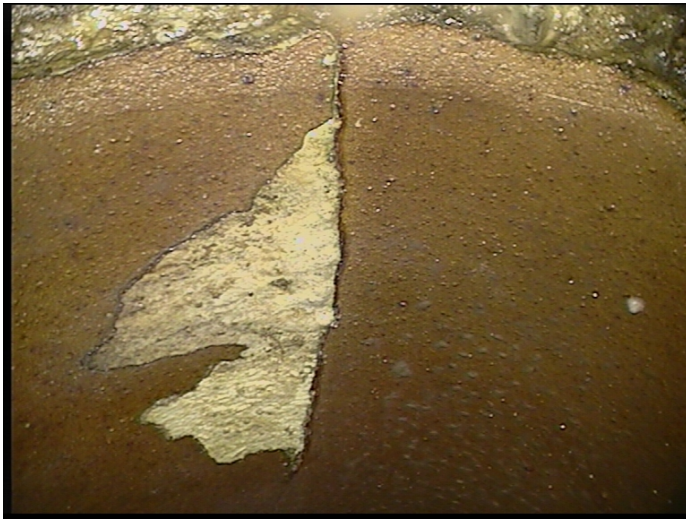
Code: **CL**  
Description: **Crack Longitudinal**

Distance (ft): **40.5**  
Structural Grade: **2**  
O&M Grade: **0**  
Clock Start/From: **11**  
Clock To:  
1st Value:  
2nd Value:  
Value Percent:  
Continuous Index:  
Within 8" of Joint: **YES**  
Remarks:

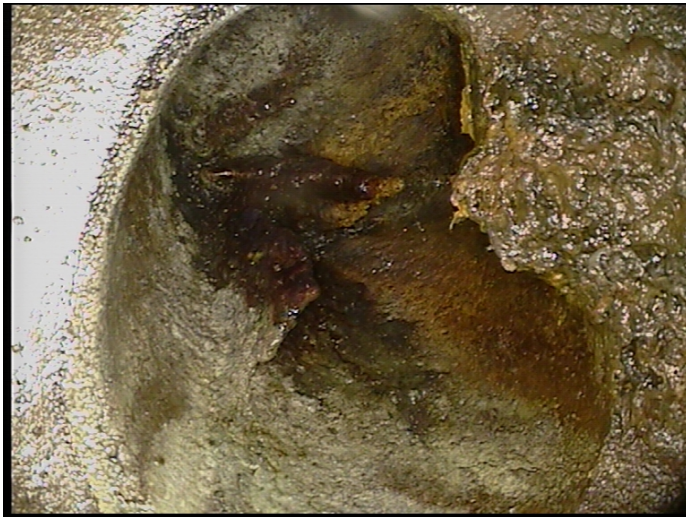
Code: **TFC**  
Description: **Tap Factory Capped**

Distance (ft): **47.8**  
Structural Grade: **0**  
O&M Grade: **0**  
Clock Start/From: **2**  
Clock To:  
1st Value: **4.000**  
2nd Value:  
Value Percent:  
Continuous Index:  
Within 8" of Joint: **NO**  
Remarks:

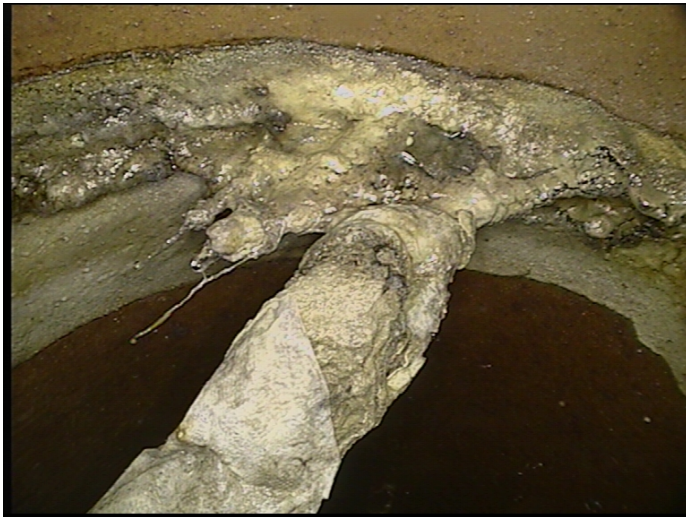
Code:	<b>DAE</b>
Description:	<b>Deposits Attached Encrustation</b>
Distance (ft):	<b>58.2</b>
Structural Grade:	<b>0</b>
O&M Grade:	<b>2</b>
Clock Start/From:	<b>11</b>
Clock To:	
1st Value:	
2nd Value:	
Value Percent:	<b>5.000</b>
Continuous Index:	
Within 8" of Joint:	<b>YES</b>
Remarks:

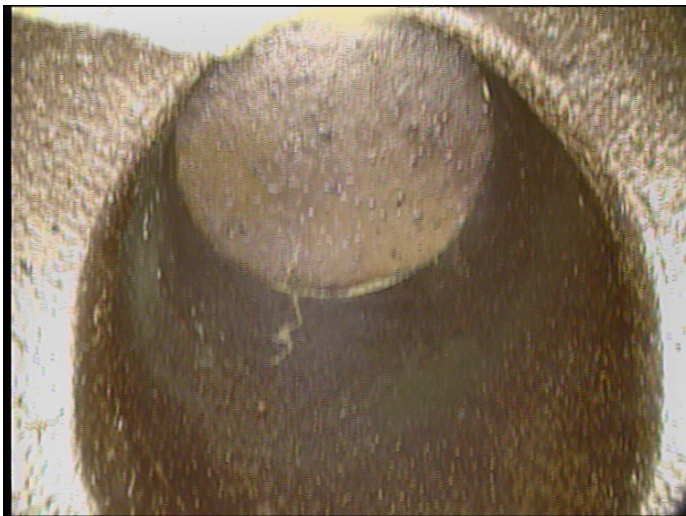
Code:	<b>TFC</b>
Description:	<b>Tap Factory Capped</b>
Distance (ft):	<b>71.9</b>
Structural Grade:	<b>0</b>
O&M Grade:	<b>0</b>
Clock Start/From:	<b>10</b>
Clock To:	
1st Value:	<b>4.000</b>
2nd Value:	
Value Percent:	
Continuous Index:	
Within 8" of Joint:	<b>NO</b>
Remarks:

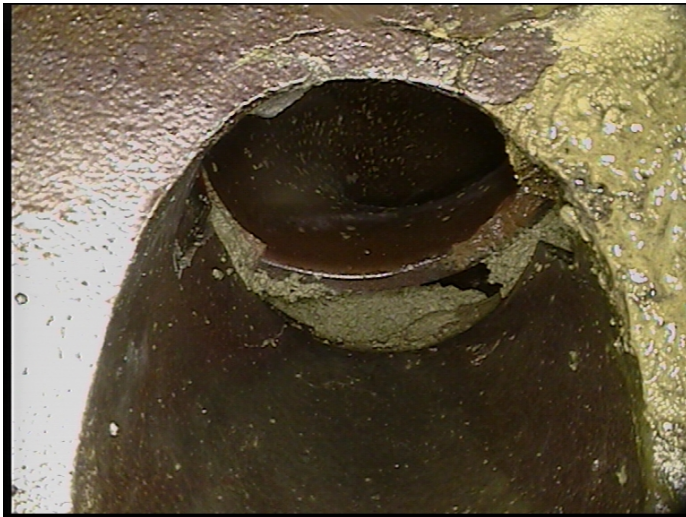
Code: **TF**  
Description: **Tap Factory**

Distance (ft): **73.8**  
Structural Grade: **0**  
O&M Grade: **0**  
Clock Start/From: **2**  
Clock To:  
1st Value: **4.000**  
2nd Value:  
Value Percent:  
Continuous Index:  
Within 8" of Joint: **NO**  
Remarks:

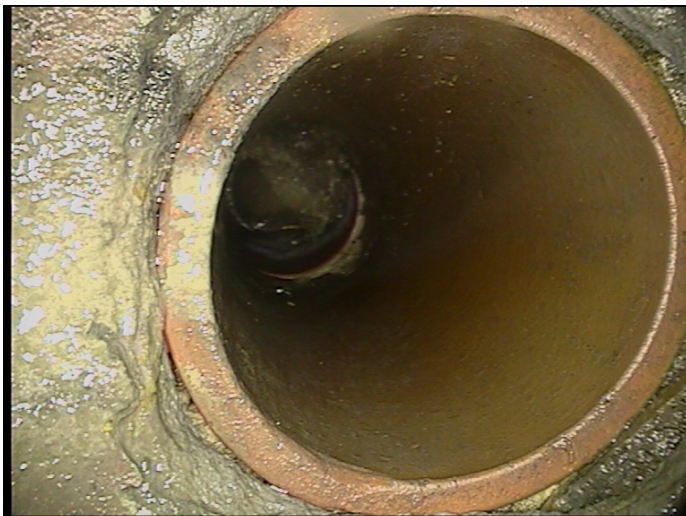
Code: **TB**  
Description: **Tap Break-in**

Distance (ft): **74.4**  
Structural Grade: **0**  
O&M Grade: **0**  
Clock Start/From: **11**  
Clock To:  
1st Value: **4.000**  
2nd Value:  
Value Percent:  
Continuous Index:  
Within 8" of Joint: **NO**  
Remarks:

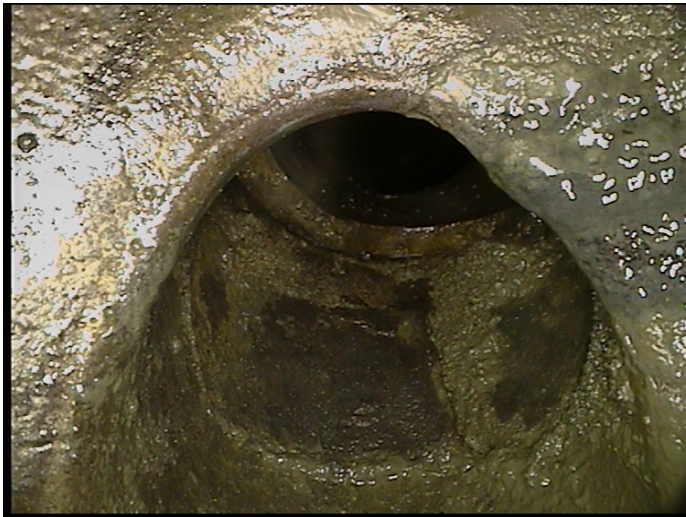
Code: **TF**  
Description: **Tap Factory**

Distance (ft): **96.4**  
Structural Grade: **0**  
O&M Grade: **0**  
Clock Start/From: **2**  
Clock To:  
1st Value: **4.000**  
2nd Value:  
Value Percent:  
Continuous Index:  
Within 8" of Joint: **NO**  
Remarks:

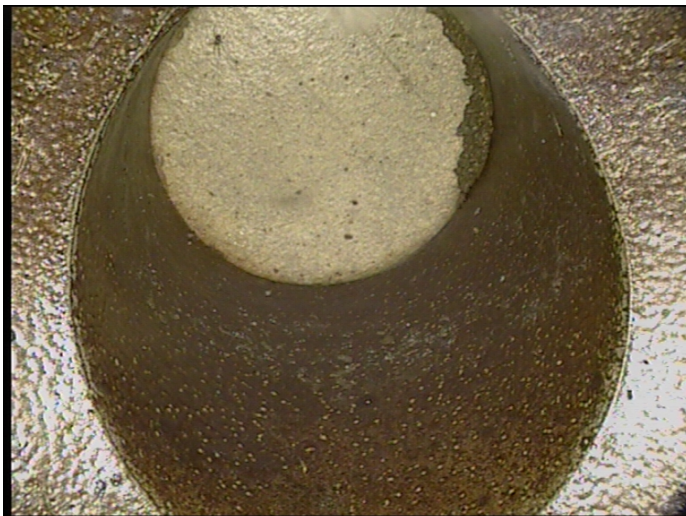
Code: **TFC**  
Description: **Tap Factory Capped**

Distance (ft): **123.2**  
Structural Grade: **0**  
O&M Grade: **0**  
Clock Start/From: **2**  
Clock To:  
1st Value: **4.000**  
2nd Value:  
Value Percent:  
Continuous Index:  
Within 8" of Joint: **NO**  
Remarks:

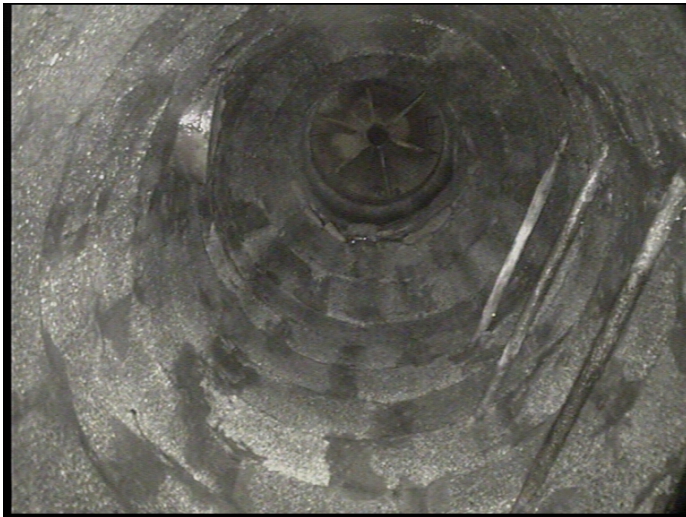
Code:	<b>AMH</b>
Description:	<b>Manhole</b>
Distance (ft):	<b>152.8</b>
Structural Grade:	<b>0</b>
O&M Grade:	<b>0</b>
Clock Start/From:	
Clock To:	
1st Value:	
2nd Value:	
Value Percent:	
Continuous Index:	
Within 8" of Joint:	<b>NO</b>
Remarks:	<b>M-504-067</b>
