Profile/Photo Observation Report

Date:	04/11/2018	Weather:		Coding:	PACP 6.0
Pipe Length (ft):		Owner:	City of Hobart	Pre Clean:	No Pre-Cleaning
P.O.#:	28-1	Surveyor:	M. Pielacha	PSR:	M-504-069-M-504-068
Customer:	City of Hobart	Clean Date:		Shape:	C

Street:	Off Old Ridge Road	Flow Control:	Not Controlled
City:	Hobart, IN	Year Renewed:	
Location:	Yard	Tape/Media #:	DEP 28
Purpose:	Routine Assessment	Dia/Height:	18"
Use:	Sanitary	Material:	VCP
Drain Area:		Lining:	
Category:	NA		
Comment:			
Location Details:		Direction of Survey:	Upstream
US MH:	M-504-069	DS MH:	M-504-068
		Total Length Surveyed (ft):	90.5

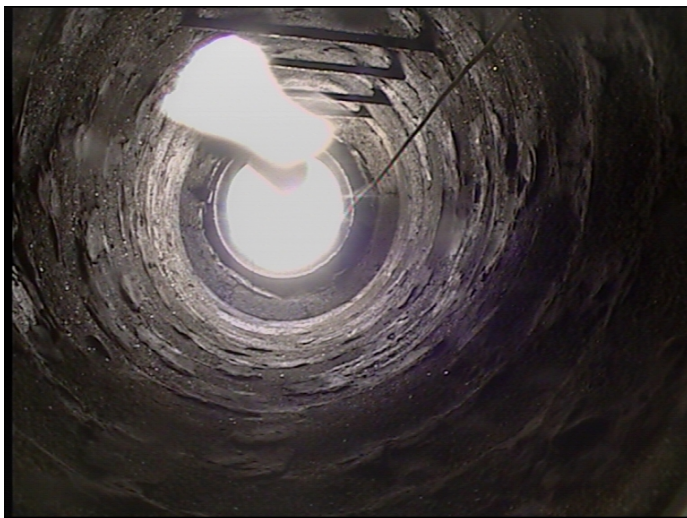
Code: **AMH**
 Description: **Manhole**

Distance (ft): **.0**
 Structural Grade: **0**
 O&M Grade: **0**
 Clock Start/From:
 Clock To:
 1st Value:
 2nd Value:
 Value Percent:
 Continuous Index:
 Within 8" of Joint: **NO**
 Remarks: **M-504-068**

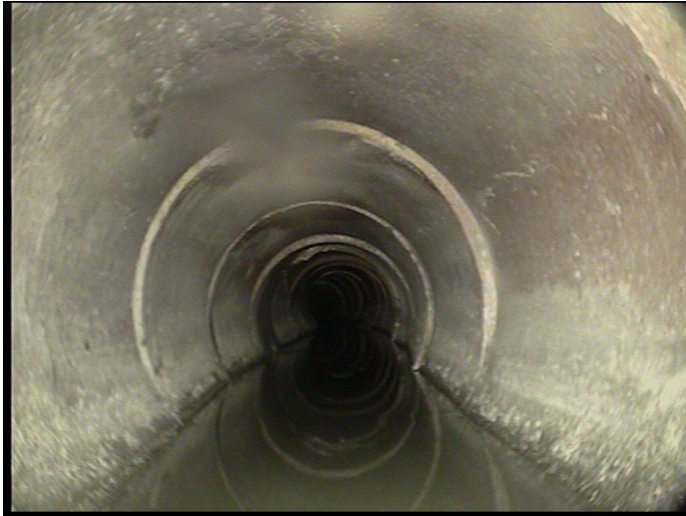
Code: **MWL**
Description: **Water Level**

Distance (ft): **.0**
Structural Grade: **0**
O&M Grade: **0**
Clock Start/From:
Clock To:
1st Value:
2nd Value:
Value Percent: **10.000**
Continuous Index:
Within 8" of Joint: **NO**
Remarks:

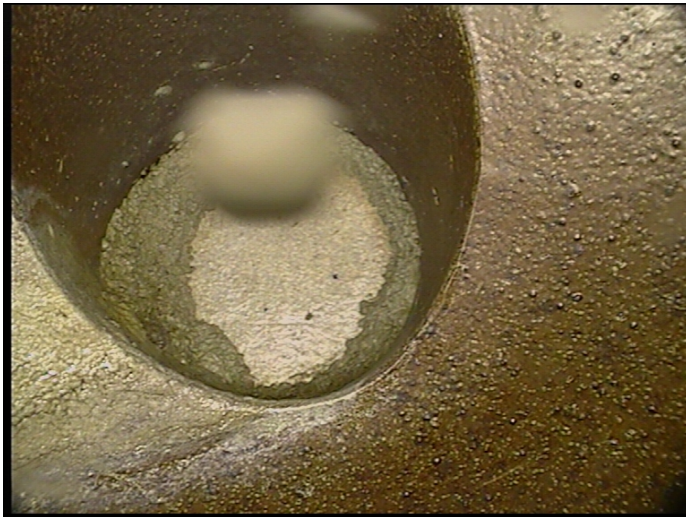
Code: **TFC**
Description: **Tap Factory Capped**

Distance (ft): **26.6**
Structural Grade: **0**
O&M Grade: **0**
Clock Start/From: **11**
Clock To:
1st Value: **4.000**
2nd Value:
Value Percent:
Continuous Index:
Within 8" of Joint: **NO**
Remarks:

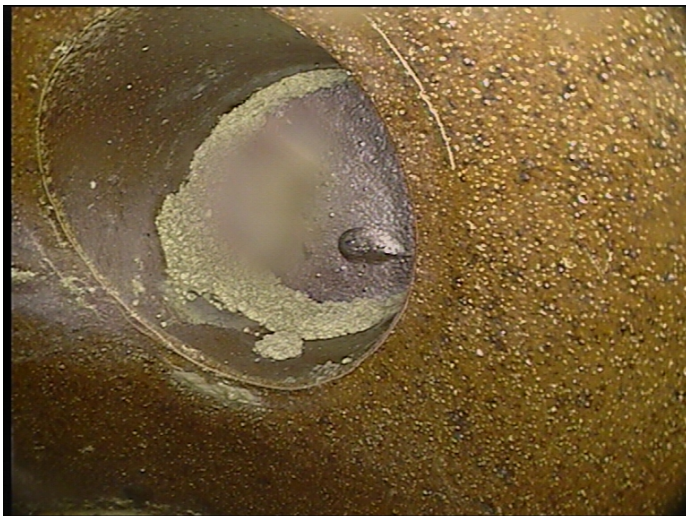
Code: **TFC**
Description: **Tap Factory Capped**

Distance (ft): **48.7**
Structural Grade: **0**
O&M Grade: **0**
Clock Start/From: **10**
Clock To:
1st Value: **4.000**
2nd Value:
Value Percent:
Continuous Index:
Within 8" of Joint: **NO**
Remarks:

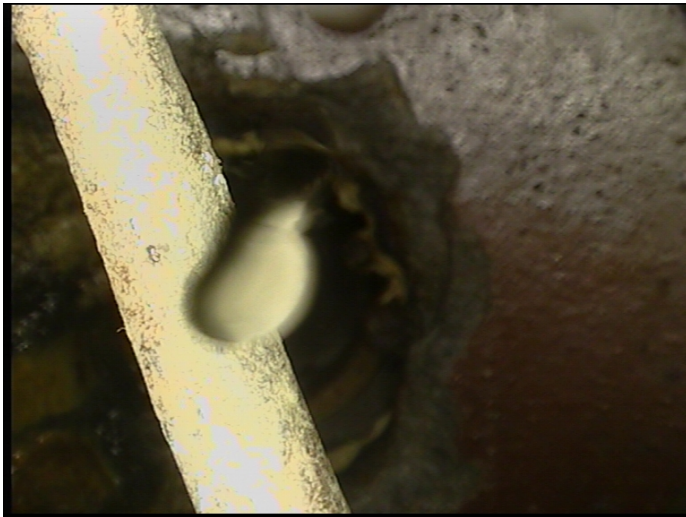
Code: **TB**
Description: **Tap Break-in**

Distance (ft): **75.9**
Structural Grade: **0**
O&M Grade: **0**
Clock Start/From: **10**
Clock To:
1st Value: **4.000**
2nd Value:
Value Percent:
Continuous Index:
Within 8" of Joint: **NO**
Remarks:

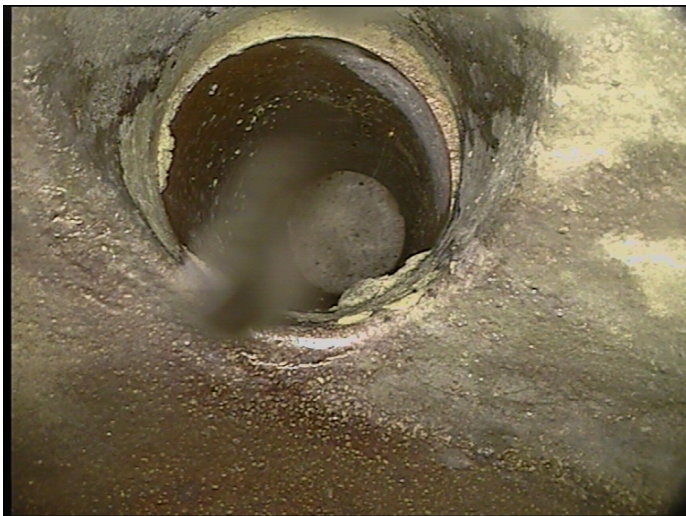
Code: **TFC**
Description: **Tap Factory Capped**

Distance (ft): **80.0**
Structural Grade: **0**
O&M Grade: **0**
Clock Start/From: **2**
Clock To:
1st Value: **4.000**
2nd Value:
Value Percent:
Continuous Index:
Within 8" of Joint: **NO**
Remarks:
