## Profile/Photo Observation Report

Date:	<b>04/10/2018</b>	Weather:		Coding:	<b>PACP 6.0</b>
Pipe Length (ft):		Owner:	<b>City of Hobart</b>	Pre Clean:	<b>No Pre-Cleaning</b>
P.O.#:	<b>26-1</b>	Surveyor:	<b>M. Pielacha</b>	PSR:	<b>M-504-070-M-504-069</b>
Customer:	<b>City of Hobart</b>	Clean Date:		Shape:	<b>C</b>

Street:	<b>Off Virginia Street</b>	Flow Control:	<b>Not Controlled</b>
City:	<b>Hobart, IN</b>	Year Renewed:	
Location:	<b>Light Highway</b>	Tape/Media #:	<b>DEP 25</b>
Purpose:	<b>Routine Assessment</b>	Dia/Height:	<b>18"</b>
Use:	<b>Sanitary</b>	Material:	<b>VCP</b>
Drain Area:		Lining:

US MH: **M-504-070** DS MH: **M-504-069** Total Length Surveyed (ft): **165.0**

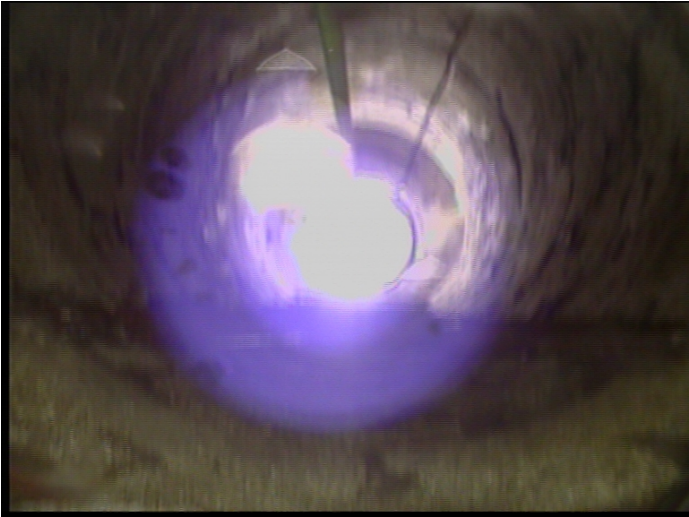
AMH

Manhole

.0

M-504-070

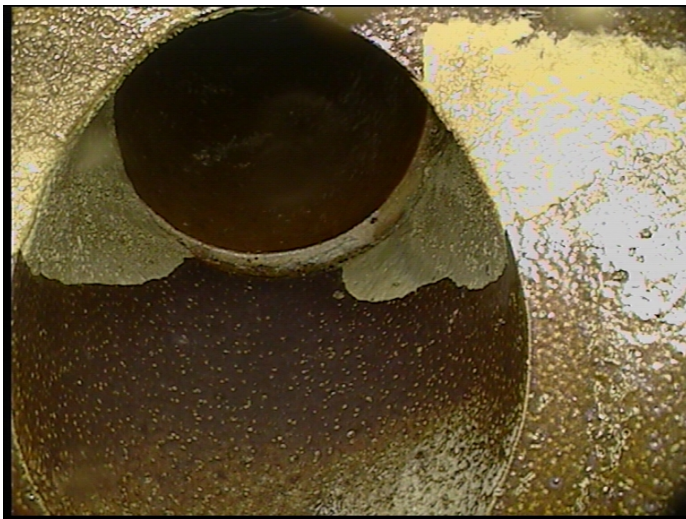
Code: **TF**  
Description: **Tap Factory**

Distance (ft): **73.7**  
Structural Grade: **0**  
O&M Grade: **0**  
Clock Start/From: **10**  
Clock To:  
1st Value: **4.000**  
2nd Value:  
Value Percent:  
Continuous Index:  
Within 8" of Joint: **NO**  
Remarks:
