Profile/Photo Observation Report

Date:	04/10/2018	Weather:		Coding:	PACP 6.0
Pipe Length (ft):		Owner:	City of Hobart	Pre Clean:	No Pre-Cleaning
P.O.#:	26-1	Surveyor:	M. Pielacha	PSR:	M-504-070-M-504-069
Customer:	City of Hobart	Clean Date:		Shape:	C

Street:	Off Virginia Street	Flow Control:	Not Controlled
City:	Hobart, IN	Year Renewed:	
Location:	Light Highway	Tape/Media #:	DEP 25
Purpose:	Routine Assessment	Dia/Height:	18"
Use:	Sanitary	Material:	VCP
Drain Area:		Lining:

US MH: **M-504-070** DS MH: **M-504-069** Total Length Surveyed (ft): **165.0**

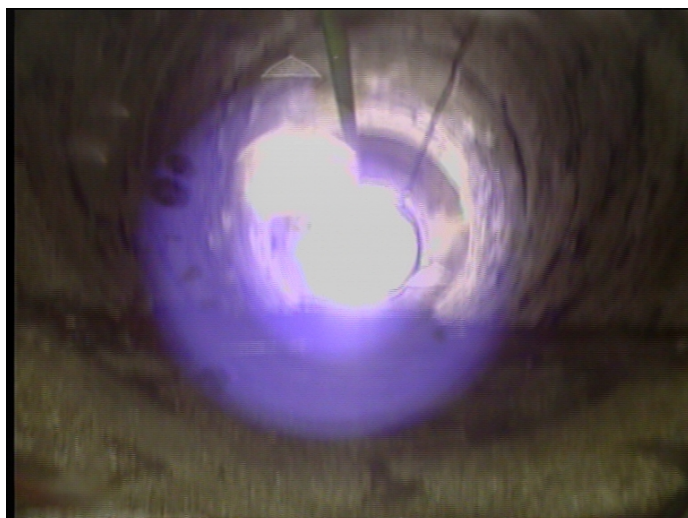
Code: **AMH**
 Description: **Manhole**

Distance (ft): **.0**
 Structural Grade: **0**
 O&M Grade: **0**
 Clock Start/From:
 Clock To:
 1st Value:
 2nd Value:
 Value Percent:
 Continuous Index:
 Within 8" of Joint: **NO**
 Remarks: **M-504-070**

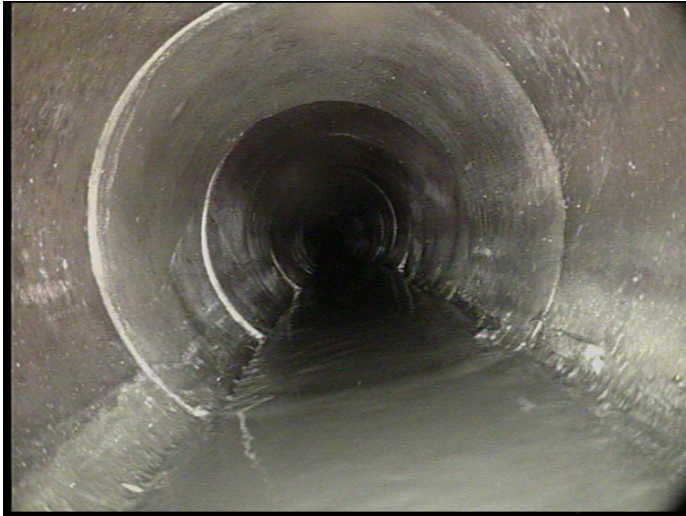
Code: **MWL**
Description: **Water Level**

Distance (ft): **.0**
Structural Grade: **0**
O&M Grade: **0**
Clock Start/From:
Clock To:
1st Value:
2nd Value:
Value Percent: **10.000**
Continuous Index:
Within 8" of Joint: **NO**
Remarks:

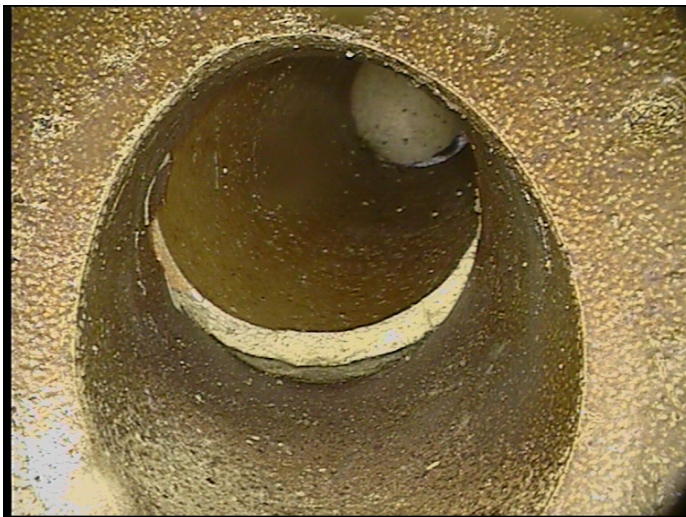
Code: **TFC**
Description: **Tap Factory Capped**

Distance (ft): **24.5**
Structural Grade: **0**
O&M Grade: **0**
Clock Start/From: **2**
Clock To:
1st Value: **4.000**
2nd Value:
Value Percent:
Continuous Index:
Within 8" of Joint: **NO**
Remarks:

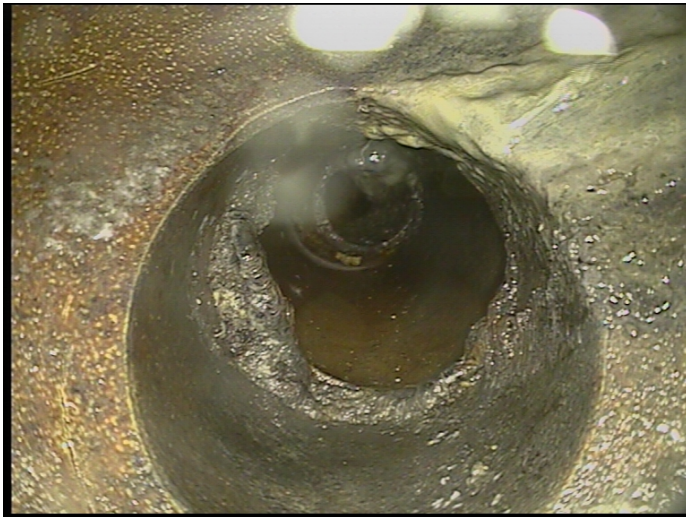
Code: **TF**
Description: **Tap Factory**

Distance (ft): **49.9**
Structural Grade: **0**
O&M Grade: **0**
Clock Start/From: **2**
Clock To:
1st Value: **4.000**
2nd Value:
Value Percent:
Continuous Index:
Within 8" of Joint: **NO**
Remarks:

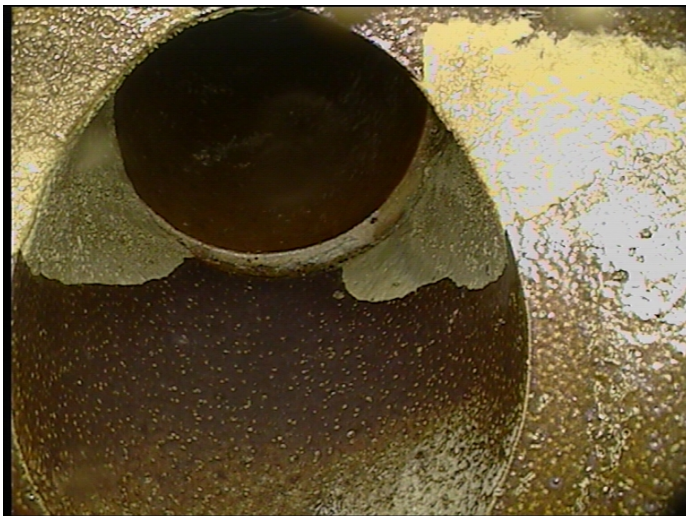
Code: **TF**
Description: **Tap Factory**

Distance (ft): **73.7**
Structural Grade: **0**
O&M Grade: **0**
Clock Start/From: **10**
Clock To:
1st Value: **4.000**
2nd Value:
Value Percent:
Continuous Index:
Within 8" of Joint: **NO**
Remarks:

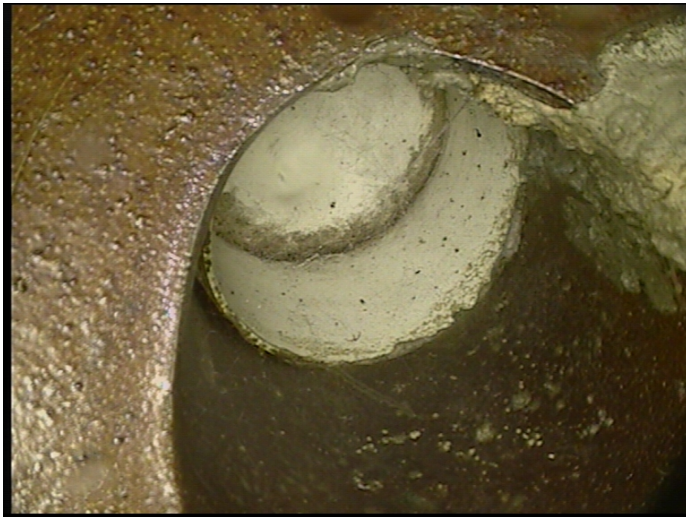
Code: **TFC**
Description: **Tap Factory Capped**

Distance (ft): **76.0**
Structural Grade: **0**
O&M Grade: **0**
Clock Start/From: **2**
Clock To:
1st Value: **4.000**
2nd Value:
Value Percent:
Continuous Index:
Within 8" of Joint: **NO**
Remarks:

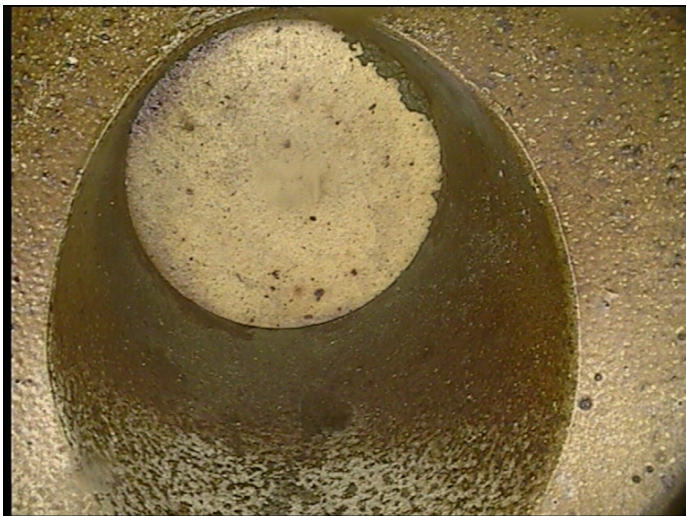
Code: **TFC**
Description: **Tap Factory Capped**

Distance (ft): **98.6**
Structural Grade: **0**
O&M Grade: **0**
Clock Start/From: **2**
Clock To:
1st Value: **4.000**
2nd Value:
Value Percent:
Continuous Index:
Within 8" of Joint: **NO**
Remarks:

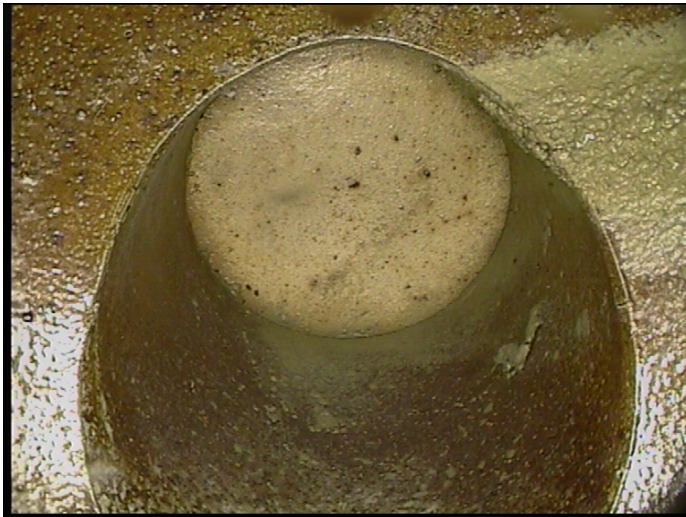
Code: **TFC**
Description: **Tap Factory Capped**

Distance (ft): **126.9**
Structural Grade: **0**
O&M Grade: **0**
Clock Start/From: **2**
Clock To:
1st Value: **4.000**
2nd Value:
Value Percent:
Continuous Index:
Within 8" of Joint: **NO**
Remarks:

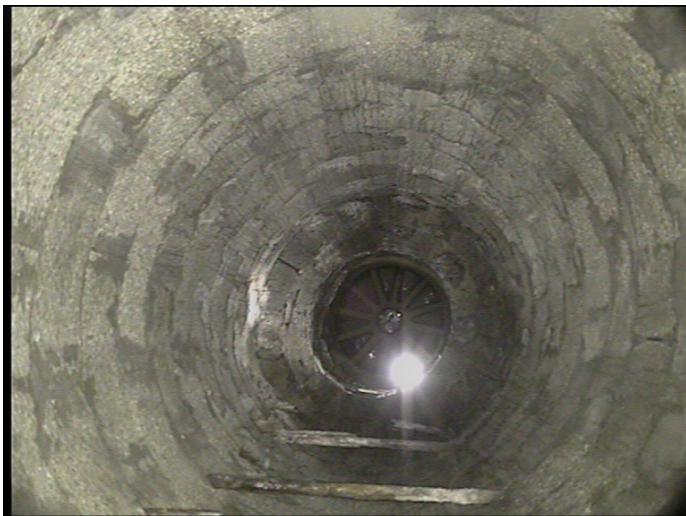
Code: **AMH**
Description: **Manhole**

Distance (ft): **165.0**
Structural Grade: **0**
O&M Grade: **0**
Clock Start/From:
Clock To:
1st Value:
2nd Value:
Value Percent:
Continuous Index:
Within 8" of Joint: **NO**
Remarks: **M-504-069**
