## Profile/Photo Observation Report

| P.O.#: | <b>22-3</b> | Surveyor: | <b>M. Pielacha</b> | PSR: | <b>M-504-072-M-504-071</b> |

| US MH: | <b>M-504-072</b> | DS MH: | <b>M-504-071</b> |

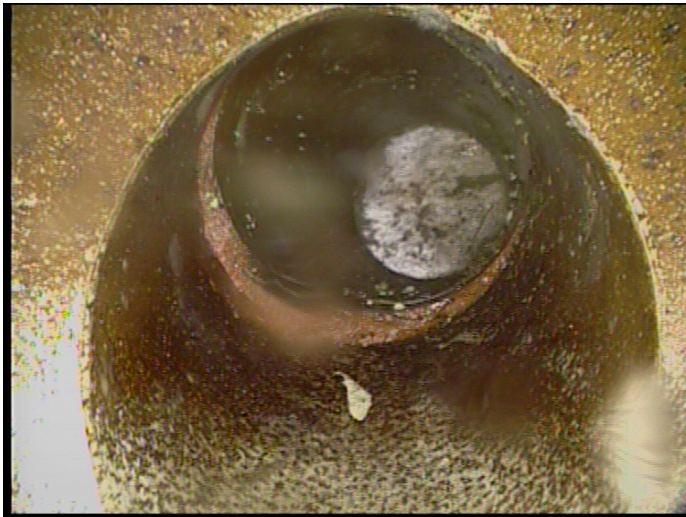
Code: **TFC**  
Description: **Tap Factory Capped**

Distance (ft): **26.2**  
Structural Grade: **0**  
O&M Grade: **0**  
Clock Start/From: **2**  
Clock To:  
1st Value: **4.000**  
2nd Value:  
Value Percent:  
Continuous Index:  
Within 8" of Joint: **NO**  
Remarks:

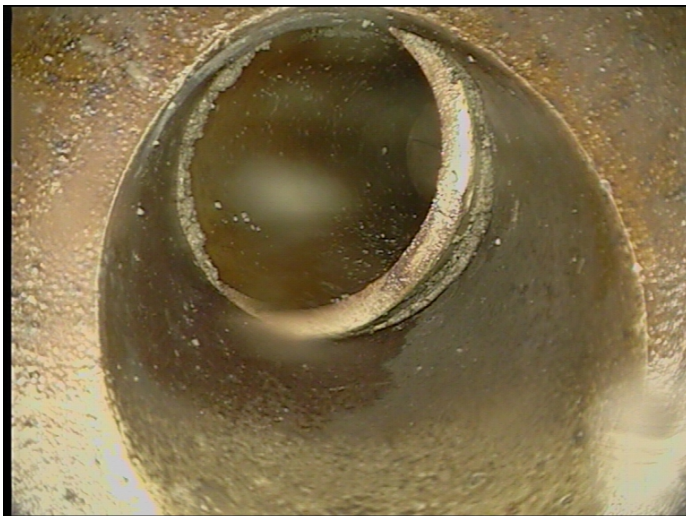
Code: **TF**  
Description: **Tap Factory**

Distance (ft): **49.2**  
Structural Grade: **0**  
O&M Grade: **0**  
Clock Start/From: **10**  
Clock To:  
1st Value: **4.000**  
2nd Value:  
Value Percent:  
Continuous Index:  
Within 8" of Joint: **NO**  
Remarks:

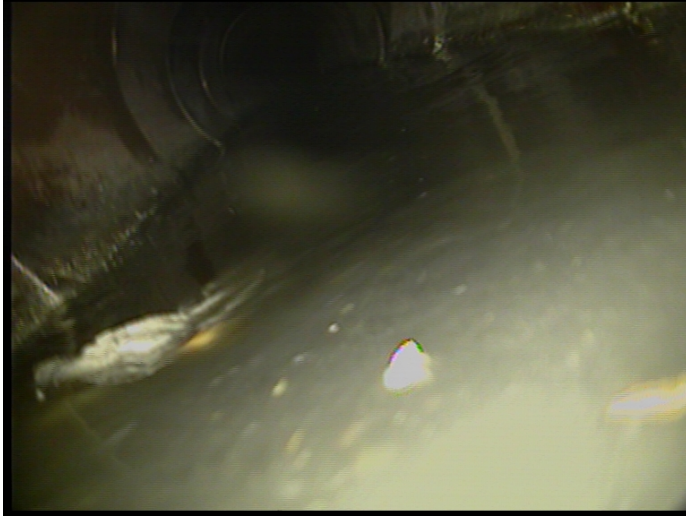
Code: **OBZ**  
Description: **Obstacle Other**

| Position | Code | Observation | Video (sec) | Grade |
|---|---|---|---|---|
| 93.3 | OBZ | Obstacle Other | 422 | M 3 |

Distance (ft): **93.3**  
Structural Grade: **0**  
O&M Grade: **3**  
Clock Start/From: **5**  
Clock To: **7**  
1st Value:  
2nd Value:  
Value Percent: **15.000**  
Continuous Index:  
Within 8" of Joint: **NO**  
Remarks: **under water debris**

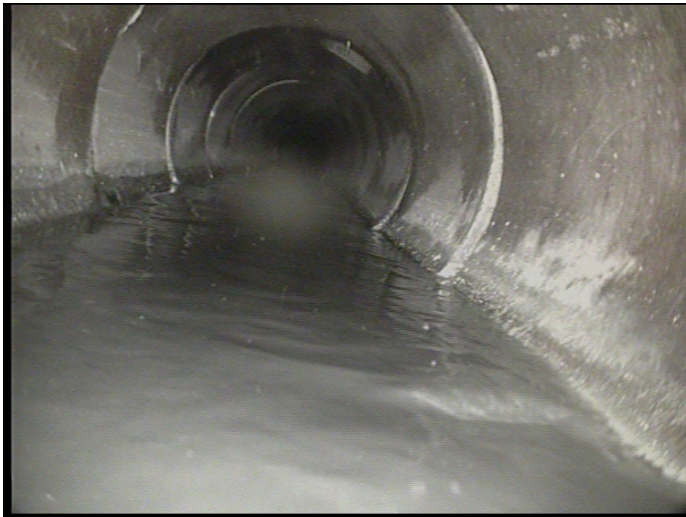
Code: **MSA**  
Description: **Abandoned Survey**

Distance (ft): **94.2**  
Structural Grade: **0**  
O&M Grade: **0**  
Clock Start/From:  
Clock To:  
1st Value:  
2nd Value:  
Value Percent:  
Continuous Index:  
Within 8" of Joint: **NO**  
Remarks: **debris**
