## Profile/Photo Observation Report

Date:	<b>04/10/2018</b>	Weather:		Coding:	<b>PACP 6.0</b>
Pipe Length (ft):		Owner:	<b>City of Hobart</b>	Pre Clean:	<b>No Pre-Cleaning</b>
P.O.#:	<b>23-1</b>	Surveyor:	<b>M. Pielacha</b>	PSR:	<b>M-504-072-M-504-071</b>
Customer:	<b>City of Hobart</b>	Clean Date:		Shape:	<b>C</b>

Street:	<b>Virginia Street</b>	Flow Control:	<b>Not Controlled</b>
City:	<b>Hobart, IN</b>	Year Renewed:	
Location:	<b>Light Highway</b>	Tape/Media #:	<b>DEP 23</b>
Purpose:	<b>Routine Assessment</b>	Dia/Height:	<b>18"</b>
Use:	<b>Sanitary</b>	Material:	<b>VCP</b>
Drain Area:		Lining:	
Category:	<b>NA</b>		
Comment:			
Location Details:		Direction of Survey:	<b>Upstream</b>
US MH:	<b>M-504-072</b>	DS MH:	<b>M-504-071</b>
		Total Length Surveyed (ft):	<b>75.6</b>

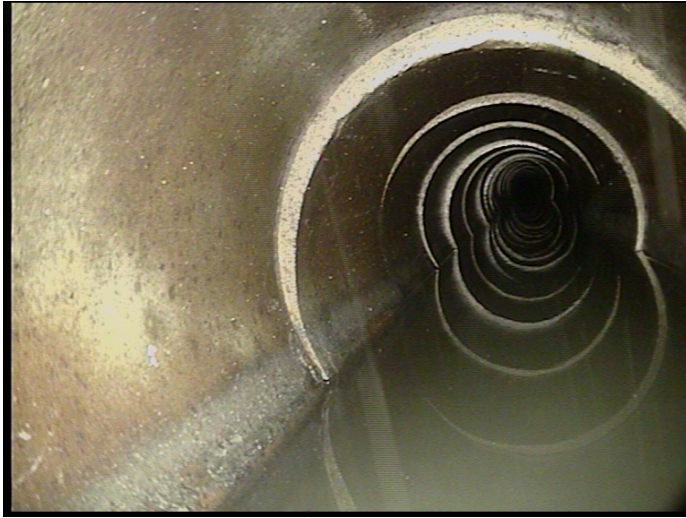
Code: **MWL**  
Description: **Water Level**

Distance (ft): **.0**  
Structural Grade: **0**  
O&M Grade: **0**  
Clock Start/From:  
Clock To:  
1st Value:  
2nd Value:  
Value Percent: **15.000**  
Continuous Index:  
Within 8" of Joint: **NO**  
Remarks:

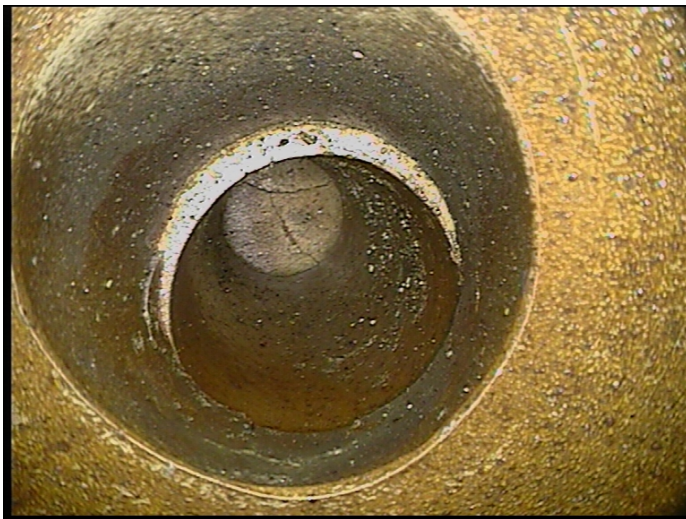
Code: **TFC**  
Description: **Tap Factory Capped**

Distance (ft): **40.4**  
Structural Grade: **0**  
O&M Grade: **0**  
Clock Start/From: **10**  
Clock To:  
1st Value: **4.000**  
2nd Value:  
Value Percent:  
Continuous Index:  
Within 8" of Joint: **NO**  
Remarks:

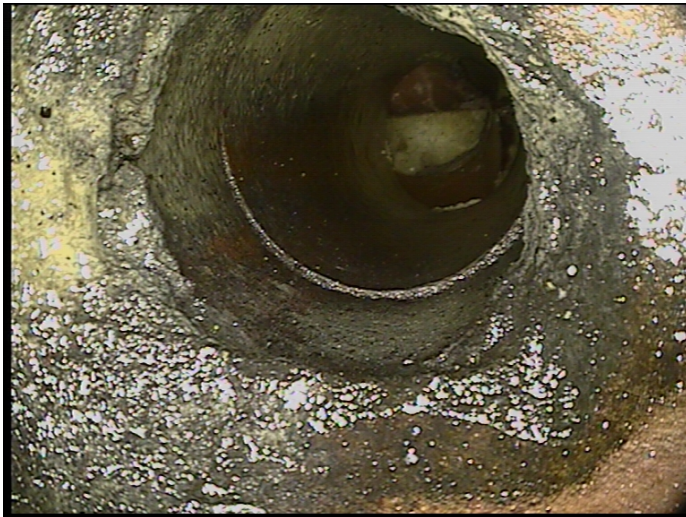
Code: **TFC**  
Description: **Tap Factory Capped**

Distance (ft): **47.4**  
Structural Grade: **0**  
O&M Grade: **0**  
Clock Start/From: **10**  
Clock To:  
1st Value: **4.000**  
2nd Value:  
Value Percent:  
Continuous Index:  
Within 8" of Joint: **NO**  
Remarks:

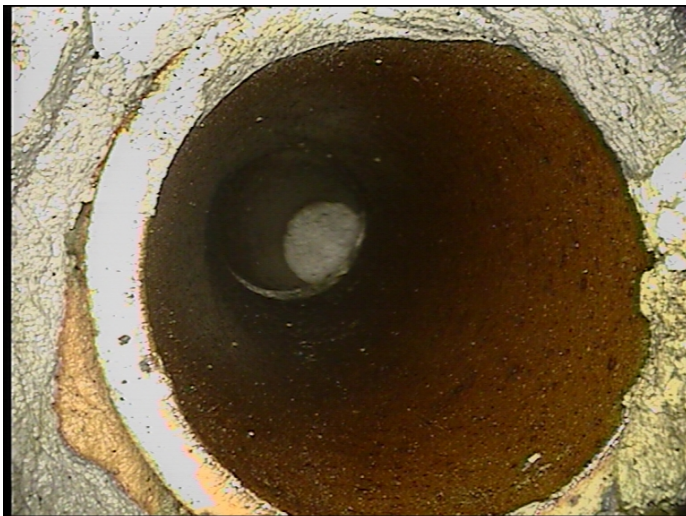
Code: **TFC**  
Description: **Tap Factory Capped**

Distance (ft): **56.7**  
Structural Grade: **0**  
O&M Grade: **0**  
Clock Start/From: **2**  
Clock To:  
1st Value: **4.000**  
2nd Value:  
Value Percent:  
Continuous Index:  
Within 8" of Joint: **NO**  
Remarks:

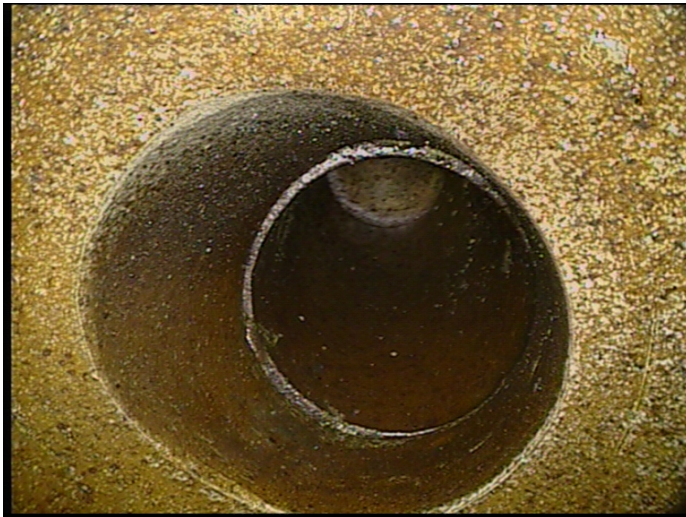
Code: **TFC**  
Description: **Tap Factory Capped**

Distance (ft): **64.5**  
Structural Grade: **0**  
O&M Grade: **0**  
Clock Start/From: **10**  
Clock To:  
1st Value: **4.000**  
2nd Value:  
Value Percent:  
Continuous Index:  
Within 8" of Joint: **NO**  
Remarks:

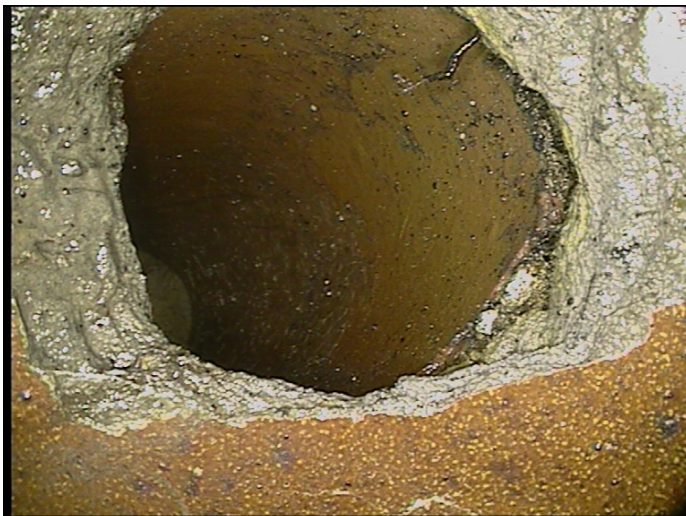
Code: **TB**  
Description: **Tap Break-in**

Distance (ft): **75.6**  
Structural Grade: **0**  
O&M Grade: **0**  
Clock Start/From: **10**  
Clock To:  
1st Value: **4.000**  
2nd Value:  
Value Percent:  
Continuous Index:  
Within 8" of Joint: **NO**  
Remarks:

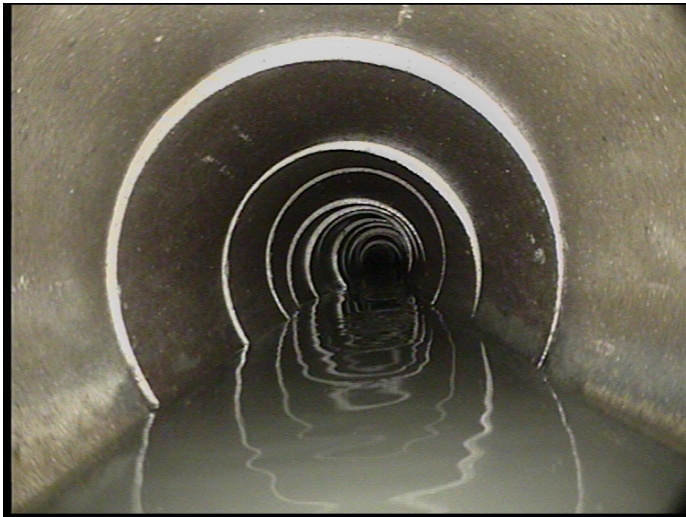
Code:	<b>MSA</b>
Description:	<b>Abandoned Survey</b>
Distance (ft):	<b>75.6</b>
Structural Grade:	<b>0</b>
O&M Grade:	<b>0</b>
Clock Start/From:	
Clock To:	
1st Value:	
2nd Value:	
Value Percent:	
Continuous Index:	
Within 8" of Joint:	<b>NO</b>
Remarks:	<b>reversecomplete</b>
