## Profile/Photo Observation Report

Date:	<b>04/08/2018</b>	Weather:		Coding:	<b>PACP 6.0</b>
Pipe Length (ft):		Owner:	<b>City of Hobart</b>	Pre Clean:	<b>No Pre-Cleaning</b>
P.O.#:	<b>22-2</b>	Surveyor:	<b>M. Pielacha</b>	PSR:	<b>M-504-073-M-504-072</b>
Customer:	<b>City of Hobart</b>	Clean Date:		Shape:	<b>C</b>

Street:	<b>Off Colorado Street</b>	Flow Control:	<b>Not Controlled</b>
City:	<b>Hobart, IN</b>	Year Renewed:	
Location:	<b>Light Highway</b>	Tape/Media #:	<b>DEP 22</b>
Purpose:	<b>Routine Assessment</b>	Dia/Height:	<b>18"</b>
Use:	<b>Sanitary</b>	Material:	<b>VCP</b>
Drain Area:		Lining:	
Category:	<b>NA</b>		
Comment:			
Location Details:		Direction of Survey:	<b>Downstream</b>
US MH:	<b>M-504-073</b>	DS MH:	<b>M-504-072</b>
		Total Length Surveyed (ft):	<b>197.8</b>

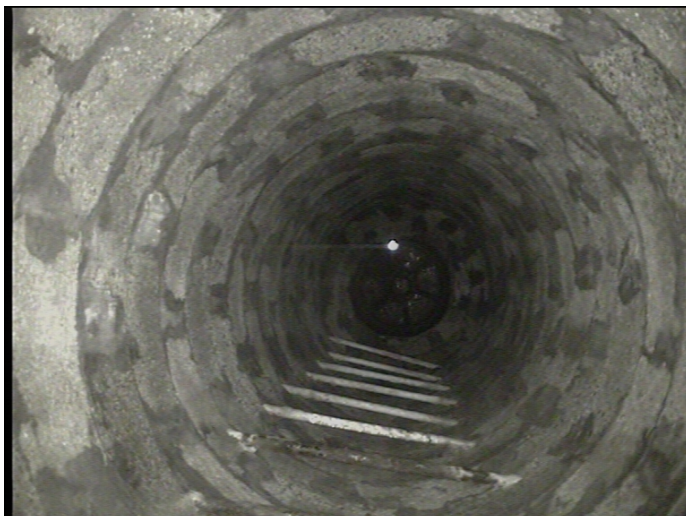
Code: **AMH**  
 Description: **Manhole**

Distance (ft): **.0**  
 Structural Grade: **0**  
 O&M Grade: **0**  
 Clock Start/From:  
 Clock To:  
 1st Value:  
 2nd Value:  
 Value Percent:  
 Continuous Index:  
 Within 8" of Joint: **NO**  
 Remarks: **M-504-073**

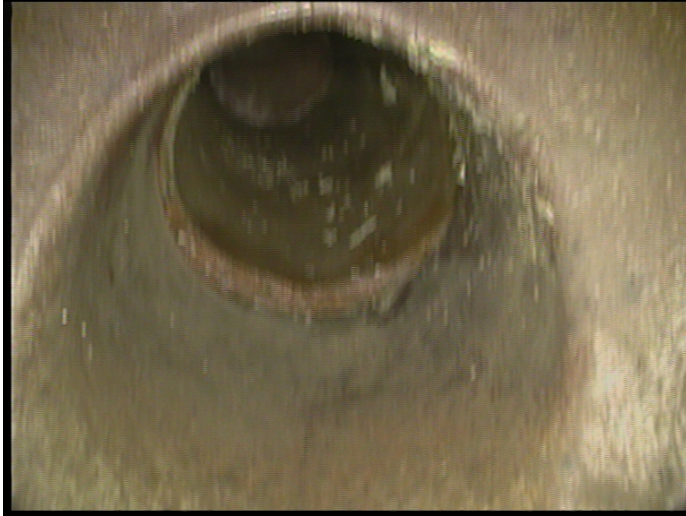
Code:	<b>TF</b>
Description:	<b>Tap Factory</b>
Distance (ft):	<b>94.9</b>
Structural Grade:	<b>0</b>
O&M Grade:	<b>0</b>
Clock Start/From:	<b>2</b>
Clock To:	
1st Value:	<b>4.000</b>
2nd Value:	
Value Percent:	
Continuous Index:	
Within 8" of Joint:	<b>NO</b>
Remarks:

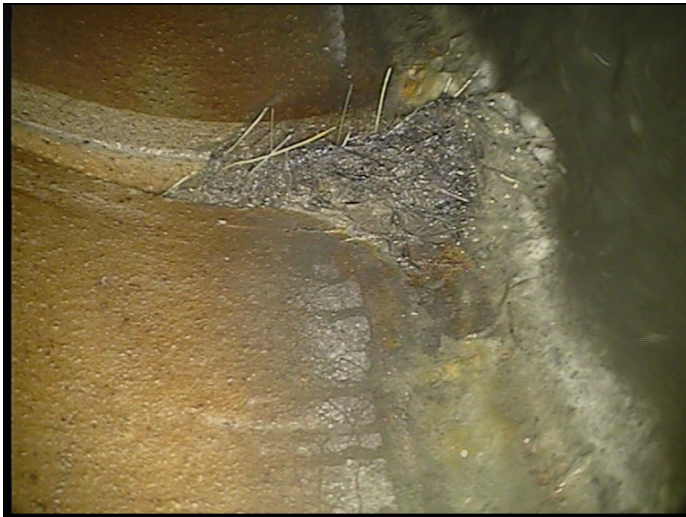
Code:	<b>RFJ</b>
Description:	<b>Roots Fine Joint</b>
Distance (ft):	<b>109.0</b>
Structural Grade:	<b>0</b>
O&M Grade:	<b>1</b>
Clock Start/From:	<b>7</b>
Clock To:	
1st Value:	
2nd Value:	
Value Percent:	
Continuous Index:	
Within 8" of Joint:	<b>YES</b>
Remarks:

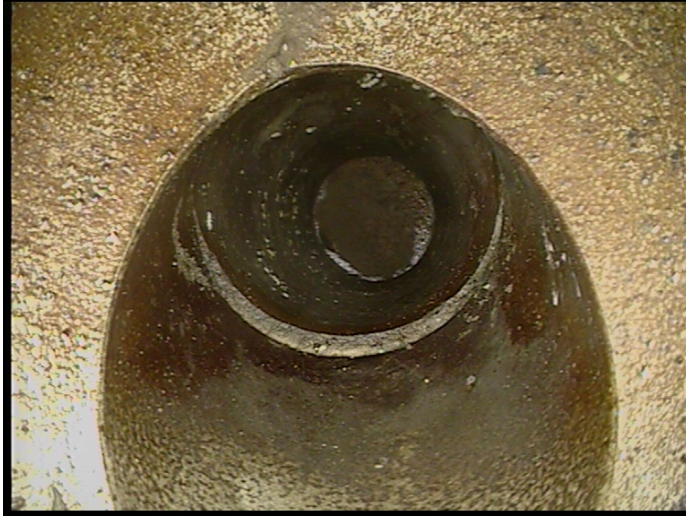
Code: **TF**  
Description: **Tap Factory**

Distance (ft): **119.2**  
Structural Grade: **0**  
O&M Grade: **0**  
Clock Start/From: **1**  
Clock To:  
1st Value: **4.000**  
2nd Value:  
Value Percent:  
Continuous Index:  
Within 8" of Joint: **NO**  
Remarks:

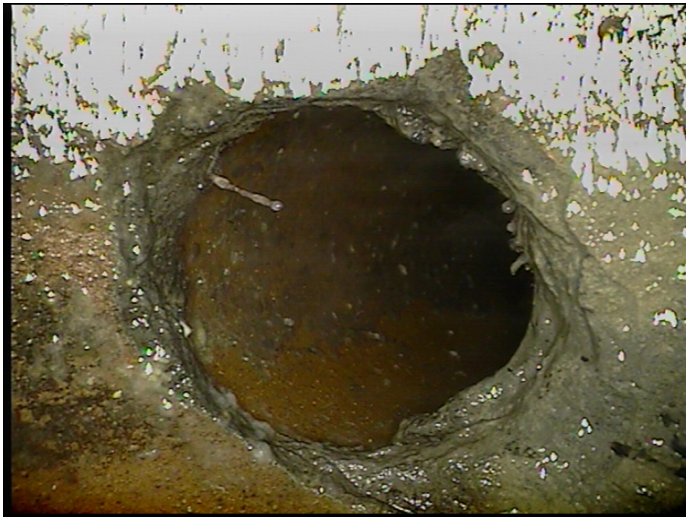
Code: **TB**  
Description: **Tap Break-in**

Distance (ft): **120.9**  
Structural Grade: **0**  
O&M Grade: **0**  
Clock Start/From: **1**  
Clock To:  
1st Value: **4.000**  
2nd Value:  
Value Percent:  
Continuous Index:  
Within 8" of Joint: **NO**  
Remarks:

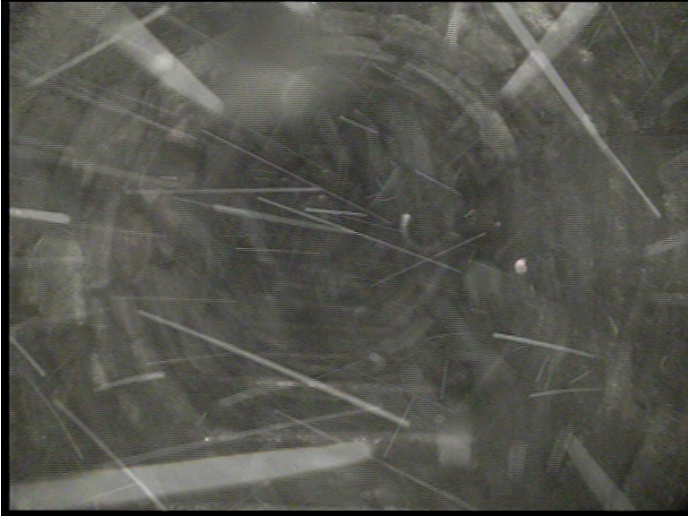
Code:	AMH
Description:	Manhole
Distance (ft):	197.8
Structural Grade:	0
O&M Grade:	0
Clock Start/From:	
Clock To:	
1st Value:	
2nd Value:	
Value Percent:	
Continuous Index:	
Within 8" of Joint:	NO
Remarks:	M-504-072
