Profile/Photo Observation Report

Date:	04/08/2018	Weather:		Coding:	PACP 6.0
Pipe Length (ft):		Owner:	City of Hobart	Pre Clean:	No Pre-Cleaning
P.O.#:	22-2	Surveyor:	M. Pielacha	PSR:	M-504-073-M-504-072
Customer:	City of Hobart	Clean Date:		Shape:	C

US MH: **M-504-073** DS MH: **M-504-072** Total Length Surveyed (ft): **197.8**

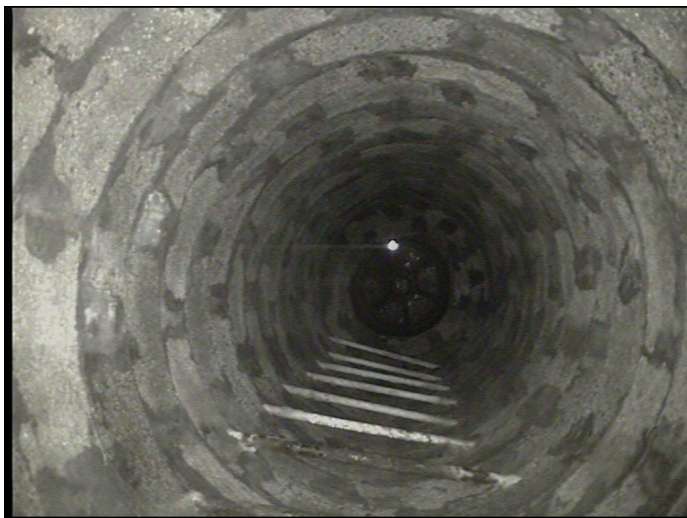
Code: **AMH**
 Description: **Manhole**

Distance (ft): **.0**
 Structural Grade: **0**
 O&M Grade: **0**
 Clock Start/From:
 Clock To:
 1st Value:
 2nd Value:
 Value Percent:
 Continuous Index:
 Within 8" of Joint: **NO**
 Remarks: **M-504-073**

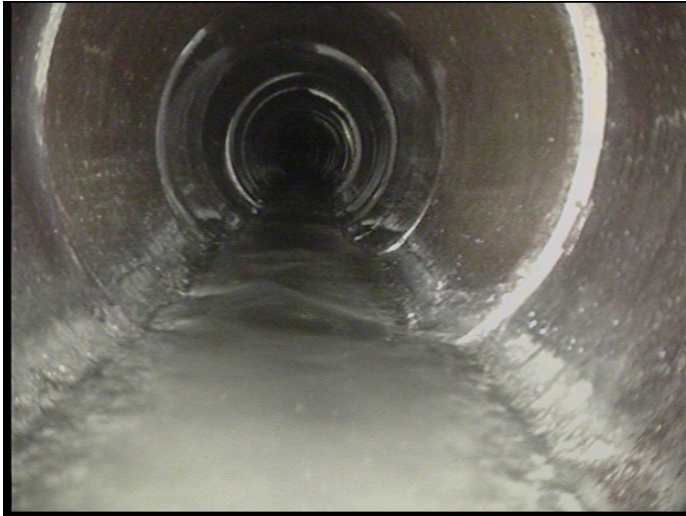
Code: **MWL**
Description: **Water Level**

Distance (ft): **.0**
Structural Grade: **0**
O&M Grade: **0**
Clock Start/From:
Clock To:
1st Value:
2nd Value:
Value Percent: **5.000**
Continuous Index:
Within 8" of Joint: **NO**
Remarks:

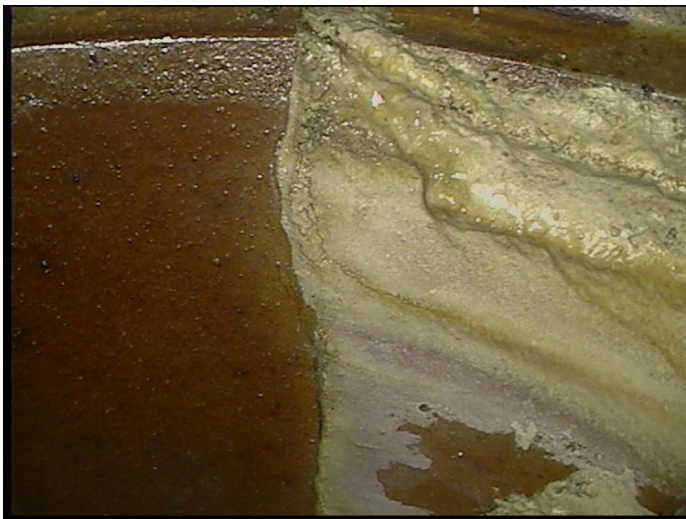
Code: **CL**
Description: **Crack Longitudinal**

Distance (ft): **18.2**
Structural Grade: **2**
O&M Grade: **0**
Clock Start/From: **12**
Clock To:
1st Value:
2nd Value:
Value Percent:
Continuous Index:
Within 8" of Joint: **YES**
Remarks:

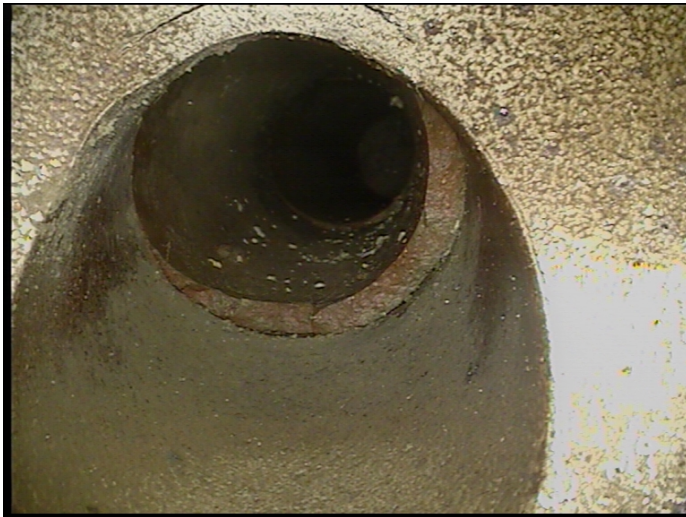
Code: **TF**
Description: **Tap Factory**

Distance (ft): **45.9**
Structural Grade: **0**
O&M Grade: **0**
Clock Start/From: **10**
Clock To:
1st Value: **4.000**
2nd Value:
Value Percent:
Continuous Index:
Within 8" of Joint: **NO**
Remarks:

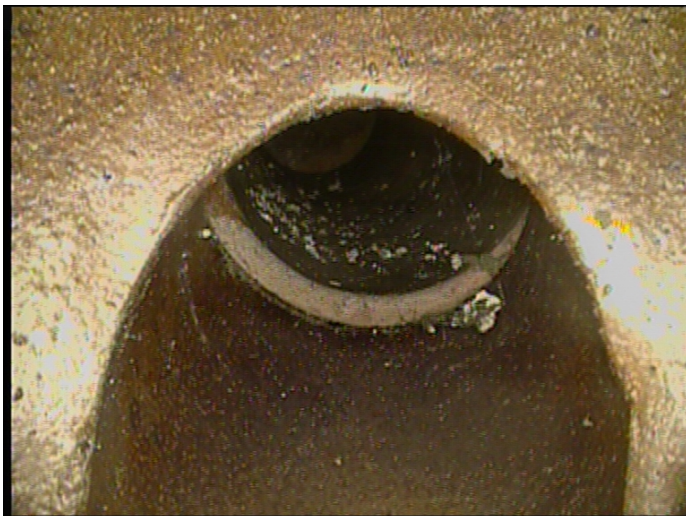
Code: **TF**
Description: **Tap Factory**

Distance (ft): **70.3**
Structural Grade: **0**
O&M Grade: **0**
Clock Start/From: **2**
Clock To:
1st Value: **4.000**
2nd Value:
Value Percent:
Continuous Index:
Within 8" of Joint: **NO**
Remarks:

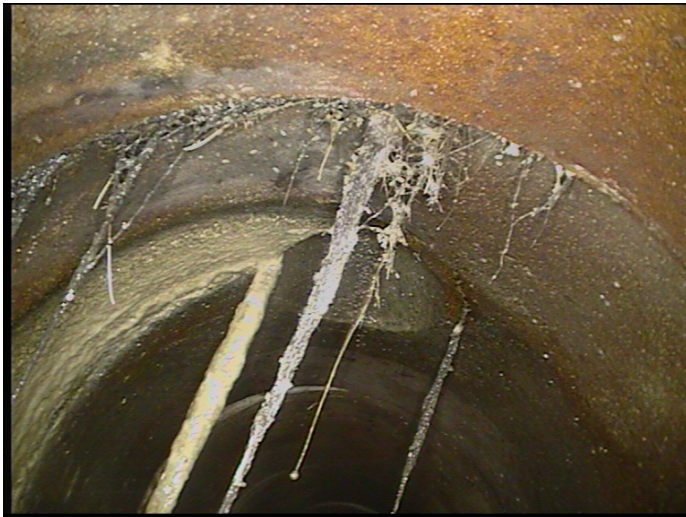
Code: **RFJ**
Description: **Roots Fine Joint**

Distance (ft): **84.6**
Structural Grade: **0**
O&M Grade: **1**
Clock Start/From: **10**
Clock To: **2**
1st Value:
2nd Value:
Value Percent:
Continuous Index:
Within 8" of Joint: **YES**
Remarks:

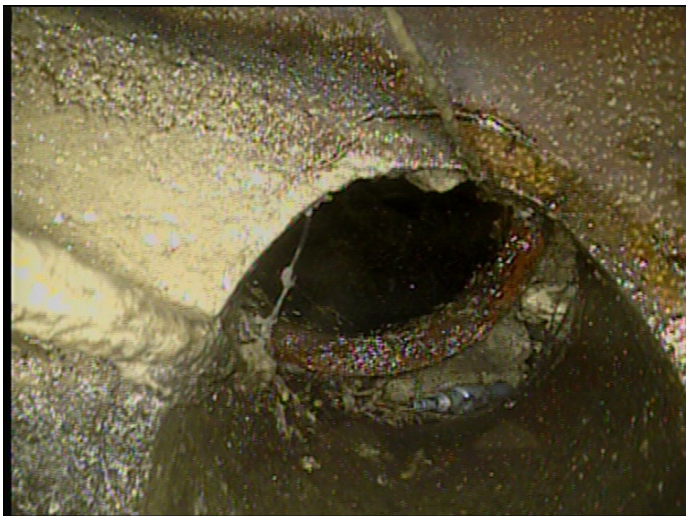
Code: **TF**
Description: **Tap Factory**

Distance (ft): **86.8**
Structural Grade: **0**
O&M Grade: **0**
Clock Start/From: **10**
Clock To:
1st Value: **4.000**
2nd Value:
Value Percent:
Continuous Index:
Within 8" of Joint: **NO**
Remarks:

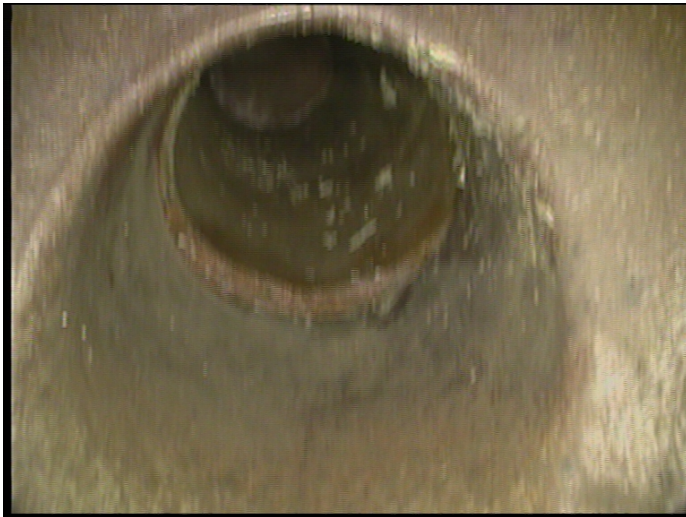
Code: **TF**
Description: **Tap Factory**

Distance (ft): **94.9**
Structural Grade: **0**
O&M Grade: **0**
Clock Start/From: **2**
Clock To:
1st Value: **4.000**
2nd Value:
Value Percent:
Continuous Index:
Within 8" of Joint: **NO**
Remarks:

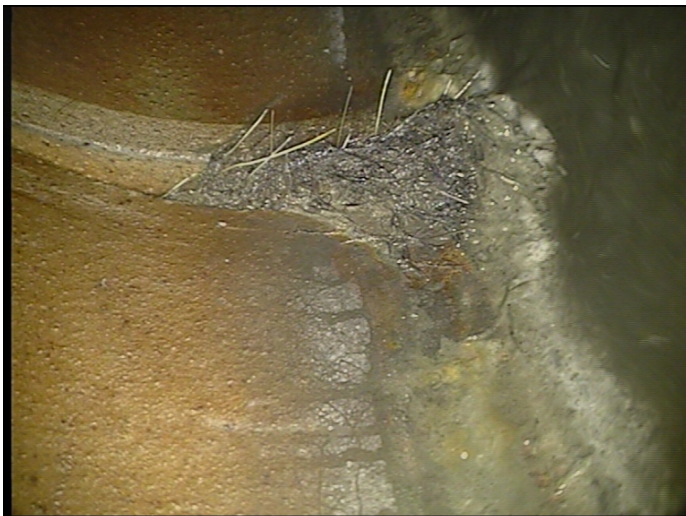
Code: **RFJ**
Description: **Roots Fine Joint**

Distance (ft): **109.0**
Structural Grade: **0**
O&M Grade: **1**
Clock Start/From: **7**
Clock To:
1st Value:
2nd Value:
Value Percent:
Continuous Index:
Within 8" of Joint: **YES**
Remarks:

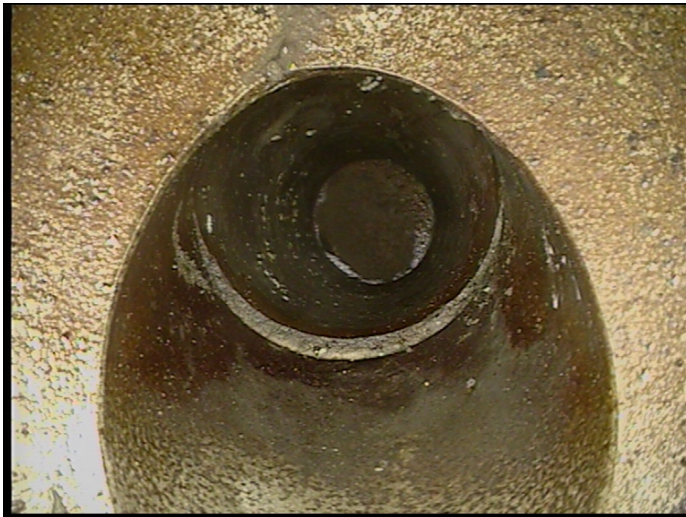
Code: **TF**
Description: **Tap Factory**

Distance (ft): **119.2**
Structural Grade: **0**
O&M Grade: **0**
Clock Start/From: **1**
Clock To:
1st Value: **4.000**
2nd Value:
Value Percent:
Continuous Index:
Within 8" of Joint: **NO**
Remarks:

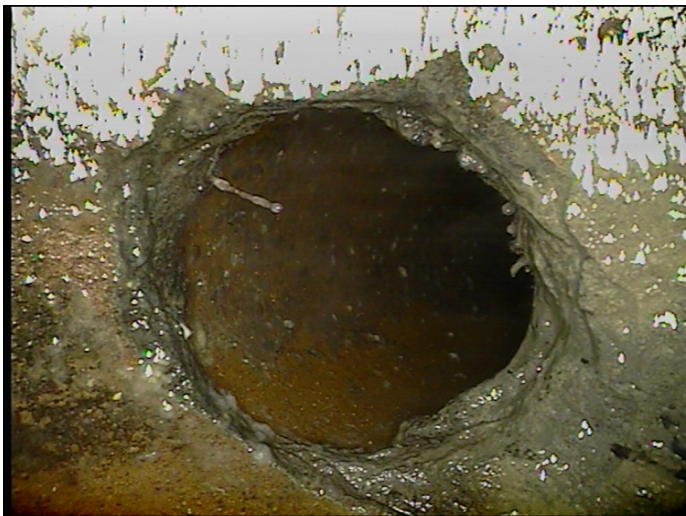
Code: **TB**
Description: **Tap Break-in**

Distance (ft): **120.9**
Structural Grade: **0**
O&M Grade: **0**
Clock Start/From: **1**
Clock To:
1st Value: **4.000**
2nd Value:
Value Percent:
Continuous Index:
Within 8" of Joint: **NO**
Remarks:

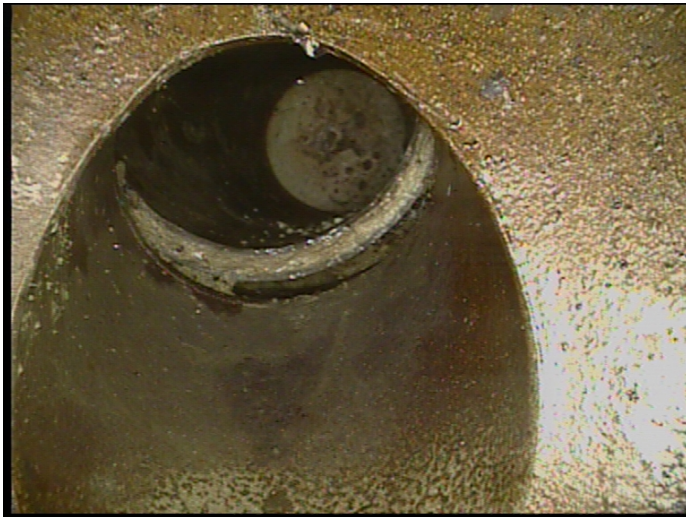
Code: **TF**
Description: **Tap Factory**

Distance (ft): **123.2**
Structural Grade: **0**
O&M Grade: **0**
Clock Start/From: **10**
Clock To:
1st Value: **4.000**
2nd Value:
Value Percent:
Continuous Index:
Within 8" of Joint: **NO**
Remarks:

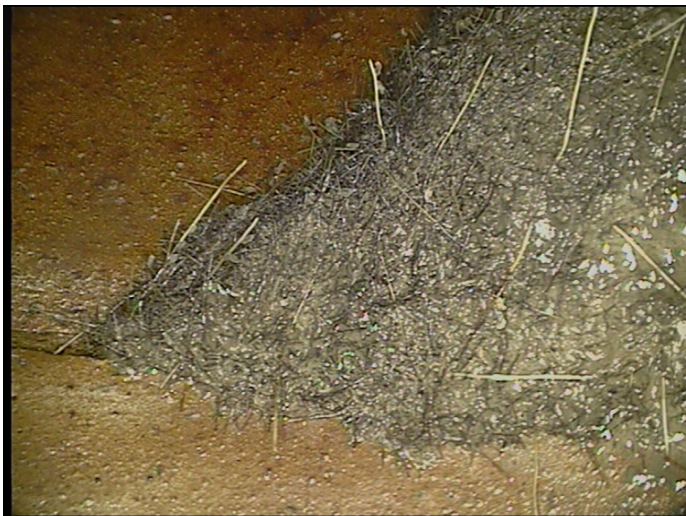
Code: **RMJ**
Description: **Roots Medium Joint**

Distance (ft): **135.9**
Structural Grade: **0**
O&M Grade: **3**
Clock Start/From: **7**
Clock To: **9**
1st Value:
2nd Value:
Value Percent: **5.000**
Continuous Index:
Within 8" of Joint: **YES**
Remarks:

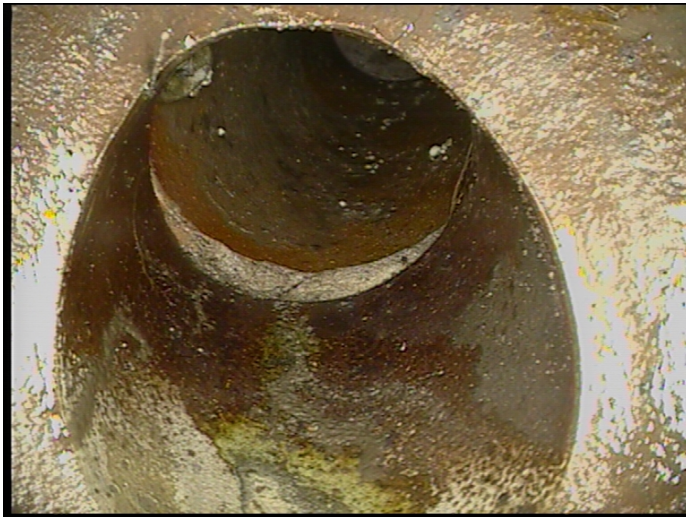
Code: **TF**
Description: **Tap Factory**

Distance (ft): **143.4**
Structural Grade: **0**
O&M Grade: **0**
Clock Start/From: **2**
Clock To:
1st Value: **4.000**
2nd Value:
Value Percent:
Continuous Index:
Within 8" of Joint: **NO**
Remarks:

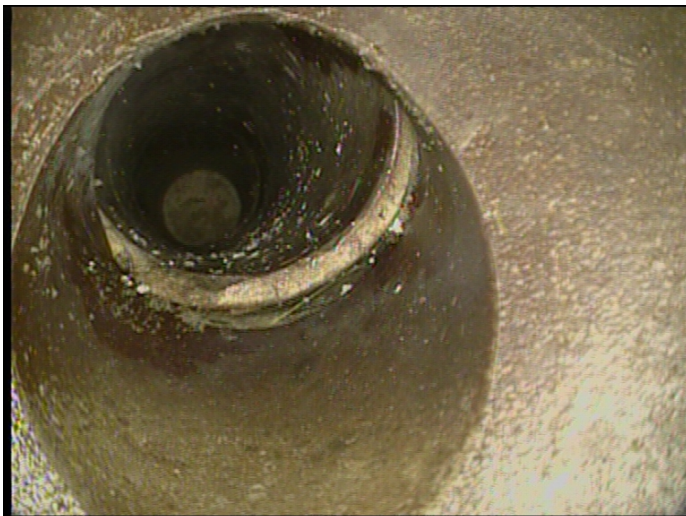
Code: **TF**
Description: **Tap Factory**

Distance (ft): **164.0**
Structural Grade: **0**
O&M Grade: **0**
Clock Start/From: **10**
Clock To:
1st Value: **4.000**
2nd Value:
Value Percent:
Continuous Index:
Within 8" of Joint: **NO**
Remarks:

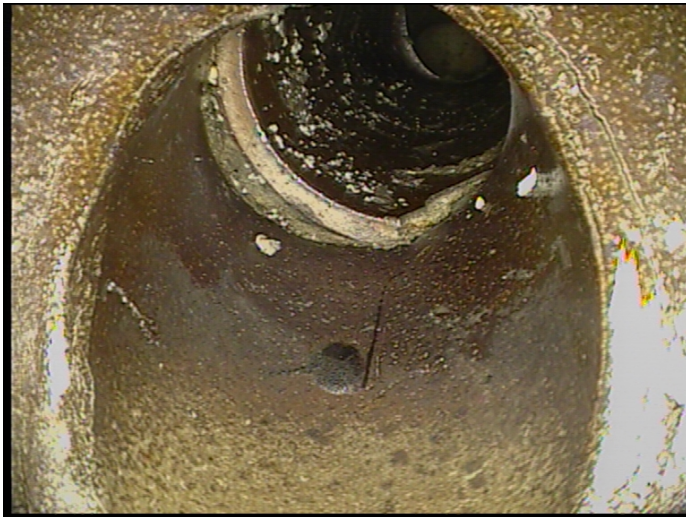
Code: **TF**
Description: **Tap Factory**

Distance (ft): **174.0**
Structural Grade: **0**
O&M Grade: **0**
Clock Start/From: **2**
Clock To:
1st Value: **4.000**
2nd Value:
Value Percent:
Continuous Index:
Within 8" of Joint: **NO**
Remarks:

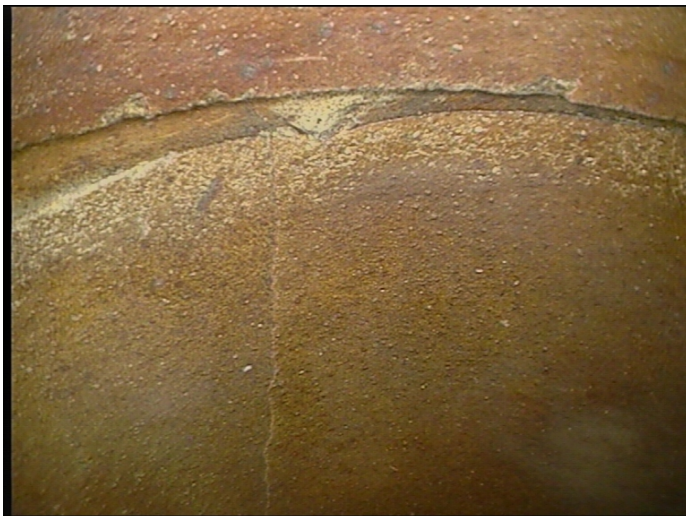
Code: **CL**
Description: **Crack Longitudinal**

Distance (ft): **190.7**
Structural Grade: **2**
O&M Grade: **0**
Clock Start/From: **10**
Clock To:
1st Value:
2nd Value:
Value Percent:
Continuous Index:
Within 8" of Joint: **YES**
Remarks:

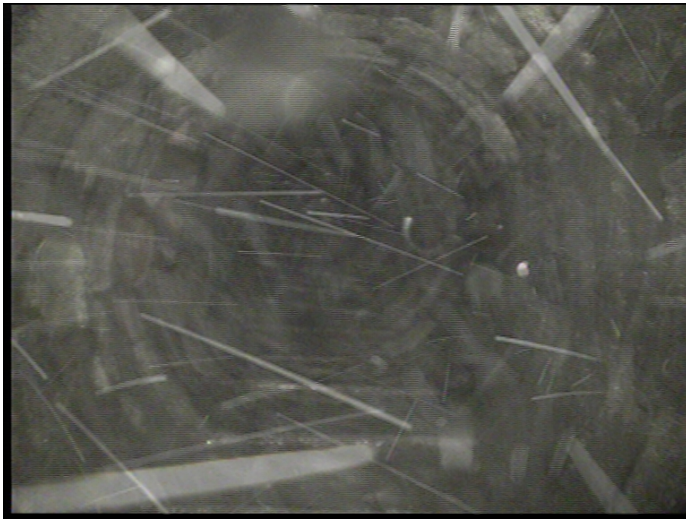
Code:	AMH
Description:	Manhole
Distance (ft):	197.8
Structural Grade:	0
O&M Grade:	0
Clock Start/From:	
Clock To:	
1st Value:	
2nd Value:	
Value Percent:	
Continuous Index:	
Within 8" of Joint:	NO
Remarks:	M-504-072
