Profile/Photo Observation Report

Date:	04/08/2018	Weather:		Coding:	PACP 6.0
Pipe Length (ft):		Owner:	City of Hobart	Pre Clean:	No Pre-Cleaning
P.O.#:	22-1	Surveyor:	M. Pielacha	PSR:	M-504-074-M-504-073
Customer:	City of Hobart	Clean Date:		Shape:	C

Street:	Off Colorado Street	Flow Control:	Not Controlled
City:	Hobart, IN	Year Renewed:	
Location:	Light Highway	Tape/Media #:	DEP 22
Purpose:	Routine Assessment	Dia/Height:	18"
Use:	Sanitary	Material:	VCP
Drain Area:		Lining:	
Category:	NA		
Comment:			
Location Details:		Direction of Survey:	Downstream
US MH:	M-504-074	DS MH:	M-504-073
		Total Length Surveyed (ft):	237.1

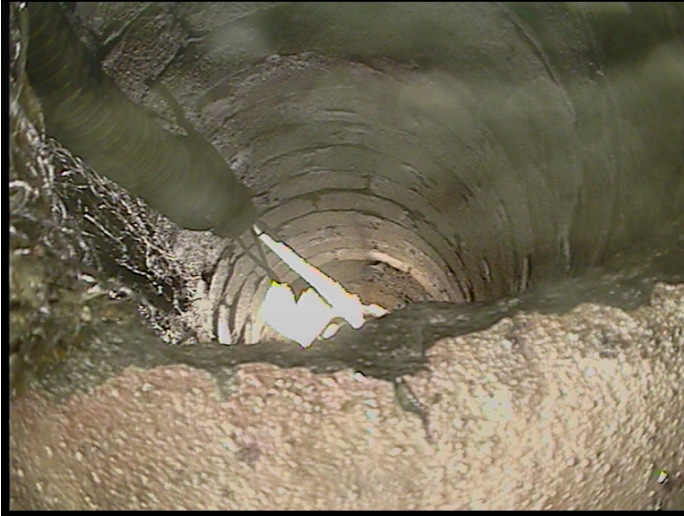
Code: **AMH**
Description: **Manhole**

Distance (ft): **.0**
Structural Grade: **0**
O&M Grade: **0**
Clock Start/From:
Clock To:
1st Value:
2nd Value:
Value Percent:
Continuous Index:
Within 8" of Joint: **NO**
Remarks: **M-504-074**

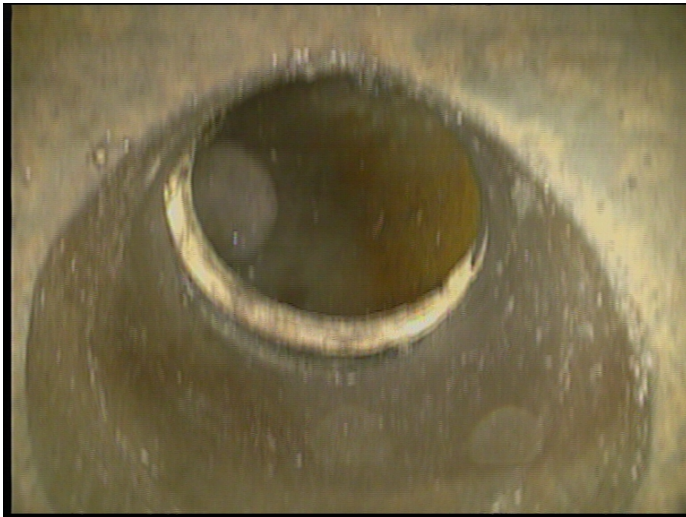
Code: **TF**
Description: **Tap Factory**

Distance (ft): **20.4**
Structural Grade: **0**
O&M Grade: **0**
Clock Start/From: **1**
Clock To:
1st Value: **4.000**
2nd Value:
Value Percent:
Continuous Index:
Within 8" of Joint: **NO**
Remarks:

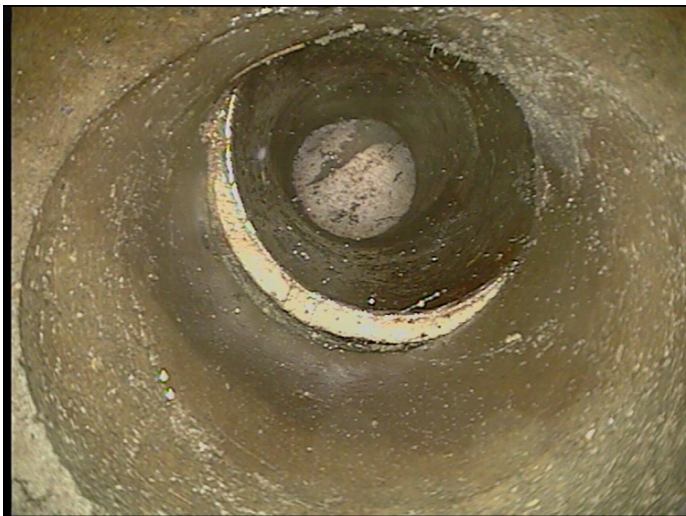
Code: **TF**
Description: **Tap Factory**

Distance (ft): **44.8**
Structural Grade: **0**
O&M Grade: **0**
Clock Start/From: **1**
Clock To:
1st Value: **4.000**
2nd Value:
Value Percent:
Continuous Index:
Within 8" of Joint: **YES**
Remarks:

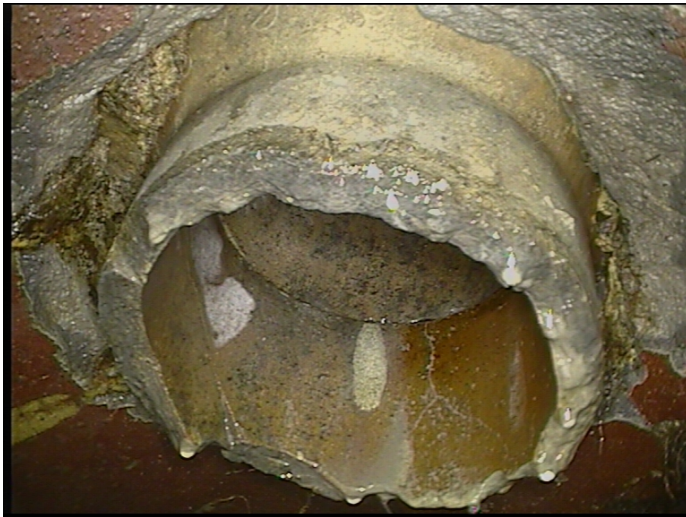
Code:	TBA
Description:	Tap Break-in Active
Distance (ft):	55.8
Structural Grade:	0
O&M Grade:	0
Clock Start/From:	1
Clock To:	
1st Value:	4.000
2nd Value:	
Value Percent:	
Continuous Index:	
Within 8" of Joint:	NO
Remarks:

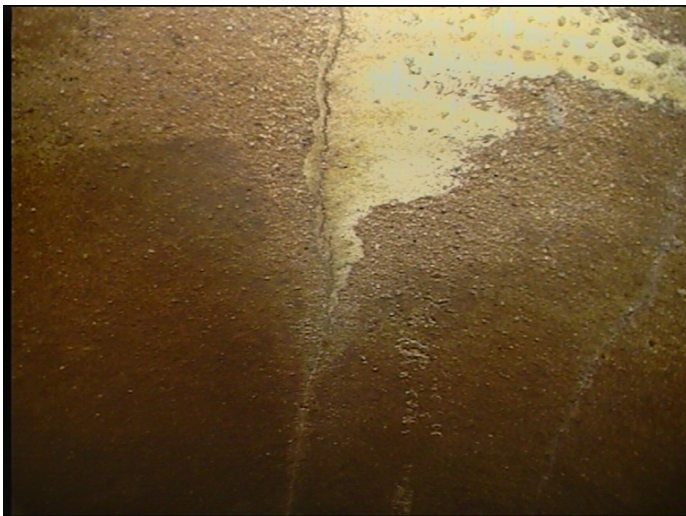
Code:	CL
Description:	Crack Longitudinal
Distance (ft):	59.8
Structural Grade:	2
O&M Grade:	0
Clock Start/From:	12
Clock To:	
1st Value:	
2nd Value:	
Value Percent:	
Continuous Index:	
Within 8" of Joint:	YES
Remarks:

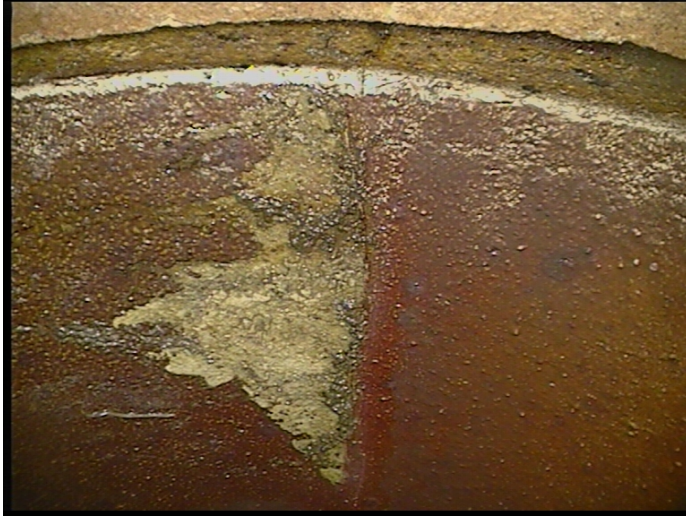
Code:	CL
Description:	Crack Longitudinal
Distance (ft):	65.9
Structural Grade:	2
O&M Grade:	0
Clock Start/From:	11
Clock To:	
1st Value:	
2nd Value:	
Value Percent:	
Continuous Index:	
Within 8" of Joint:	YES
Remarks:

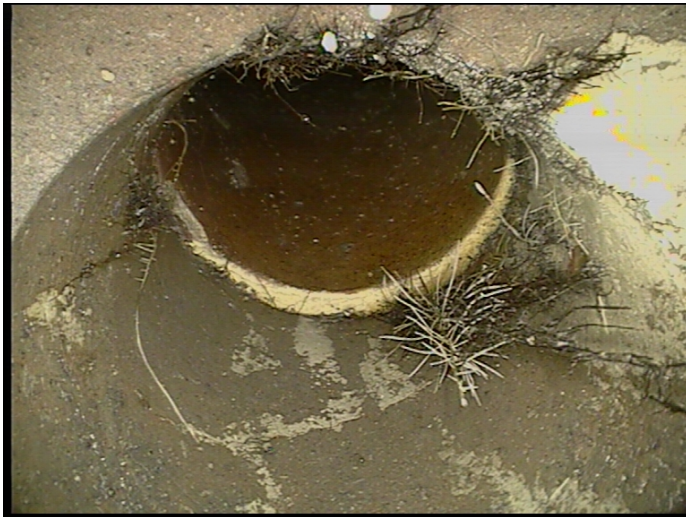
Code:	TF
Description:	Tap Factory
Distance (ft):	68.9
Structural Grade:	0
O&M Grade:	0
Clock Start/From:	1
Clock To:	
1st Value:	4.000
2nd Value:	
Value Percent:	
Continuous Index:	
Within 8" of Joint:	YES
Remarks:

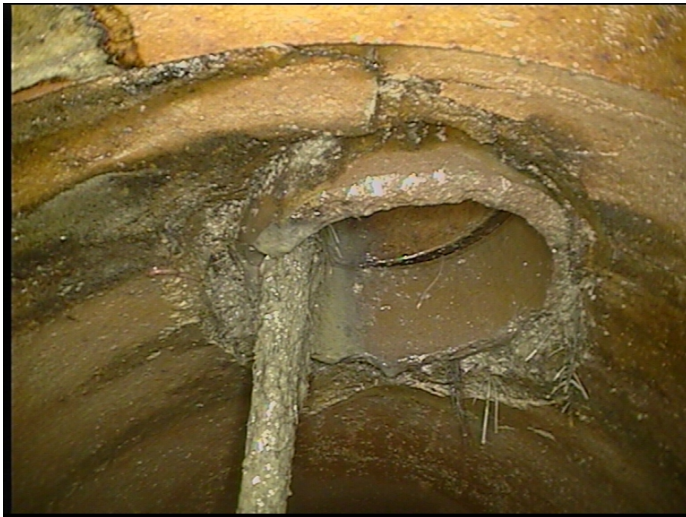
Code:	TBD
Description:	Tap Break-in Defective
Distance (ft):	75.6
Structural Grade:	0
O&M Grade:	3
Clock Start/From:	12
Clock To:	
1st Value:	4.000
2nd Value:	
Value Percent:	
Continuous Index:	
Within 8" of Joint:	NO
Remarks:	Defective

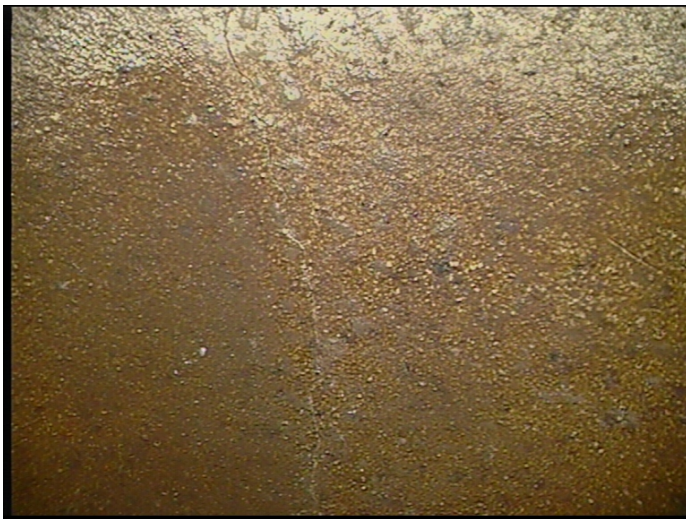
Code:	CL
Description:	Crack Longitudinal
Distance (ft):	80.3
Structural Grade:	2
O&M Grade:	0
Clock Start/From:	1
Clock To:	
1st Value:	
2nd Value:	
Value Percent:	
Continuous Index:	
Within 8" of Joint:	YES
Remarks:

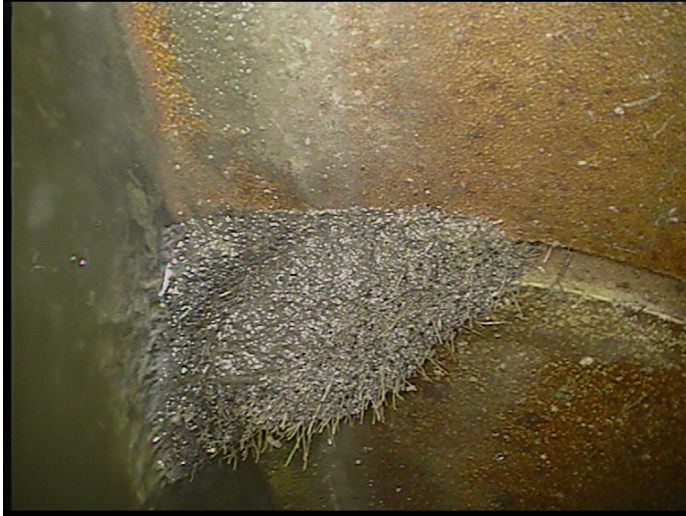
Code:	RMJ
Description:	Roots Medium Joint
Distance (ft):	81.6
Structural Grade:	0
O&M Grade:	3
Clock Start/From:	7
Clock To:	8
1st Value:	
2nd Value:	
Value Percent:	5.000
Continuous Index:	
Within 8" of Joint:	YES
Remarks:

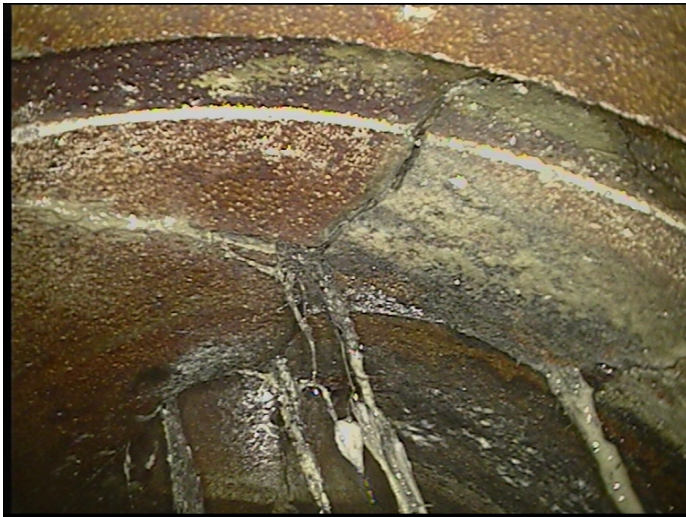
Code:	FM
Description:	Fracture Multiple
Distance (ft):	94.0
Structural Grade:	4
O&M Grade:	0
Clock Start/From:	12
Clock To:	3
1st Value:	
2nd Value:	
Value Percent:	
Continuous Index:	
Within 8" of Joint:	YES
Remarks:

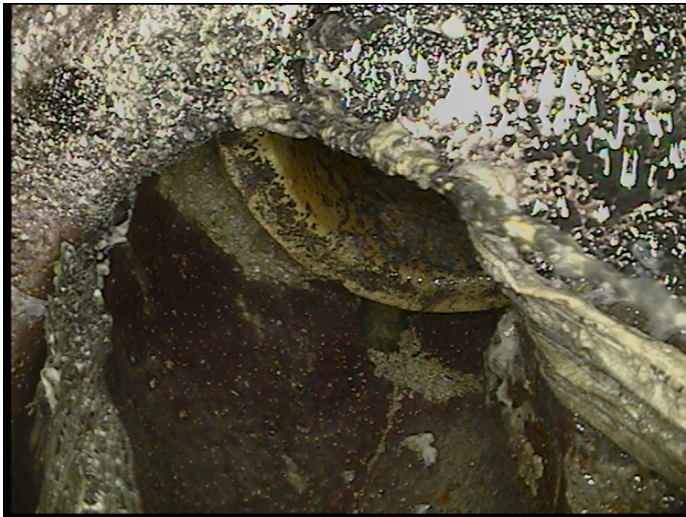
Code:	TFD
Description:	Tap Factory Defective
Distance (ft):	95.2
Structural Grade:	0
O&M Grade:	2
Clock Start/From:	1
Clock To:	
1st Value:	4.000
2nd Value:	
Value Percent:	
Continuous Index:	
Within 8" of Joint:	NO
Remarks:	roots

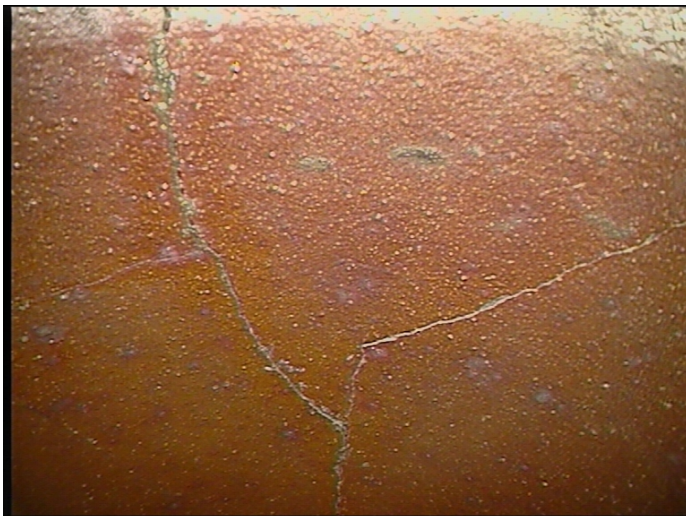
Code:	CM
Description:	Crack Multiple
Distance (ft):	98.3
Structural Grade:	3
O&M Grade:	0
Clock Start/From:	12
Clock To:	2
1st Value:	
2nd Value:	
Value Percent:	
Continuous Index:	
Within 8" of Joint:	YES
Remarks:

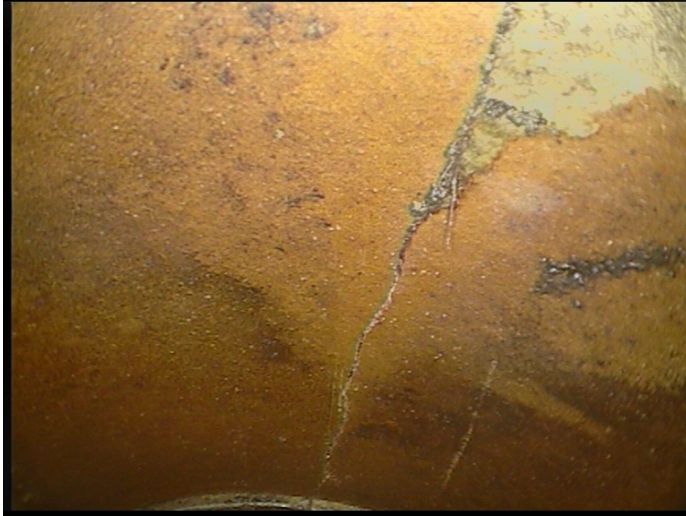
Code: **CL**
Description: **Crack Longitudinal**

Distance (ft): **100.9**
Structural Grade: **2**
O&M Grade: **0**
Clock Start/From: **1**
Clock To:
1st Value:
2nd Value:
Value Percent:
Continuous Index: **S01**
Within 8" of Joint: **YES**
Remarks:

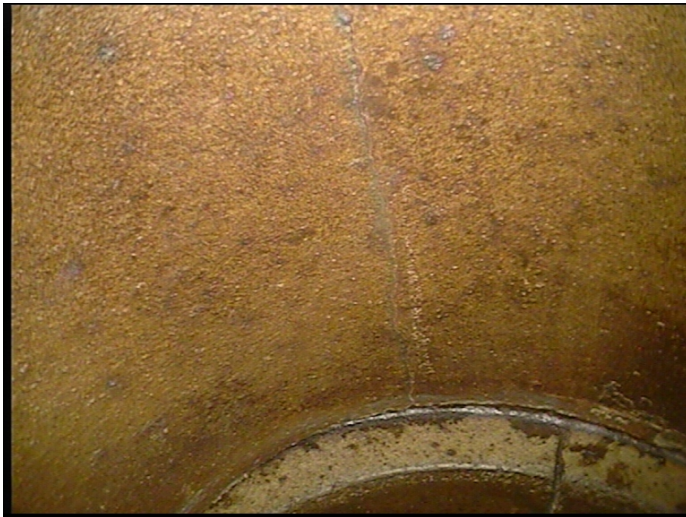
Code: **CL**
Description: **Crack Longitudinal**

Distance (ft): **113.3**
Structural Grade: **2**
O&M Grade: **0**
Clock Start/From: **1**
Clock To:
1st Value:
2nd Value:
Value Percent:
Continuous Index: **F01**
Within 8" of Joint: **NO**
Remarks:

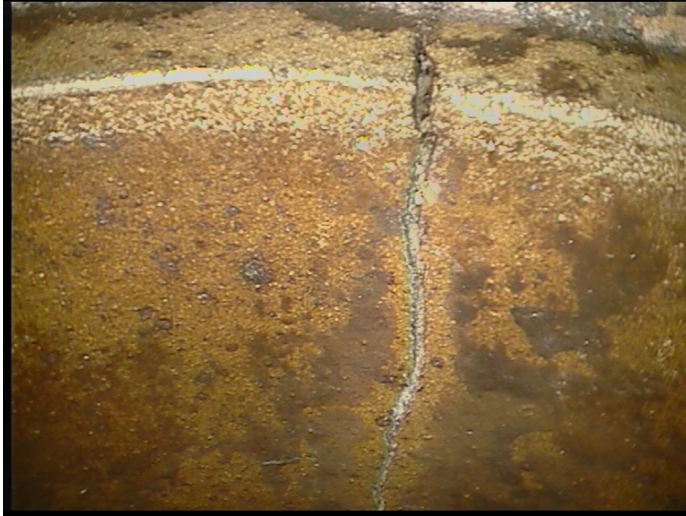
Code:	FL
Description:	Fracture Longitudinal
Distance (ft):	114.8
Structural Grade:	3
O&M Grade:	0
Clock Start/From:	12
Clock To:	
1st Value:	
2nd Value:	
Value Percent:	
Continuous Index:	
Within 8" of Joint:	YES
Remarks:

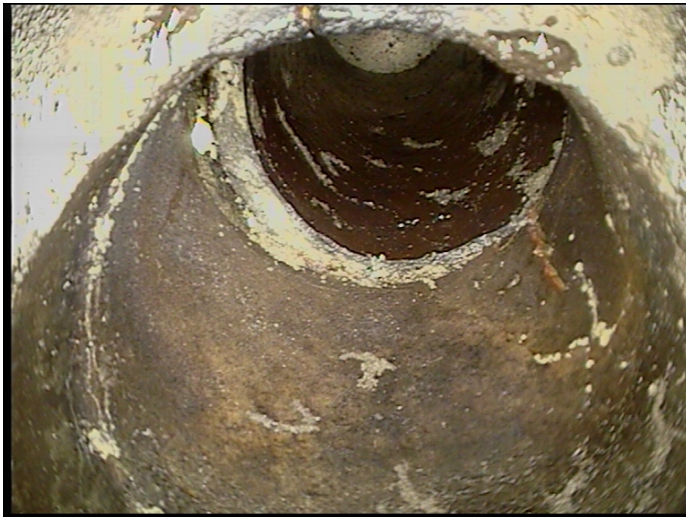
Code:	TF
Description:	Tap Factory
Distance (ft):	117.8
Structural Grade:	0
O&M Grade:	0
Clock Start/From:	2
Clock To:	
1st Value:	4.000
2nd Value:	
Value Percent:	
Continuous Index:	
Within 8" of Joint:	NO
Remarks:

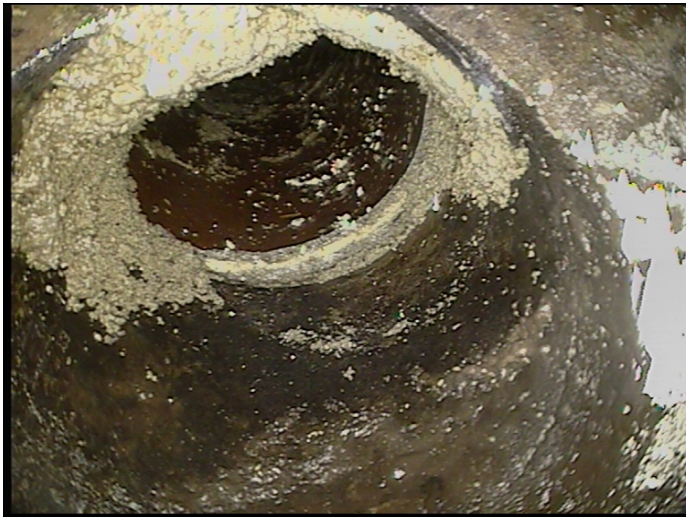
Code: **TF**
Description: **Tap Factory**

Distance (ft): **124.0**
Structural Grade: **0**
O&M Grade: **0**
Clock Start/From: **11**
Clock To:
1st Value: **4.000**
2nd Value:
Value Percent:
Continuous Index:
Within 8" of Joint: **NO**
Remarks:

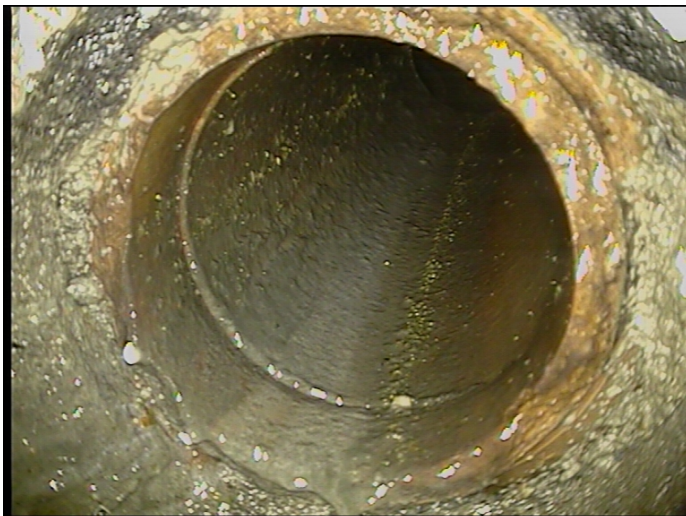
Code: **TB**
Description: **Tap Break-in**

Distance (ft): **127.6**
Structural Grade: **0**
O&M Grade: **0**
Clock Start/From: **11**
Clock To:
1st Value: **4.000**
2nd Value:
Value Percent:
Continuous Index:
Within 8" of Joint: **NO**
Remarks:

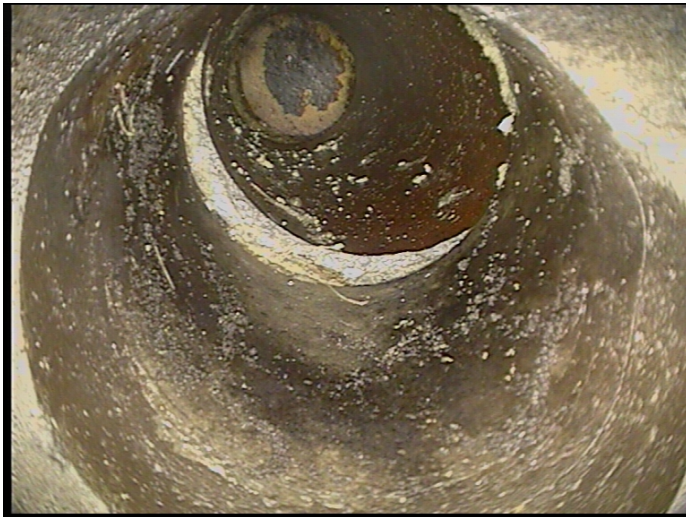
Code: **TF**
Description: **Tap Factory**

Distance (ft): **144.4**
Structural Grade: **0**
O&M Grade: **0**
Clock Start/From: **2**
Clock To:
1st Value: **4.000**
2nd Value:
Value Percent:
Continuous Index:
Within 8" of Joint: **NO**
Remarks:

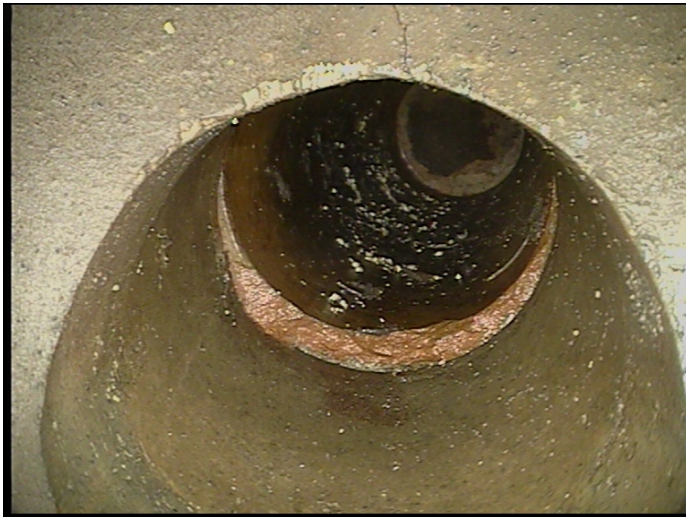
Code: **TF**
Description: **Tap Factory**

Distance (ft): **168.8**
Structural Grade: **0**
O&M Grade: **0**
Clock Start/From: **1**
Clock To:
1st Value: **4.000**
2nd Value:
Value Percent:
Continuous Index:
Within 8" of Joint: **NO**
Remarks:

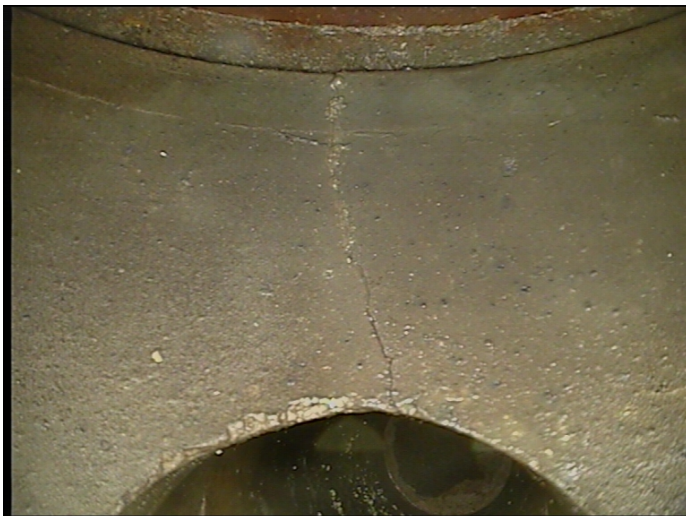
Code: **CL**
Description: **Crack Longitudinal**

Distance (ft): **168.8**
Structural Grade: **2**
O&M Grade: **0**
Clock Start/From: **1**
Clock To:
1st Value:
2nd Value:
Value Percent:
Continuous Index:
Within 8" of Joint: **YES**
Remarks:

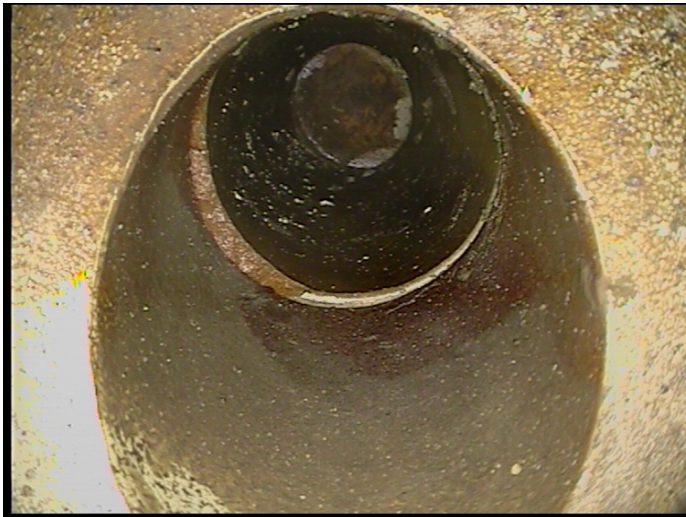
Code: **TF**
Description: **Tap Factory**

Distance (ft): **193.6**
Structural Grade: **0**
O&M Grade: **0**
Clock Start/From: **1**
Clock To:
1st Value: **4.000**
2nd Value:
Value Percent:
Continuous Index:
Within 8" of Joint: **NO**
Remarks:

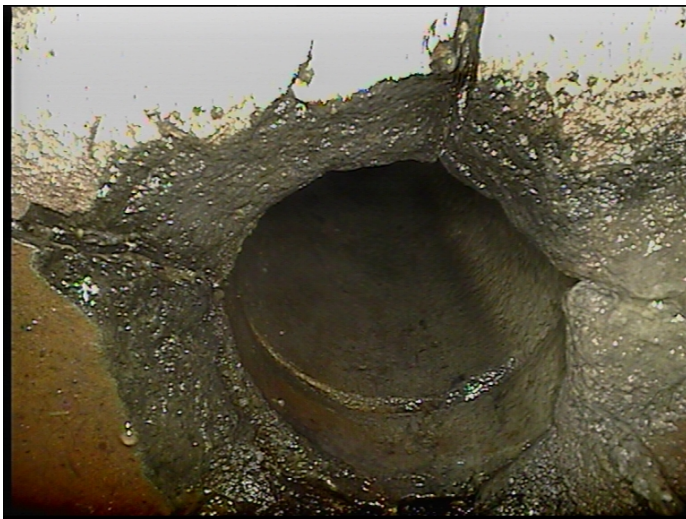
Code: **TB**
Description: **Tap Break-in**

Distance (ft): **204.6**
Structural Grade: **0**
O&M Grade: **0**
Clock Start/From: **1**
Clock To:
1st Value: **4.000**
2nd Value:
Value Percent:
Continuous Index:
Within 8" of Joint: **NO**
Remarks:

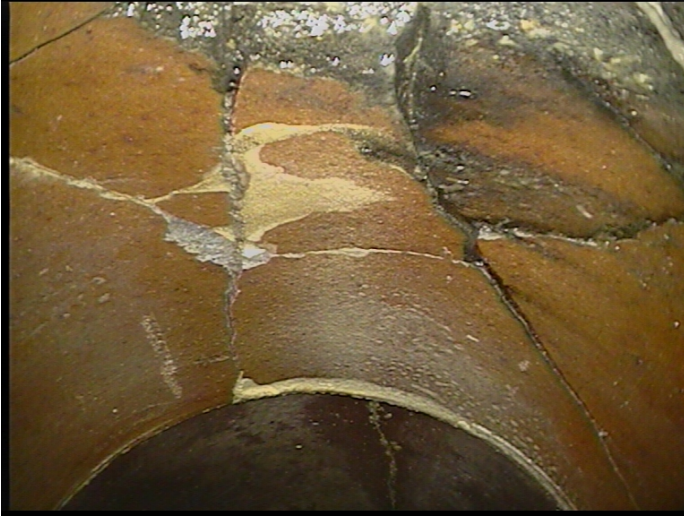
Code: **CM**
Description: **Crack Multiple**

Distance (ft): **204.6**
Structural Grade: **3**
O&M Grade: **0**
Clock Start/From: **11**
Clock To: **2**
1st Value:
2nd Value:
Value Percent:
Continuous Index:
Within 8" of Joint: **YES**
Remarks:

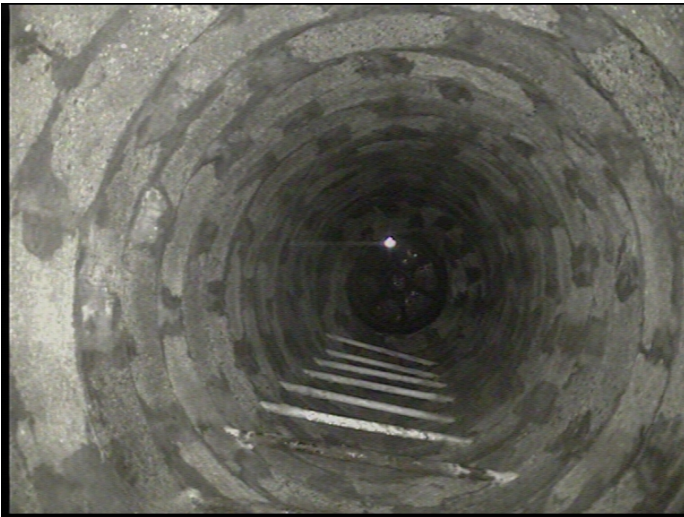
Code: **AMH**
Description: **Manhole**

Distance (ft): **237.1**
Structural Grade: **0**
O&M Grade: **0**
Clock Start/From:
Clock To:
1st Value:
2nd Value:
Value Percent:
Continuous Index:
Within 8" of Joint: **NO**
Remarks: **M-504-073**
