Profile/Photo Observation Report

Date:	04/08/2018	Weather:		Coding:	PACP 6.0
Pipe Length (ft):		Owner:	City of Hobart	Pre Clean:	No Pre-Cleaning
P.O.#:	21-1	Surveyor:	M. Pielacha	PSR:	M-504-076-M-504-075
Customer:	City of Hobart	Clean Date:		Shape:	C

Location Details:		Direction of Survey:	Downstream
US MH:	M-504-076	DS MH:	M-504-075
		Total Length Surveyed (ft):	158.8

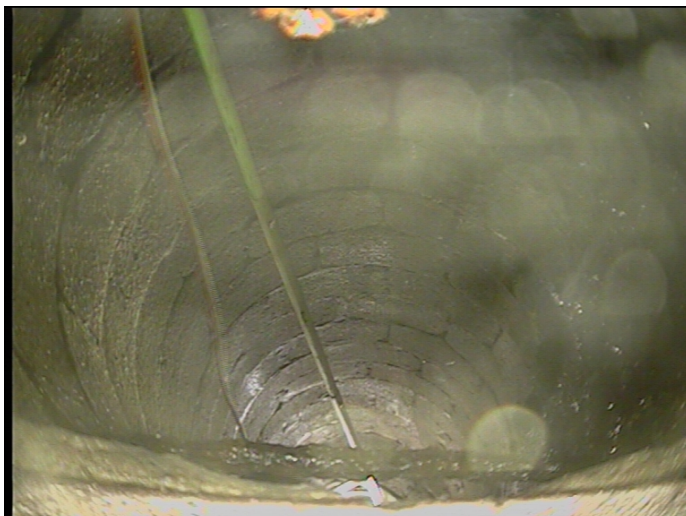
Code: **AMH**
 Description: **Manhole**

Distance (ft): **.0**
 Structural Grade: **0**
 O&M Grade: **0**
 Clock Start/From:
 Clock To:
 1st Value:
 2nd Value:
 Value Percent:
 Continuous Index:
 Within 8" of Joint: **NO**
 Remarks: **M-504-076**

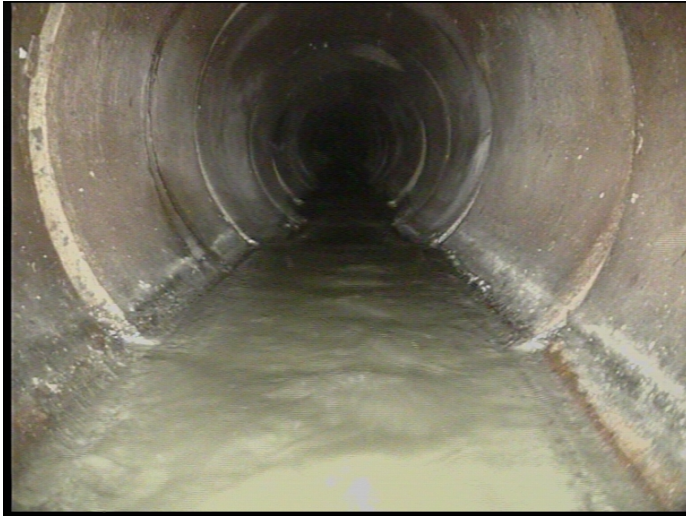
Code:	MWL
Description:	Water Level
Distance (ft):	.0
Structural Grade:	0
O&M Grade:	0
Clock Start/From:	
Clock To:	
1st Value:	
2nd Value:	
Value Percent:	5.000
Continuous Index:	
Within 8" of Joint:	NO
Remarks:

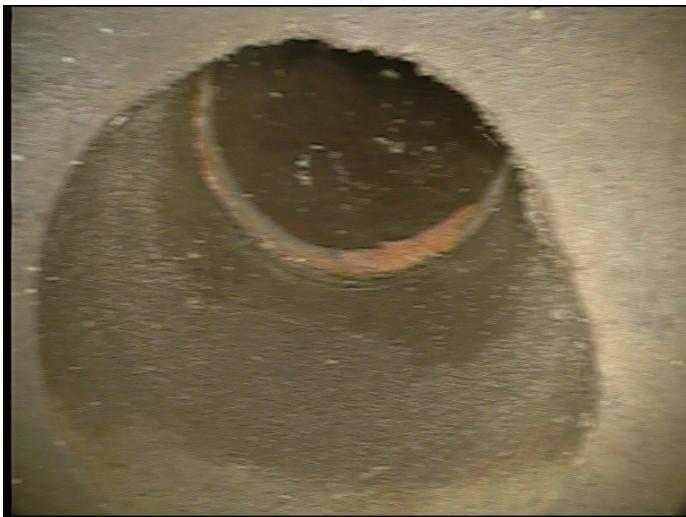
Code:	TF
Description:	Tap Factory
Distance (ft):	6.9
Structural Grade:	0
O&M Grade:	0
Clock Start/From:	2
Clock To:	
1st Value:	4.000
2nd Value:	
Value Percent:	
Continuous Index:	
Within 8" of Joint:	NO
Remarks:

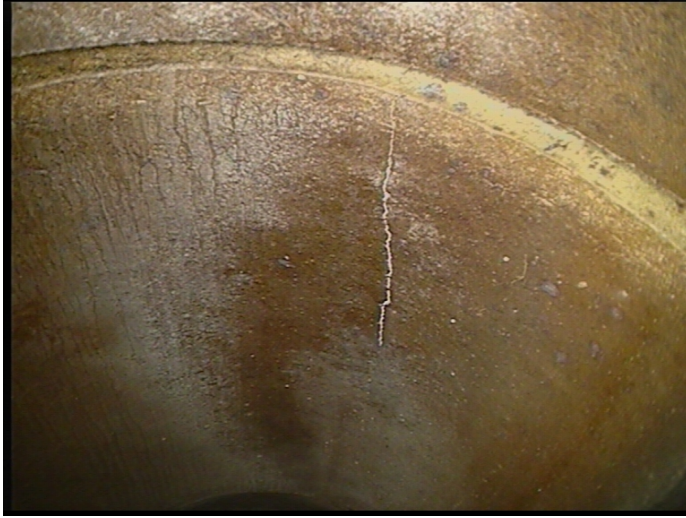
Code: **CL**
Description: **Crack Longitudinal**

Distance (ft): **9.5**
Structural Grade: **2**
O&M Grade: **0**
Clock Start/From: **3**
Clock To:
1st Value:
2nd Value:
Value Percent:
Continuous Index:
Within 8" of Joint: **YES**
Remarks:

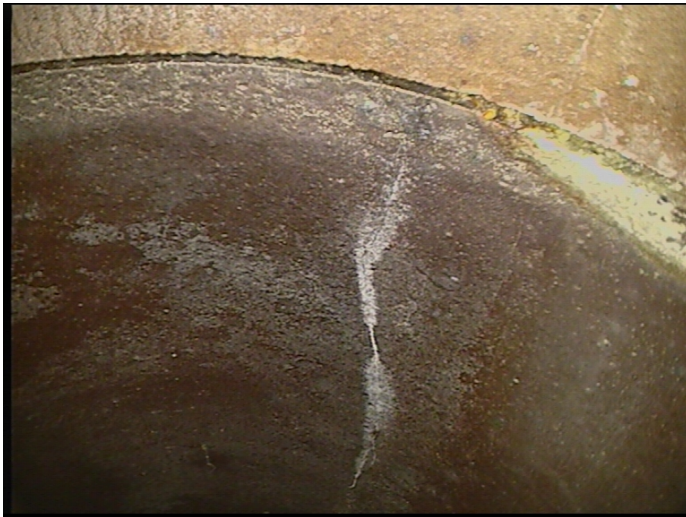
Code: **CL**
Description: **Crack Longitudinal**

Distance (ft): **11.7**
Structural Grade: **2**
O&M Grade: **0**
Clock Start/From: **3**
Clock To:
1st Value:
2nd Value:
Value Percent:
Continuous Index:
Within 8" of Joint: **YES**
Remarks:

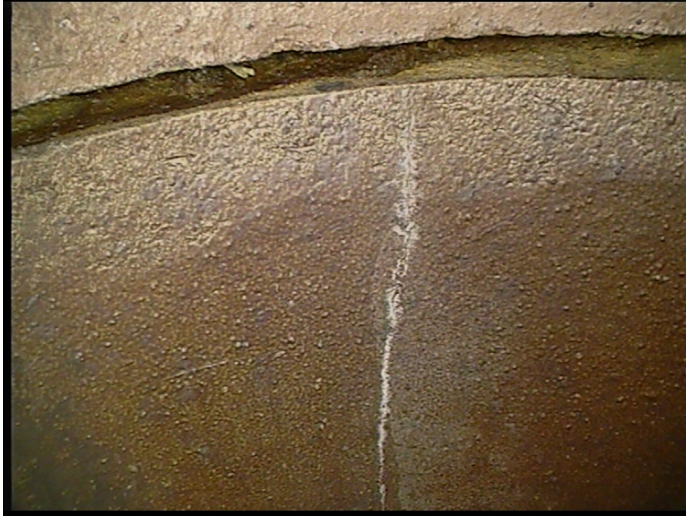
Code: **CL**
Description: **Crack Longitudinal**

Distance (ft): **21.1**
Structural Grade: **2**
O&M Grade: **0**
Clock Start/From: **9**
Clock To:
1st Value:
2nd Value:
Value Percent:
Continuous Index:
Within 8" of Joint: **YES**
Remarks:

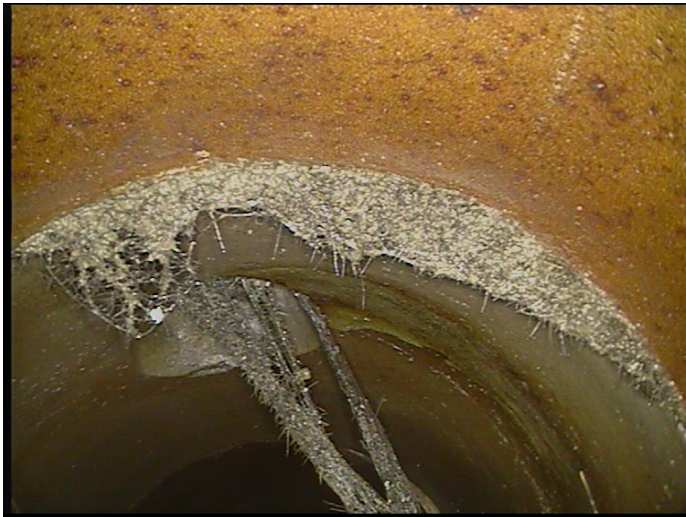
Code: **RFJ**
Description: **Roots Fine Joint**

Distance (ft): **46.7**
Structural Grade: **0**
O&M Grade: **1**
Clock Start/From: **12**
Clock To: **3**
1st Value:
2nd Value:
Value Percent:
Continuous Index:
Within 8" of Joint: **YES**
Remarks:

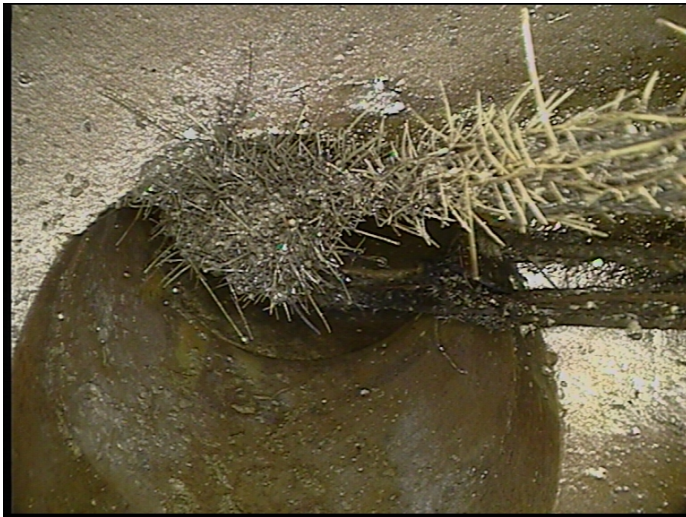
Code: **TFD**
Description: **Tap Factory Defective**

Distance (ft): **48.5**
Structural Grade: **0**
O&M Grade: **2**
Clock Start/From: **1**
Clock To:
1st Value: **4.000**
2nd Value:
Value Percent:
Continuous Index:
Within 8" of Joint: **NO**
Remarks: **Defective**

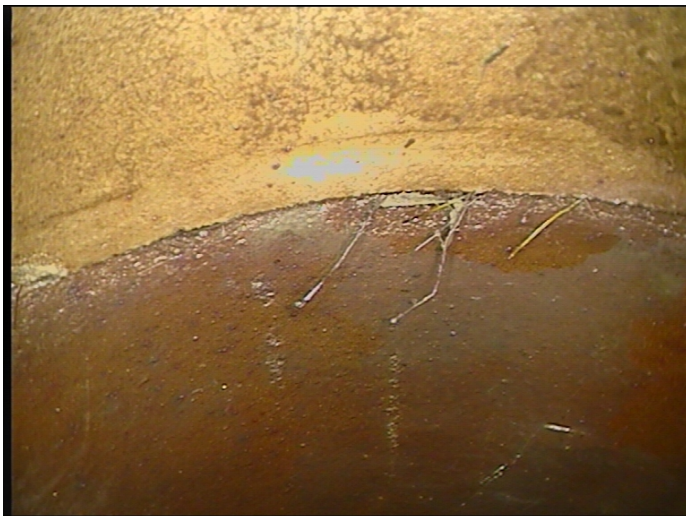
Code: **RFJ**
Description: **Roots Fine Joint**

Distance (ft): **59.5**
Structural Grade: **0**
O&M Grade: **1**
Clock Start/From: **11**
Clock To:
1st Value:
2nd Value:
Value Percent:
Continuous Index:
Within 8" of Joint: **YES**
Remarks:

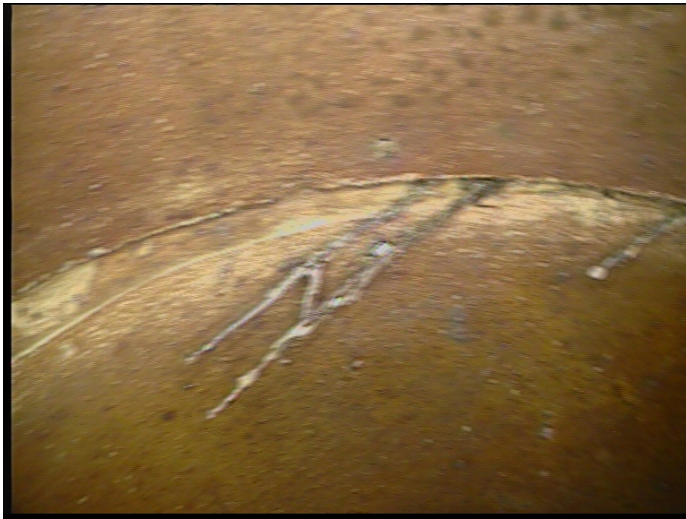
Code: **RFJ**
Description: **Roots Fine Joint**

Distance (ft): **61.6**
Structural Grade: **0**
O&M Grade: **1**
Clock Start/From: **10**
Clock To: **1**
1st Value:
2nd Value:
Value Percent:
Continuous Index:
Within 8" of Joint: **YES**
Remarks:

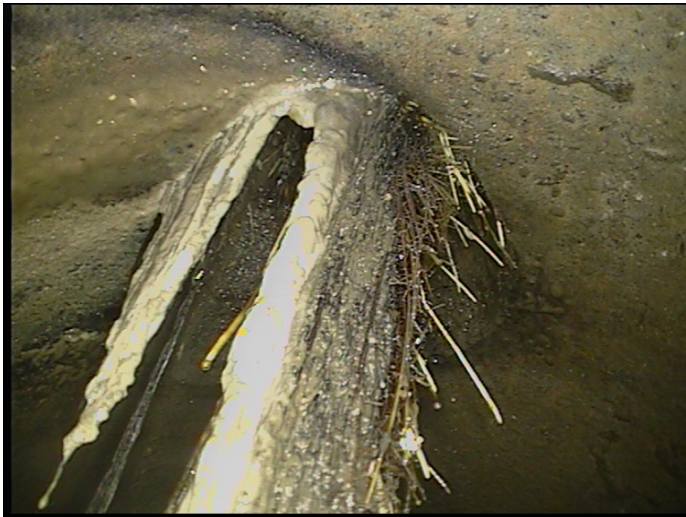
Code: **TFD**
Description: **Tap Factory Defective**

Distance (ft): **68.3**
Structural Grade: **0**
O&M Grade: **2**
Clock Start/From: **11**
Clock To:
1st Value: **4.000**
2nd Value:
Value Percent:
Continuous Index:
Within 8" of Joint: **NO**
Remarks: **roots**

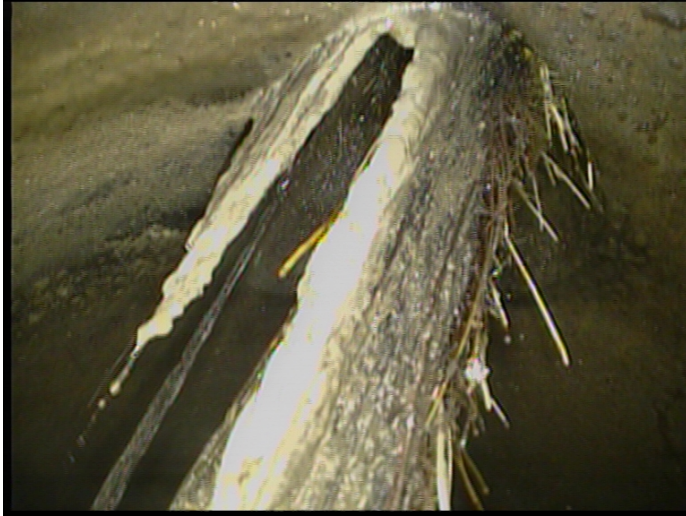
Code: **RML**
Description: **Roots Medium Lateral**

Distance (ft): **68.3**
Structural Grade: **0**
O&M Grade: **3**
Clock Start/From: **1**
Clock To:
1st Value:
2nd Value:
Value Percent: **10.000**
Continuous Index:
Within 8" of Joint: **NO**
Remarks:

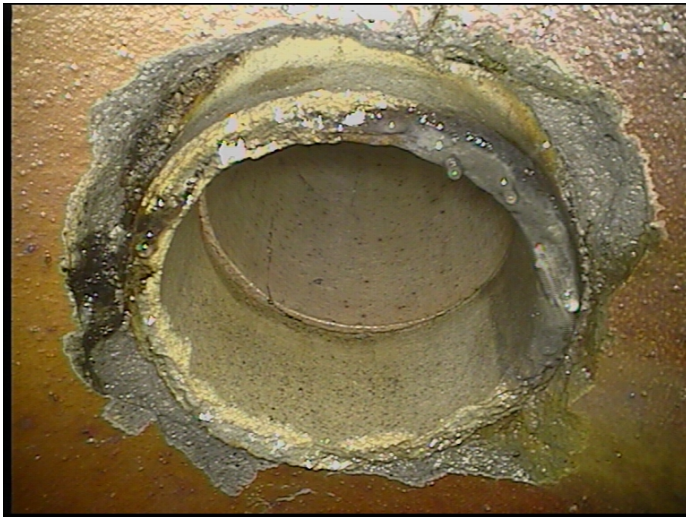
Code: **TBA**
Description: **Tap Break-in Active**

Distance (ft): **76.8**
Structural Grade: **0**
O&M Grade: **0**
Clock Start/From: **12**
Clock To:
1st Value: **4.000**
2nd Value:
Value Percent:
Continuous Index:
Within 8" of Joint: **NO**
Remarks:

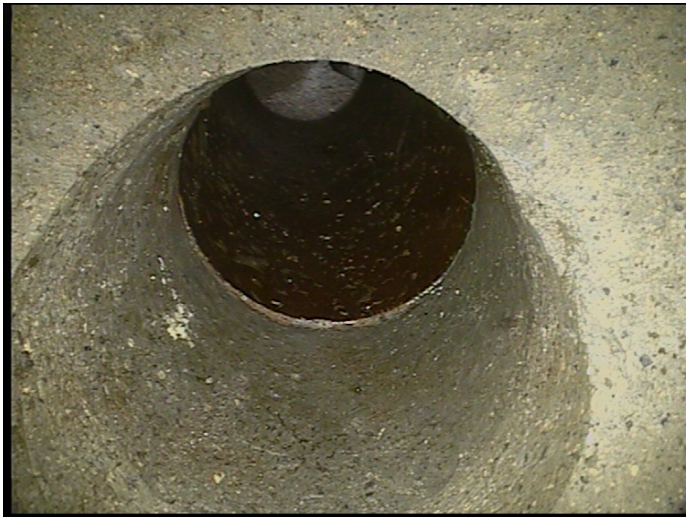
Code: **TF**
Description: **Tap Factory**

Distance (ft): **87.5**
Structural Grade: **0**
O&M Grade: **0**
Clock Start/From: **1**
Clock To:
1st Value: **4.000**
2nd Value:
Value Percent:
Continuous Index:
Within 8" of Joint: **NO**
Remarks:

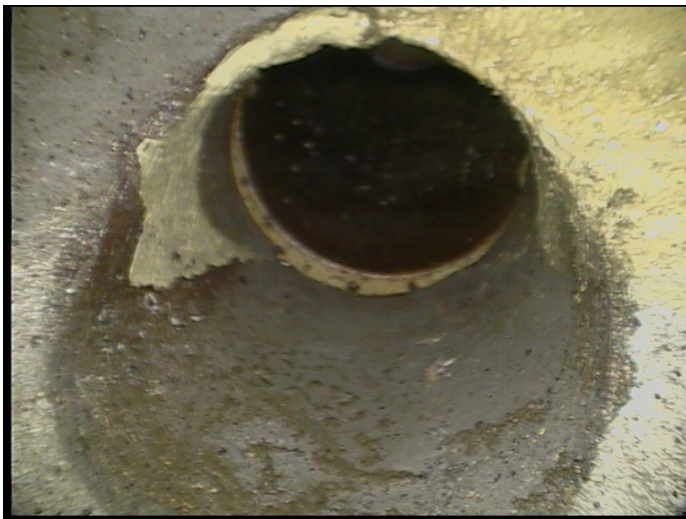
Code: **TF**
Description: **Tap Factory**

Distance (ft): **118.4**
Structural Grade: **0**
O&M Grade: **0**
Clock Start/From: **1**
Clock To:
1st Value: **4.000**
2nd Value:
Value Percent:
Continuous Index:
Within 8" of Joint: **NO**
Remarks:

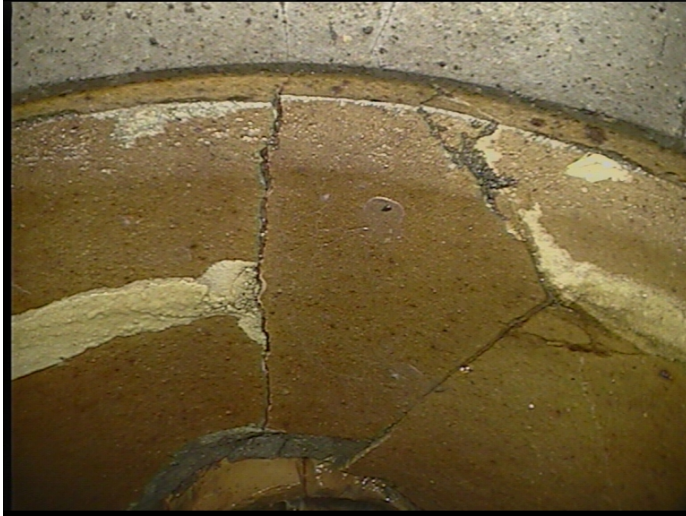
Code: **CM**
Description: **Crack Multiple**

Distance (ft): **119.0**
Structural Grade: **3**
O&M Grade: **0**
Clock Start/From: **12**
Clock To: **1**
1st Value:
2nd Value:
Value Percent:
Continuous Index:
Within 8" of Joint: **YES**
Remarks:

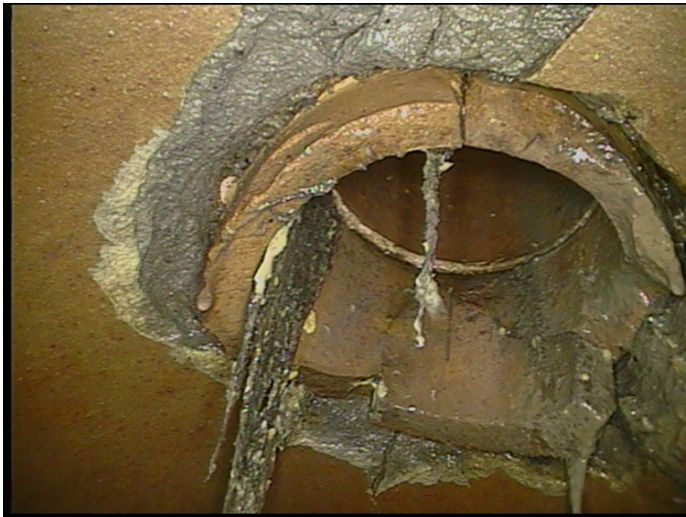
Code: **TB**
Description: **Tap Break-in**

Distance (ft): **120.1**
Structural Grade: **0**
O&M Grade: **0**
Clock Start/From: **12**
Clock To:
1st Value: **5.000**
2nd Value:
Value Percent:
Continuous Index:
Within 8" of Joint: **NO**
Remarks:

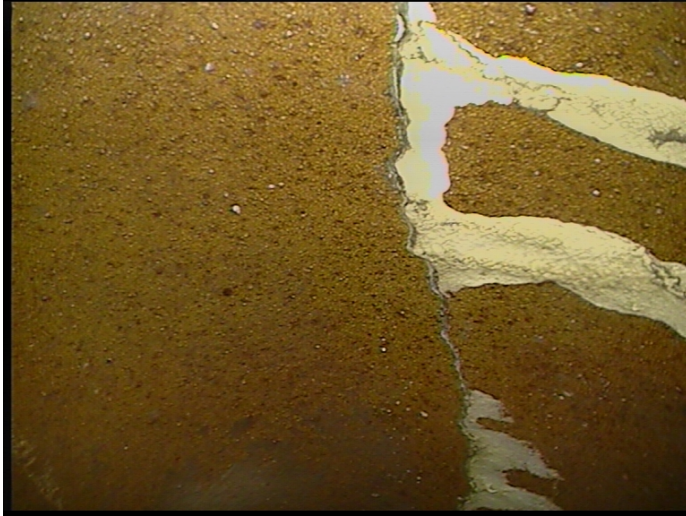
Code: **FL**
Description: **Fracture Longitudinal**

Distance (ft): **121.4**
Structural Grade: **3**
O&M Grade: **0**
Clock Start/From: **12**
Clock To:
1st Value:
2nd Value:
Value Percent:
Continuous Index: **S01**
Within 8" of Joint: **YES**
Remarks:

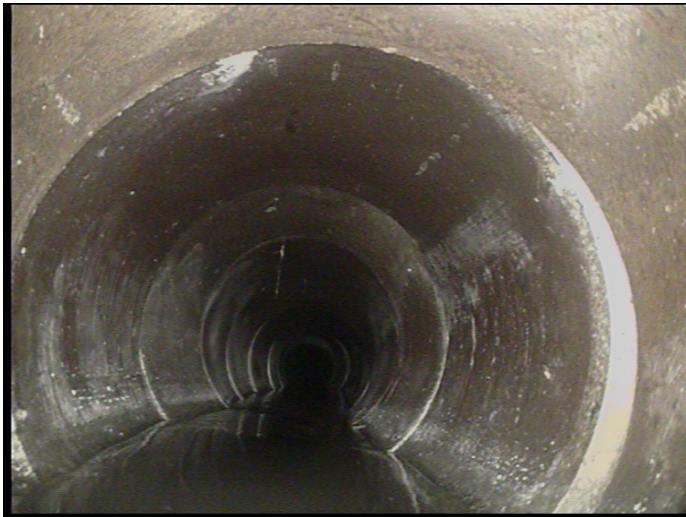
Code: **FL**
Description: **Fracture Longitudinal**

Distance (ft): **136.0**
Structural Grade: **3**
O&M Grade: **0**
Clock Start/From: **12**
Clock To:
1st Value:
2nd Value:
Value Percent:
Continuous Index: **F01**
Within 8" of Joint: **NO**
Remarks:

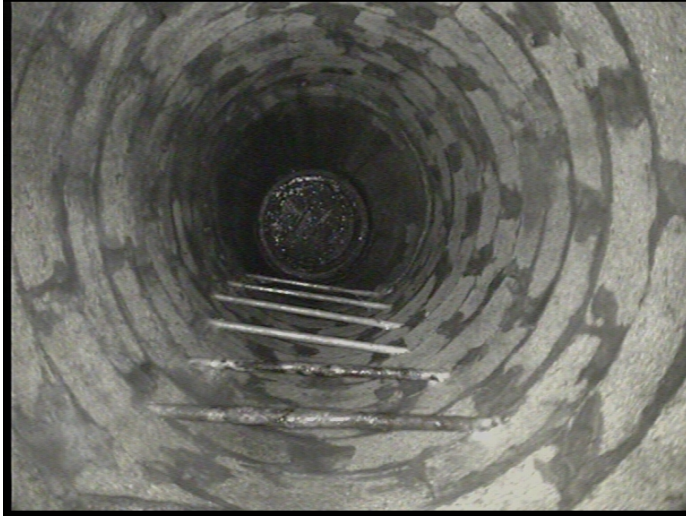
Code:	AMH
Description:	Manhole
Distance (ft):	158.8
Structural Grade:	0
O&M Grade:	0
Clock Start/From:	
Clock To:	
1st Value:	
2nd Value:	
Value Percent:	
Continuous Index:	
Within 8" of Joint:	NO
Remarks:	M-504-075
