Profile/Photo Observation Report

Date:	04/08/2018	Weather:		Coding:	PACP 6.0
Pipe Length (ft):		Owner:	City of Hobart	Pre Clean:	No Pre-Cleaning
P.O.#:	21-1	Surveyor:	M. Pielacha	PSR:	M-504-076-M-504-075
Customer:	City of Hobart	Clean Date:		Shape:	C

Street:	Off Colorado Street	Flow Control:	Not Controlled
City:	Hobart, IN	Year Renewed:	
Location:	Light Highway	Tape/Media #:	DEP 21
Purpose:	Routine Assessment	Dia/Height:	18"
Use:	Sanitary	Material:	VCP
Drain Area:		Lining:

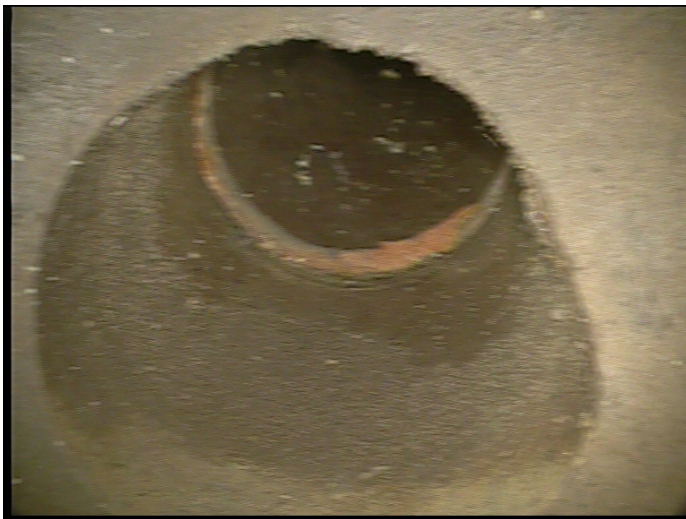
Code: **TF**
Description: **Tap Factory**

Distance (ft): **6.9**
Structural Grade: **0**
O&M Grade: **0**
Clock Start/From: **2**
Clock To:
1st Value: **4.000**
2nd Value:
Value Percent:
Continuous Index:
Within 8" of Joint: **NO**
Remarks:

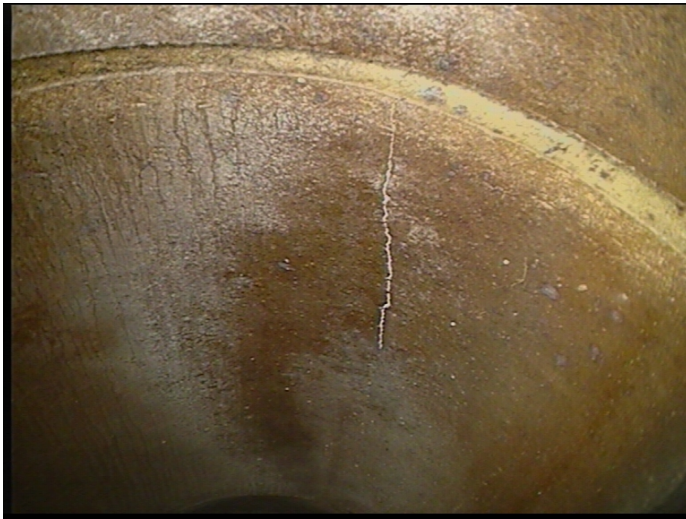
Code: **CL**
Description: **Crack Longitudinal**

Distance (ft): **9.5**
Structural Grade: **2**
O&M Grade: **0**
Clock Start/From: **3**
Clock To:
1st Value:
2nd Value:
Value Percent:
Continuous Index:
Within 8" of Joint: **YES**
Remarks:

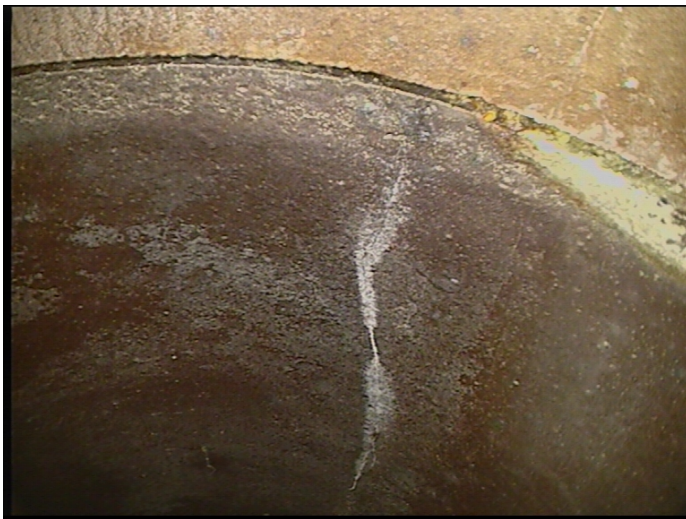
Code: **CL**
Description: **Crack Longitudinal**

Distance (ft): **11.7**
Structural Grade: **2**
O&M Grade: **0**
Clock Start/From: **3**
Clock To:
1st Value:
2nd Value:
Value Percent:
Continuous Index:
Within 8" of Joint: **YES**
Remarks:

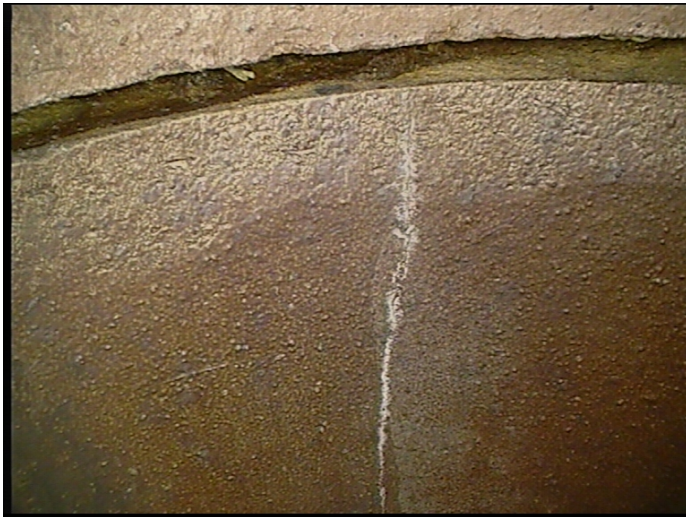
Code: **CL**
Description: **Crack Longitudinal**

Distance (ft): **21.1**
Structural Grade: **2**
O&M Grade: **0**
Clock Start/From: **9**
Clock To:
1st Value:
2nd Value:
Value Percent:
Continuous Index:
Within 8" of Joint: **YES**
Remarks:

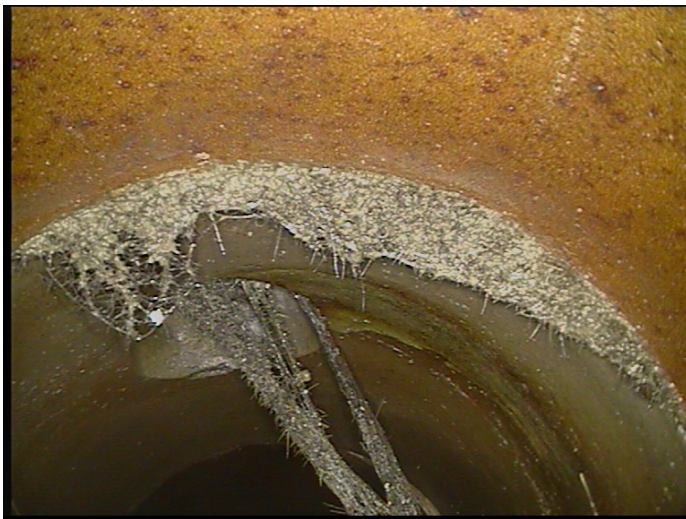
Code: **RFJ**
Description: **Roots Fine Joint**

Distance (ft): **46.7**
Structural Grade: **0**
O&M Grade: **1**
Clock Start/From: **12**
Clock To: **3**
1st Value:
2nd Value:
Value Percent:
Continuous Index:
Within 8" of Joint: **YES**
Remarks:

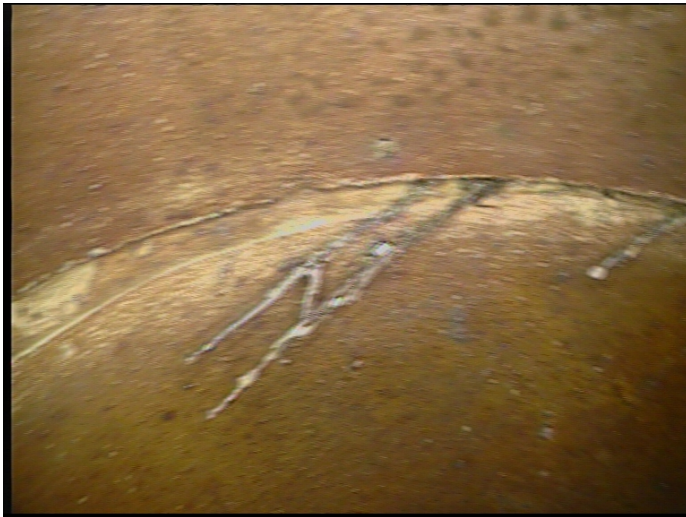
Code: **RFJ**
Description: **Roots Fine Joint**

Distance (ft): **61.6**
Structural Grade: **0**
O&M Grade: **1**
Clock Start/From: **10**
Clock To: **1**
1st Value:
2nd Value:
Value Percent:
Continuous Index:
Within 8" of Joint: **YES**
Remarks:

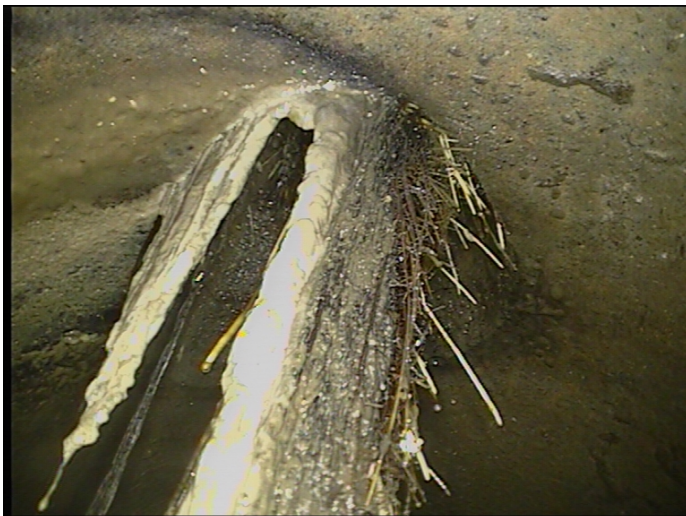
Code: **TFD**
Description: **Tap Factory Defective**

Distance (ft): **68.3**
Structural Grade: **0**
O&M Grade: **2**
Clock Start/From: **11**
Clock To:
1st Value: **4.000**
2nd Value:
Value Percent:
Continuous Index:
Within 8" of Joint: **NO**
Remarks: **roots**

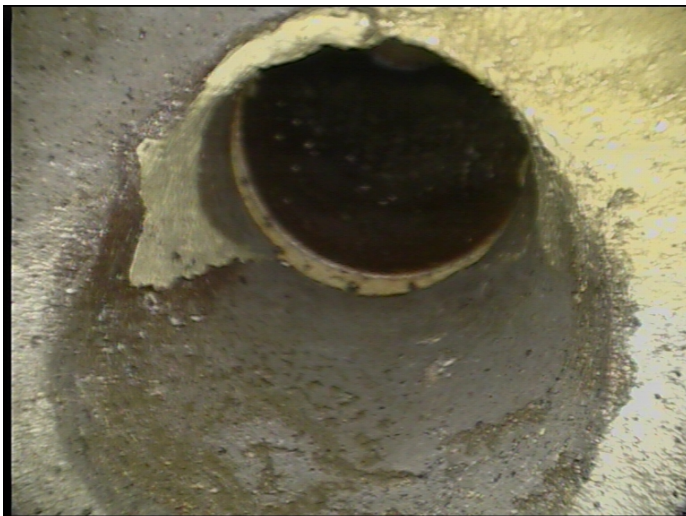
Code: **TF**
Description: **Tap Factory**

Distance (ft): **118.4**
Structural Grade: **0**
O&M Grade: **0**
Clock Start/From: **1**
Clock To:
1st Value: **4.000**
2nd Value:
Value Percent:
Continuous Index:
Within 8" of Joint: **NO**
Remarks:
