Profile/Photo Observation Report

Date:	04/20/2018	Weather:		Coding:	PACP 6.0
Pipe Length (ft):	201.1	Owner:	NA	Pre Clean:	Not Known
P.O.#:		Surveyor:	Justin Gonzales	PSR:	P-504-081-080
Customer:		Clean Date:	01/01/1900	Shape:	C

Street:	ALLEY BETWEEN N WISCONSIN ST &	Flow Control:	Not Controlled
City:	Hobart, IN	Year Renewed:	
Location:	Light Highway	Tape/Media #:	
Purpose:	Not Known	Dia/Height:	12"
Use:	Sanitary	Material:	VCP
Drain Area:	NA	Lining:	
Category:	NA		
Comment:

Location Details:		Direction of Survey:	Downstream
US MH:	M-504-080	DS MH:	M-504-081
		Total Length Surveyed (ft):	280.2

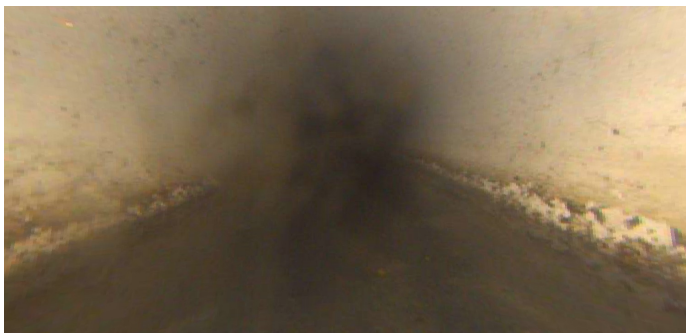
Code: **AMH**
Description: **Manhole**

Distance (ft): **.0**
Structural Grade: **0**
O&M Grade: **0**
Clock Start/From:
Clock To:
1st Value:
2nd Value:
Value Percent:
Continuous Index:
Within 8" of Joint: **NO**
Remarks: **M-504-080**

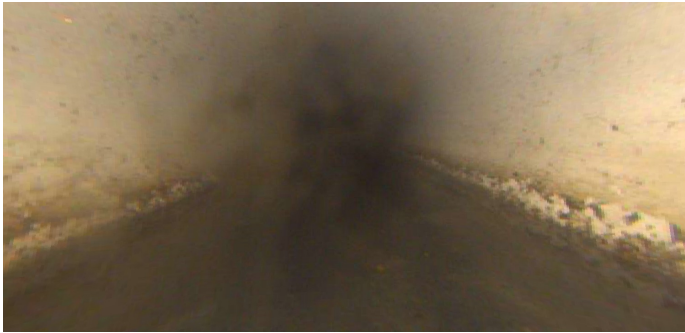
Code:	MWL
Description:	Water Level

Distance (ft):	.0
Structural Grade:	0
O&M Grade:	0
Clock Start/From:	
Clock To:	
1st Value:	
2nd Value:	
Value Percent:	10.000
Continuous Index:	
Within 8" of Joint:	NO
Remarks:

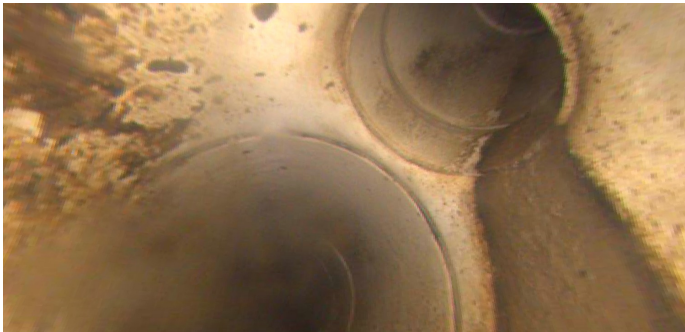
Code: **TF**
Description: **Tap Factory**

Distance (ft): **59.7**
Structural Grade: **0**
O&M Grade: **0**
Clock Start/From: **1**
Clock To:
1st Value: **4.000**
2nd Value:
Value Percent:
Continuous Index:
Within 8" of Joint:
Remarks:

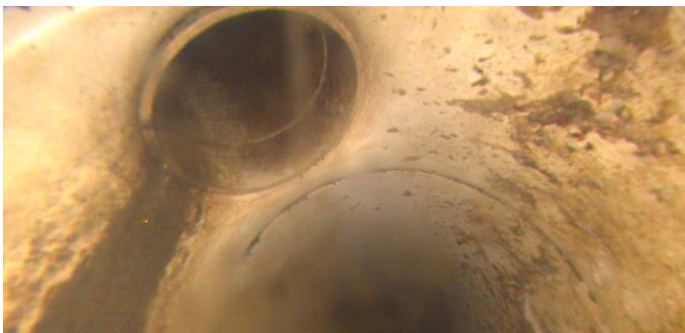
Code: **TF**
Description: **Tap Factory**

Distance (ft): **138.1**
Structural Grade: **0**
O&M Grade: **0**
Clock Start/From: **11**
Clock To:
1st Value: **4.000**
2nd Value:
Value Percent:
Continuous Index:
Within 8" of Joint:
Remarks:

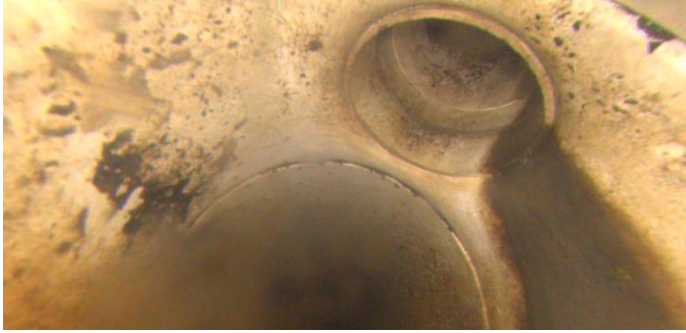
Code: **TF**
Description: **Tap Factory**

Distance (ft): **155.9**
Structural Grade: **0**
O&M Grade: **0**
Clock Start/From: **1**
Clock To:
1st Value: **4.000**
2nd Value:
Value Percent:
Continuous Index:
Within 8" of Joint:
Remarks:

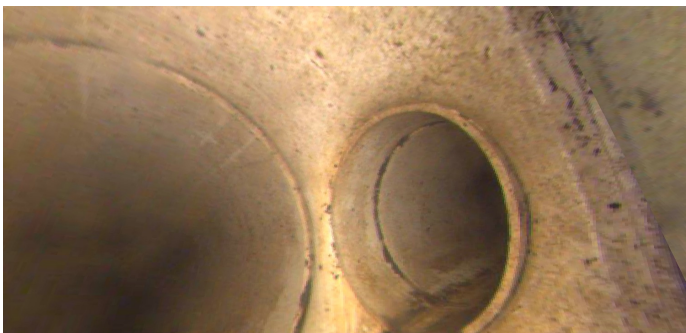
Code: **TF**
Description: **Tap Factory**

Distance (ft): **238.2**
Structural Grade: **0**
O&M Grade: **0**
Clock Start/From: **3**
Clock To:
1st Value: **4.000**
2nd Value:
Value Percent:
Continuous Index:
Within 8" of Joint:
Remarks:

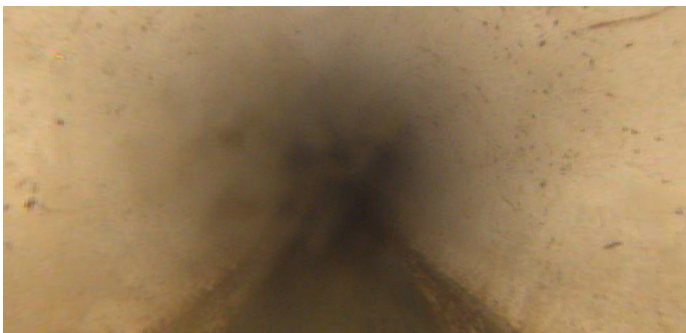
Code: **MSA**
Description: **Abandoned Survey**

Distance (ft): **280.2**
Structural Grade: **0**
O&M Grade: **0**
Clock Start/From:
Clock To:
1st Value:
2nd Value:
Value Percent:
Continuous Index:
Within 8" of Joint: **NO**
Remarks: **ROBOT HAS STOPED**
