Profile/Photo Observation Report

Date:	04/20/2018	Weather:		Coding:	PACP 6.0
Pipe Length (ft):	201.1	Owner:	NA	Pre Clean:	Not Known
P.O.#:		Surveyor:	Justin Gonzales	PSR:	P-504-081-080
Customer:		Clean Date:	01/01/1900	Shape:	C

Street:	Summerlin	Flow Control:	Not Controlled
City:	Hobart, IN	Year Renewed:	
Location:	Light Highway	Tape/Media #:	
Purpose:	Not Known	Dia/Height:	12"
Use:	Sanitary	Material:	VCP
Drain Area:	NA	Lining:	
Category:	NA		
Comment:

Location Details:		Direction of Survey:	Downstream
US MH:	M-504-080	DS MH:	M-504-081
		Total Length Surveyed (ft):	280.2

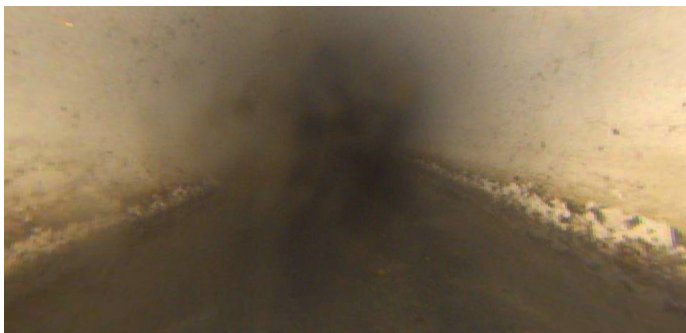
Code: **AMH**
Description: **Manhole**

Distance (ft): **.0**
Structural Grade: **0**
O&M Grade: **0**
Clock Start/From:
Clock To:
1st Value:
2nd Value:
Value Percent:
Continuous Index:
Within 8" of Joint: **NO**
Remarks: **M-504-080**

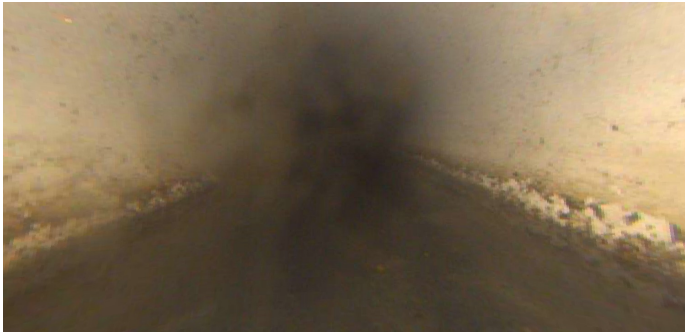
Code:	MWL
Description:	Water Level

Distance (ft):	.0
Structural Grade:	0
O&M Grade:	0
Clock Start/From:	
Clock To:	
1st Value:	
2nd Value:	
Value Percent:	10.000
Continuous Index:	
Within 8" of Joint:	NO
Remarks:

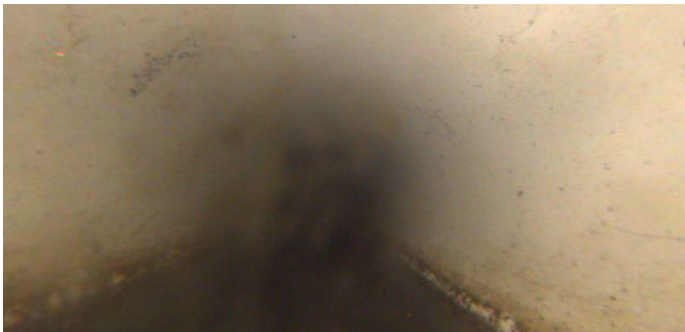
Code:	MGO
Description:	General Observation

Distance (ft):	2.1
Structural Grade:	0
O&M Grade:	0
Clock Start/From:	
Clock To:	
1st Value:	
2nd Value:	
Value Percent:	
Continuous Index:	
Within 8" of Joint:	NO
Remarks:	FRONT LENS SMUDGED

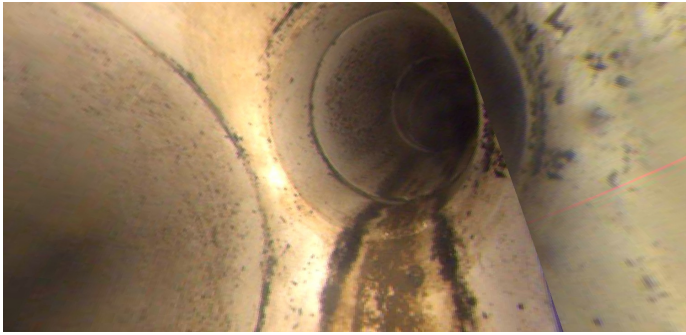
Code: **TF**
Description: **Tap Factory**

Distance (ft): **21.5**
Structural Grade: **0**
O&M Grade: **0**
Clock Start/From: **2**
Clock To:
1st Value: **4.000**
2nd Value:
Value Percent:
Continuous Index:
Within 8" of Joint:
Remarks:

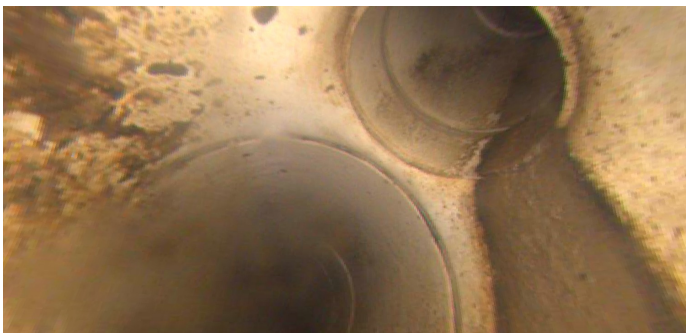
Code: **TF**
Description: **Tap Factory**

Distance (ft): **59.7**
Structural Grade: **0**
O&M Grade: **0**
Clock Start/From: **1**
Clock To:
1st Value: **4.000**
2nd Value:
Value Percent:
Continuous Index:
Within 8" of Joint:
Remarks:

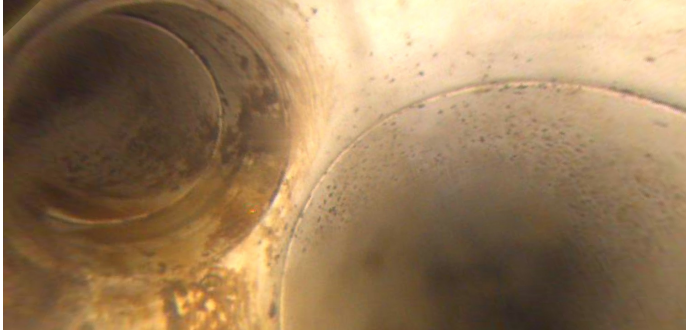
Code: **TF**
Description: **Tap Factory**

Distance (ft): **61.9**
Structural Grade: **0**
O&M Grade: **0**
Clock Start/From: **10**
Clock To:
1st Value: **4.000**
2nd Value:
Value Percent:
Continuous Index:
Within 8" of Joint:
Remarks:

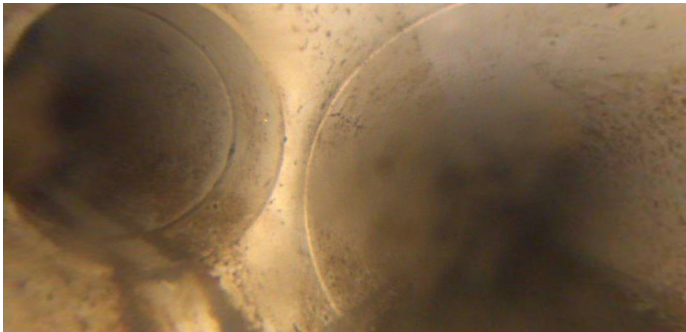
Code: **TFA**
Description: **Tap Factory Active**

Distance (ft): **92.1**
Structural Grade: **0**
O&M Grade: **0**
Clock Start/From: **9**
Clock To:
1st Value: **4.000**
2nd Value:
Value Percent:
Continuous Index:
Within 8" of Joint:
Remarks:

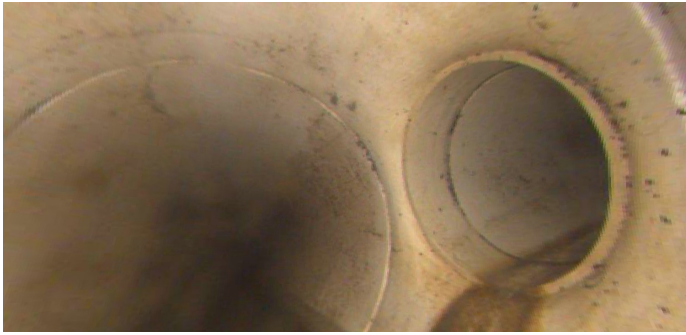
Code: **TF**
Description: **Tap Factory**

Distance (ft): **107.3**
Structural Grade: **0**
O&M Grade: **0**
Clock Start/From: **3**
Clock To:
1st Value: **4.000**
2nd Value:
Value Percent:
Continuous Index:
Within 8" of Joint:
Remarks:

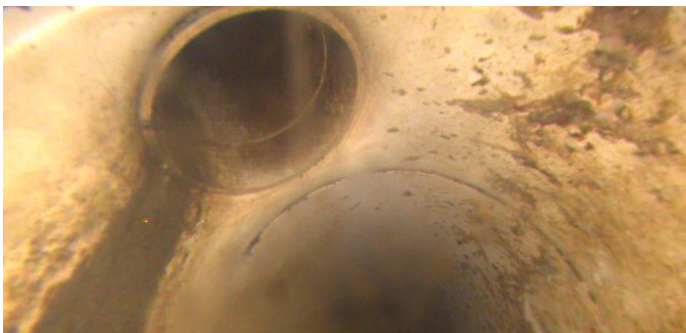
Code: **TF**
Description: **Tap Factory**

Distance (ft): **138.1**
Structural Grade: **0**
O&M Grade: **0**
Clock Start/From: **11**
Clock To:
1st Value: **4.000**
2nd Value:
Value Percent:
Continuous Index:
Within 8" of Joint:
Remarks:

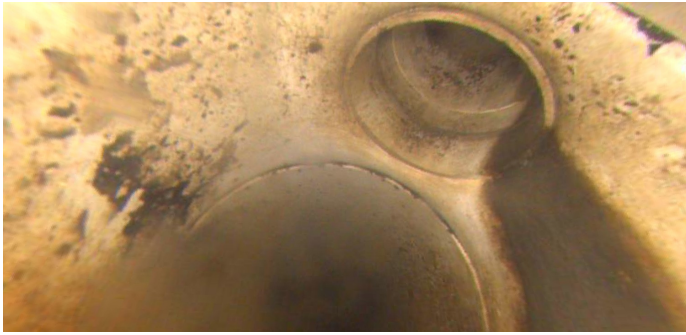
Code: **TF**
Description: **Tap Factory**

Distance (ft): **155.9**
Structural Grade: **0**
O&M Grade: **0**
Clock Start/From: **1**
Clock To:
1st Value: **4.000**
2nd Value:
Value Percent:
Continuous Index:
Within 8" of Joint:
Remarks:

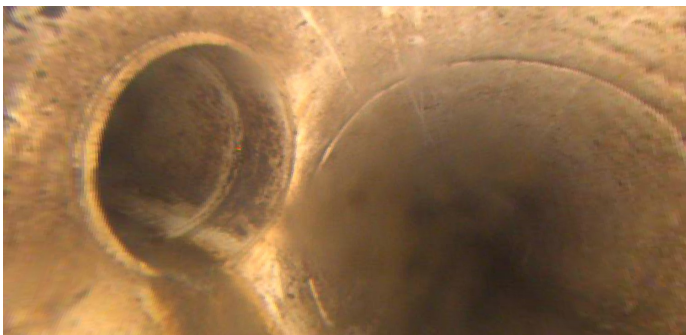
Code: **TF**
Description: **Tap Factory**

Distance (ft): **211.0**
Structural Grade: **0**
O&M Grade: **0**
Clock Start/From: **9**
Clock To:
1st Value: **4.000**
2nd Value:
Value Percent:
Continuous Index:
Within 8" of Joint:
Remarks:

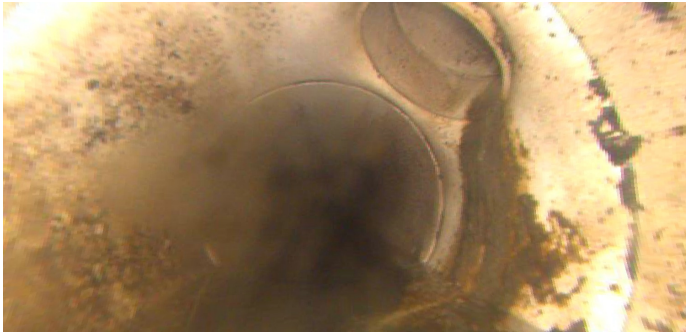
Code: **TF**
Description: **Tap Factory**

Distance (ft): **213.4**
Structural Grade: **0**
O&M Grade: **0**
Clock Start/From: **2**
Clock To:
1st Value: **4.000**
2nd Value:
Value Percent:
Continuous Index:
Within 8" of Joint:
Remarks:

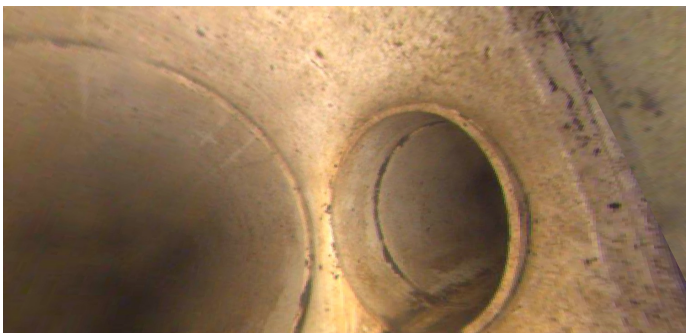
Code: **TF**
Description: **Tap Factory**

Distance (ft): **238.2**
Structural Grade: **0**
O&M Grade: **0**
Clock Start/From: **3**
Clock To:
1st Value: **4.000**
2nd Value:
Value Percent:
Continuous Index:
Within 8" of Joint:
Remarks:

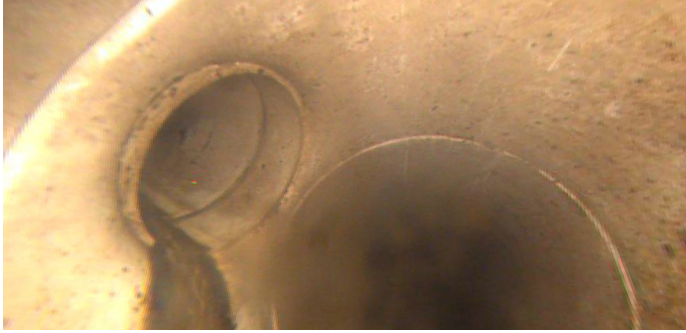
Code: **TF**
Description: **Tap Factory**

Distance (ft): **259.7**
Structural Grade: **0**
O&M Grade: **0**
Clock Start/From: **10**
Clock To:
1st Value: **4.000**
2nd Value:
Value Percent:
Continuous Index:
Within 8" of Joint:
Remarks:

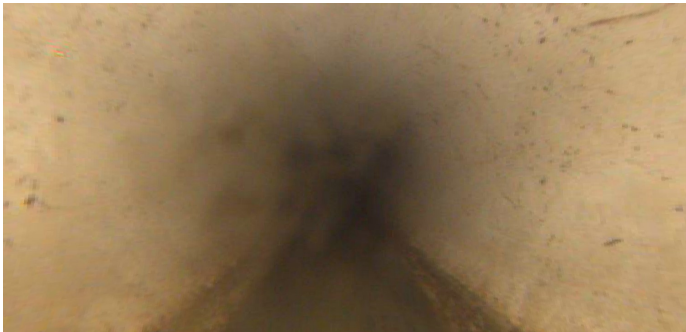
Code: **MSA**
Description: **Abandoned Survey**

Distance (ft): **280.2**
Structural Grade: **0**
O&M Grade: **0**
Clock Start/From:
Clock To:
1st Value:
2nd Value:
Value Percent:
Continuous Index:
Within 8" of Joint: **NO**
Remarks: **ROBOT HAS STOPPED**
