Profile/Photo Observation Report

Street:	W 42ND AVE	Flow Control:	Not Controlled
City:	Hobart, IN	Year Renewed:	
Location:	Light Highway	Tape/Media #:	
Purpose:	Not Known	Dia/Height:	12"
Use:	Sanitary	Material:	VCP
Drain Area:	NA	Lining:	
Category:	NA		
Comment:

Location Details:		Direction of Survey:	Downstream
US MH:	M-504-081	DS MH:	M-504-082
		Total Length Surveyed (ft):	405.3

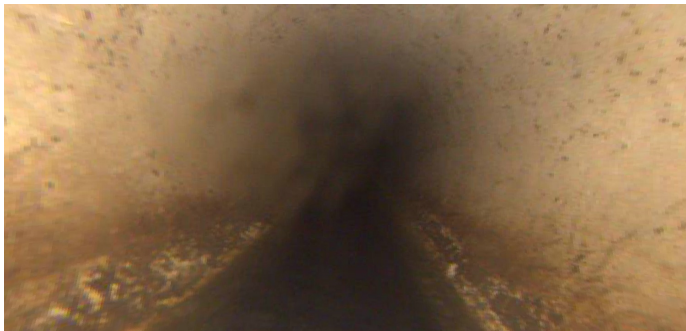
Code: **AMH**
Description: **Manhole**

Distance (ft): **.0**
Structural Grade: **0**
O&M Grade: **0**
Clock Start/From:
Clock To:
1st Value:
2nd Value:
Value Percent:
Continuous Index:
Within 8" of Joint: **NO**
Remarks: **M-504-081**

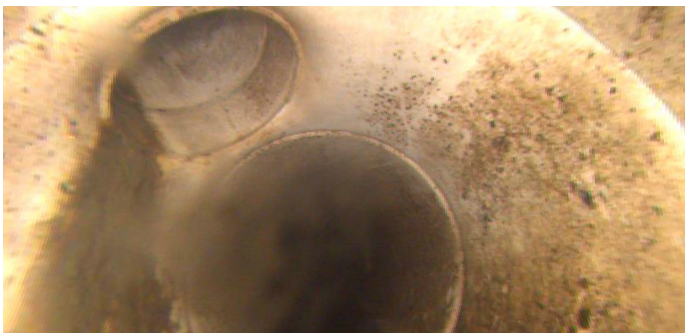
Code: **TF**
Description: **Tap Factory**

Distance (ft): **187.3**
Structural Grade: **0**
O&M Grade: **0**
Clock Start/From: **11**
Clock To:
1st Value: **4.000**
2nd Value:
Value Percent:
Continuous Index:
Within 8" of Joint:
Remarks:

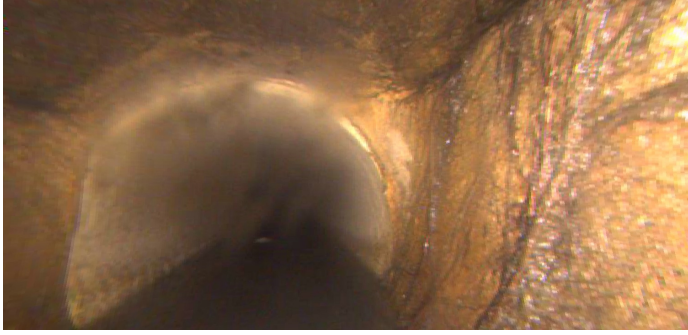
Code:	AMH
Description:	Manhole
Distance (ft):	405.3
Structural Grade:	0
O&M Grade:	0
Clock Start/From:	
Clock To:	
1st Value:	
2nd Value:	
Value Percent:	
Continuous Index:	
Within 8" of Joint:	NO
Remarks:	M-504-082
