## Profile/Photo Observation Report

Street:	<b>W 42ND AVE</b>	Flow Control:	<b>Not Controlled</b>
City:	<b>Hobart, IN</b>	Year Renewed:	
Location:	<b>Light Highway</b>	Tape/Media #:	
Purpose:	<b>Not Known</b>	Dia/Height:	<b>12"</b>
Use:	<b>Sanitary</b>	Material:	<b>PVC</b>
Drain Area:	<b>NA</b>	Lining:	
Category:	<b>NA</b>		
Comment:

Location Details:		Direction of Survey:	<b>Downstream</b>
US MH:	<b>M-504-082</b>	DS MH:	<b>M-504-083</b>
		Total Length Surveyed (ft):	<b>213.1</b>

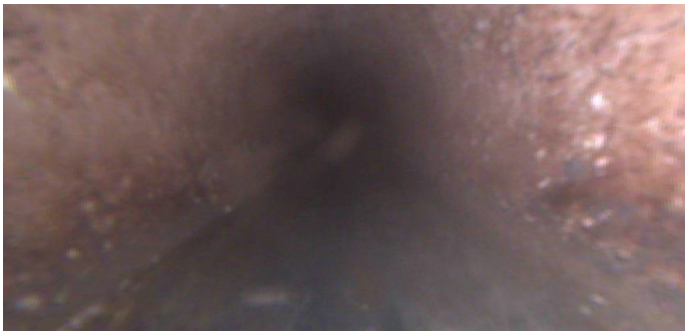
Code: **AMH**  
Description: **Manhole**

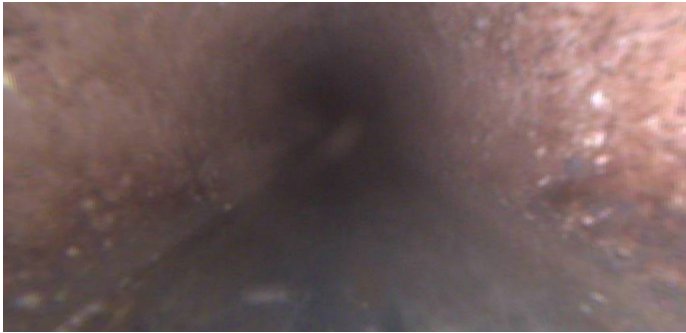
Code:	<b>MWL</b>
Description:	<b>Water Level</b>

Distance (ft):	<b>.0</b>
Structural Grade:	<b>0</b>
O&M Grade:	<b>0</b>
Clock Start/From:	
Clock To:	
1st Value:	
2nd Value:	
Value Percent:	<b>5.000</b>
Continuous Index:	
Within 8" of Joint:	<b>NO</b>
Remarks:

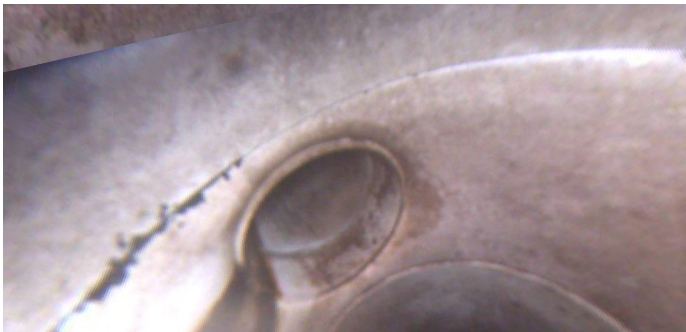
Code:	<b>TF</b>
Description:	<b>Tap Factory</b>

Distance (ft):	<b>40.5</b>
Structural Grade:	<b>0</b>
O&M Grade:	<b>0</b>
Clock Start/From:	<b>11</b>
Clock To:	
1st Value:	<b>4.000</b>
2nd Value:	
Value Percent:	
Continuous Index:	
Within 8" of Joint:	<b>YES</b>
Remarks:

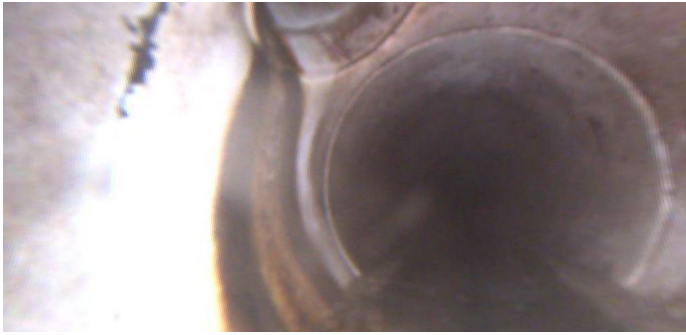
Code: **DAZ**  
Description: **Deposits Attached Other**

Distance (ft): **40.5**  
Structural Grade: **0**  
O&M Grade: **2**  
Clock Start/From: **7**  
Clock To: **10**  
1st Value:  
2nd Value:  
Value Percent: **5.000**  
Continuous Index:  
Within 8" of Joint: **NO**  
Remarks:

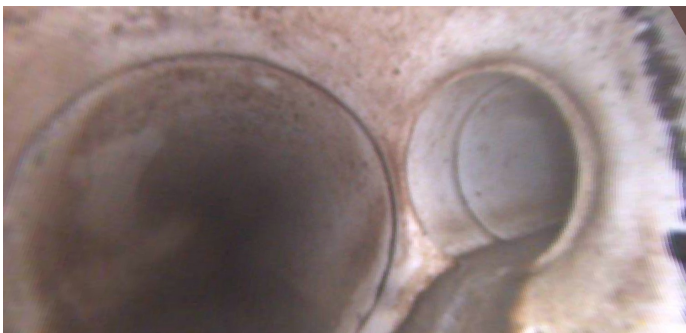
Code: **TF**  
Description: **Tap Factory**

Distance (ft): **73.3**  
Structural Grade: **0**  
O&M Grade: **0**  
Clock Start/From: **2**  
Clock To:  
1st Value: **4.000**  
2nd Value:  
Value Percent:  
Continuous Index:  
Within 8" of Joint: **YES**  
Remarks:

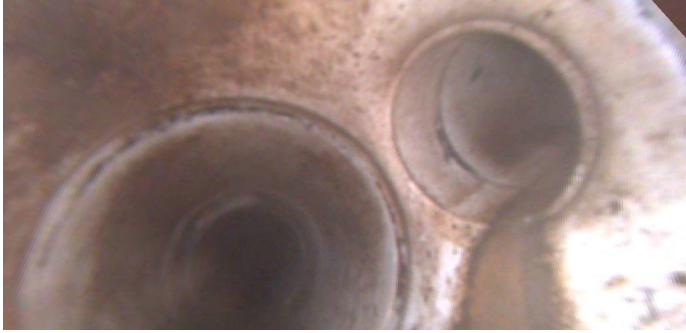
Code: **TF**  
Description: **Tap Factory**

Distance (ft): **111.8**  
Structural Grade: **0**  
O&M Grade: **0**  
Clock Start/From: **2**  
Clock To:  
1st Value: **4.000**  
2nd Value:  
Value Percent:  
Continuous Index:  
Within 8" of Joint: **YES**  
Remarks:

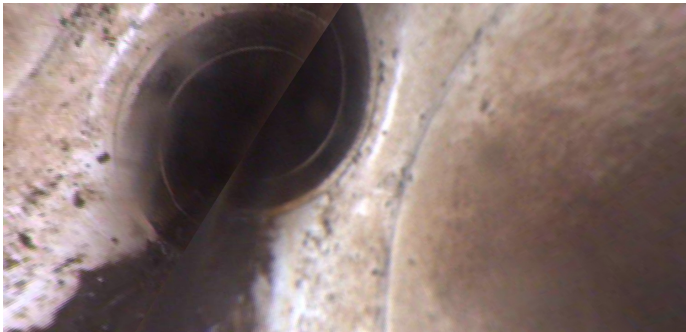
Code: **TF**  
Description: **Tap Factory**

Distance (ft): **114.2**  
Structural Grade: **0**  
O&M Grade: **0**  
Clock Start/From: **10**  
Clock To:  
1st Value: **4.000**  
2nd Value:  
Value Percent:  
Continuous Index:  
Within 8" of Joint: **YES**  
Remarks:

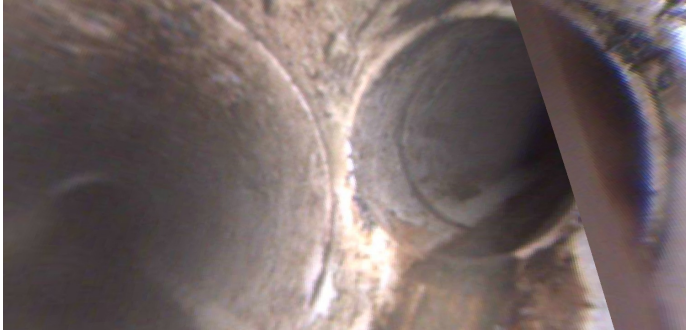
Code: **TF**  
Description: **Tap Factory**

Distance (ft): **149.6**  
Structural Grade: **0**  
O&M Grade: **0**  
Clock Start/From: **2**  
Clock To:  
1st Value: **4.000**  
2nd Value:  
Value Percent:  
Continuous Index:  
Within 8" of Joint: **YES**  
Remarks:

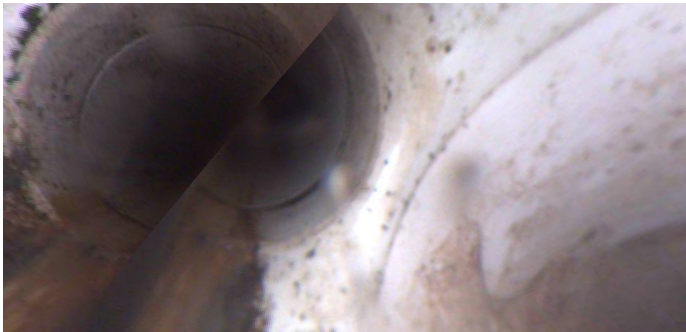
Code: **TF**  
Description: **Tap Factory**

Distance (ft): **153.6**  
Structural Grade: **0**  
O&M Grade: **0**  
Clock Start/From: **11**  
Clock To:  
1st Value: **4.000**  
2nd Value:  
Value Percent:  
Continuous Index:  
Within 8" of Joint: **YES**  
Remarks:

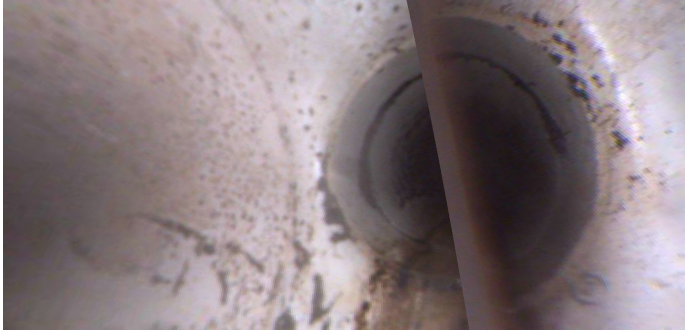
Code: **TF**  
Description: **Tap Factory**

Distance (ft): **186.2**  
Structural Grade: **0**  
O&M Grade: **0**  
Clock Start/From: **2**  
Clock To:  
1st Value: **4.000**  
2nd Value:  
Value Percent:  
Continuous Index:  
Within 8" of Joint: **YES**  
Remarks:

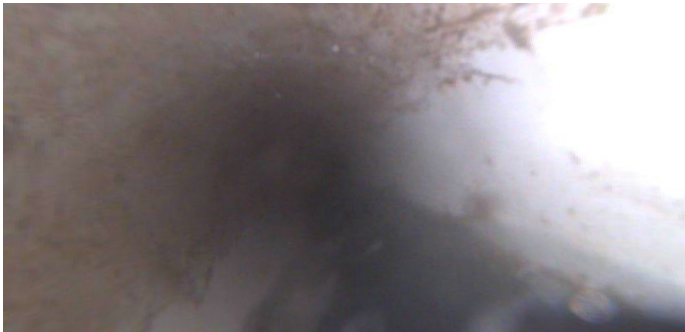
Code: **MSA**  
Description: **Abandoned Survey**

Distance (ft): **213.1**  
Structural Grade: **0**  
O&M Grade: **0**  
Clock Start/From:  
Clock To:  
1st Value:  
2nd Value:  
Value Percent:  
Continuous Index:  
Within 8" of Joint: **NO**  
Remarks: **camera flipped**
