Profile/Photo Observation Report

Date:	04/22/2018	Weather:		Coding:	PACP 6.0
Pipe Length (ft):	314.5	Owner:	NA	Pre Clean:	Not Known
P.O.#:		Surveyor:	Mark Ruby	PSR:	P-504-083-082
Customer:		Clean Date:	01/01/1900	Shape:	C

Location Details:		Direction of Survey:	Upstream
US MH:	M-504-082	DS MH:	M-504-083
		Total Length Surveyed (ft):	63.2

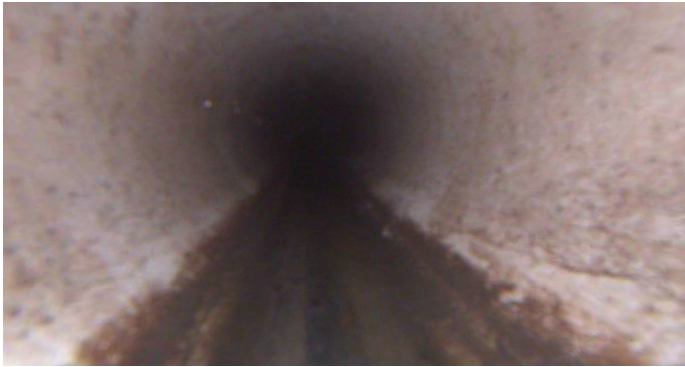
Code:	MWL
Description:	Water Level

Distance (ft):	.0
Structural Grade:	0
O&M Grade:	0
Clock Start/From:	
Clock To:	
1st Value:	
2nd Value:	
Value Percent:	10.000
Continuous Index:	
Within 8" of Joint:	NO
Remarks:

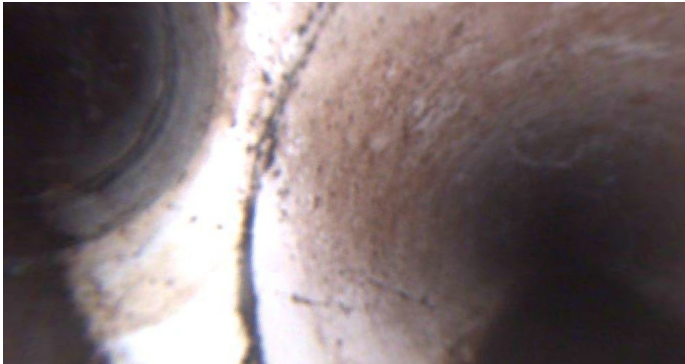
Code:	TF
Description:	Tap Factory

Distance (ft):	17.5
Structural Grade:	0
O&M Grade:	0
Clock Start/From:	9
Clock To:	
1st Value:	4.000
2nd Value:	
Value Percent:	
Continuous Index:	
Within 8" of Joint:	
Remarks:

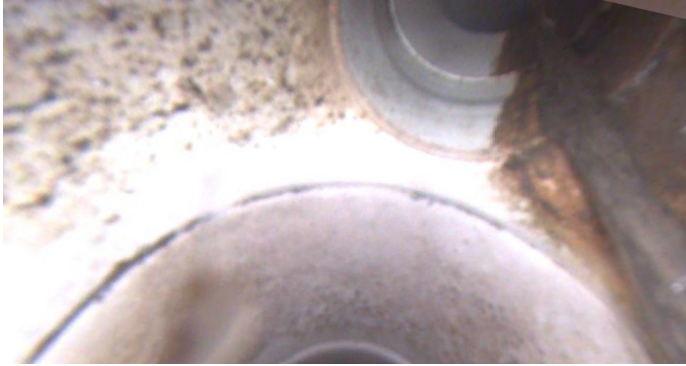
Code: **TF**
Description: **Tap Factory**

Distance (ft): **47.4**
Structural Grade: **0**
O&M Grade: **0**
Clock Start/From: **2**
Clock To:
1st Value: **4.000**
2nd Value:
Value Percent:
Continuous Index:
Within 8" of Joint:
Remarks:

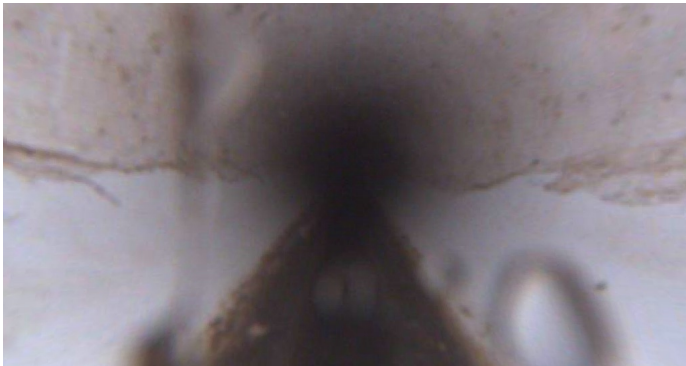
Code: **MSA**
Description: **Abandoned Survey**

Distance (ft): **63.2**
Structural Grade: **0**
O&M Grade: **0**
Clock Start/From:
Clock To:
1st Value:
2nd Value:
Value Percent:
Continuous Index:
Within 8" of Joint: **NO**
Remarks: **No blockage**
