Profile/Photo Observation Report

Date:	02/16/2024	Weather:		Coding:	PACP 7.0
Pipe Length (ft):	315.0	Owner:	City of Hobart	Pre Clean:	Heavy Cleaning
P.O.#:	YES502259	Surveyor:	S. Bucklin	PSR:	P-504-083-082
Customer:	City of Hobart	Clean Date:	10/07/2022	Shape:	C

Street:	N CALIFORNIA ST	Flow Control:	Not Controlled
City:	Hobart, IN	Year Renewed:	
Location:	Alley	Tape/Media #:	
Purpose:	Routine Assessment	Dia/Height:	12"
Use:	Sanitary Sewage Pipe	Material:	PVC
Drain Area:		Lining:	None
Category:	NA		
Comment:			
Location Details:		Direction of Survey:	Downstream
US MH:	M-504-082	DS MH:	M-504-083
		Total Length Surveyed (ft):	295.6

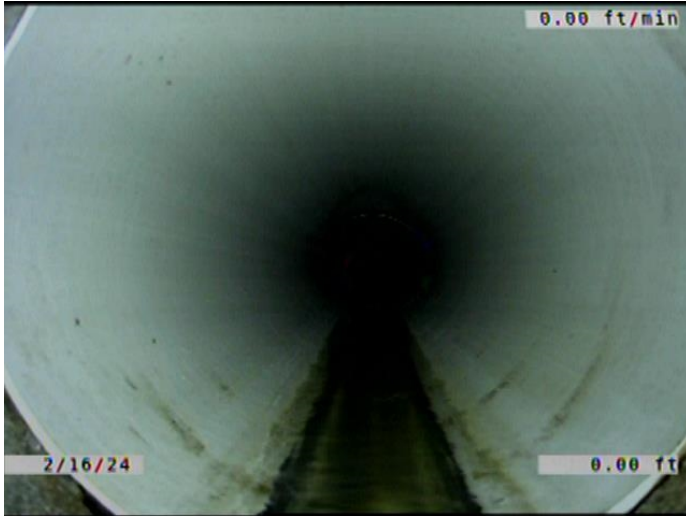
Code:	MWL
Description:	Miscellaneous Water Level
Distance (ft):	.0
Structural Grade:	0
O&M Grade:	0
Clock Start/From:	
Clock To:	
1st Value:	
2nd Value:	
Value Percent:	5.000
Continuous Index:	
Within 8" of Joint:	NO
Remarks:

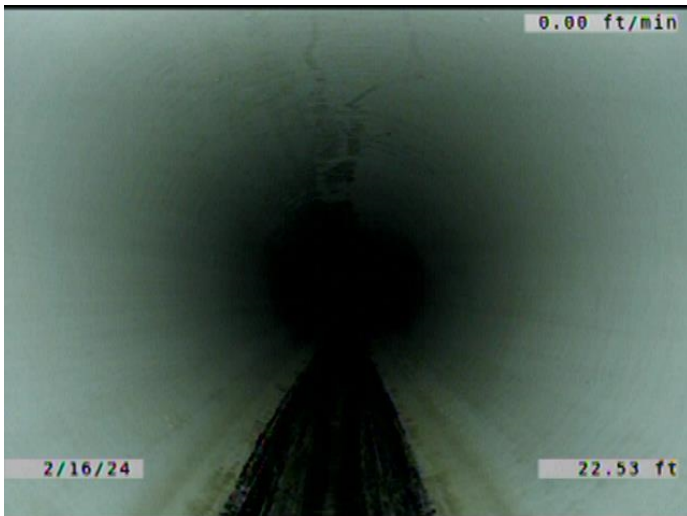
Code:	MWLS
Description:	Miscellaneous Water Level Sag
Distance (ft):	22.5
Structural Grade:	2
O&M Grade:	0
Clock Start/From:	
Clock To:	
1st Value:	
2nd Value:	
Value Percent:	5.000
Continuous Index:	F01
Within 8" of Joint:	NO
Remarks:

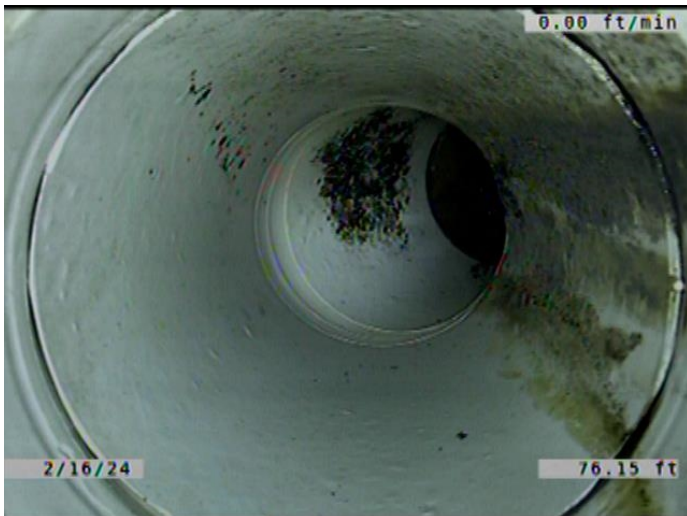
Code: **TF**
Description: **Tap Factory**

Distance (ft): **76.2**
Structural Grade: **0**
O&M Grade: **0**
Clock Start/From: **1**
Clock To:
1st Value: **6.000**
2nd Value:
Value Percent:
Continuous Index:
Within 8" of Joint: **YES**
Remarks: **PVC T. SERVICE IS VCP. ROOTS
VISIBLE IN THE SERVICE. CONSTANTL**

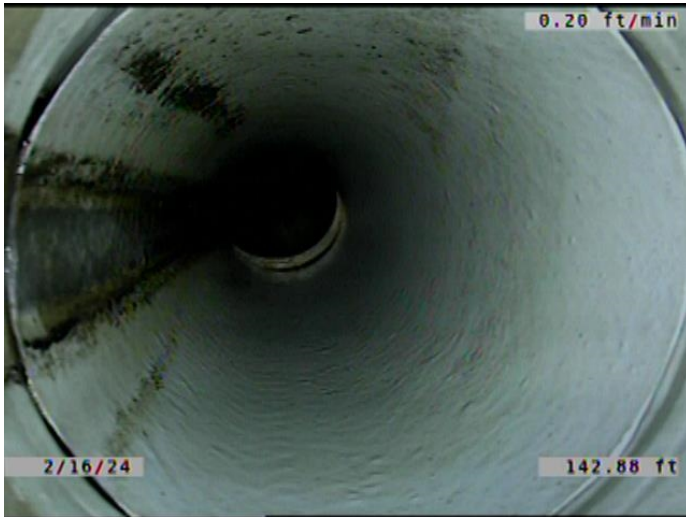
Code:	TF
Description:	Tap Factory
Distance (ft):	142.9
Structural Grade:	0
O&M Grade:	0
Clock Start/From:	9
Clock To:	
1st Value:	6.000
2nd Value:	
Value Percent:	
Continuous Index:	
Within 8" of Joint:	YES
Remarks:	PVC T. SERVICE IS VCP. CONSTANTLY RUNNING WATER.

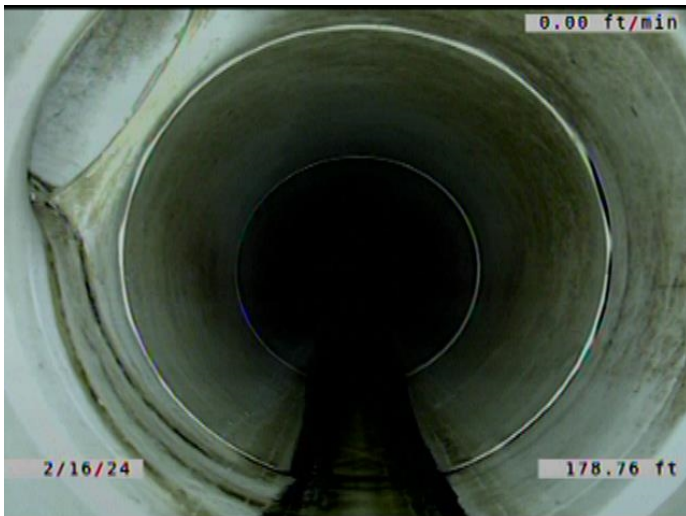
Code: **MWLS**
Description: **Miscellaneous Water Level Sag**

Distance (ft): **178.8**
Structural Grade: **2**
O&M Grade: **0**
Clock Start/From:
Clock To:
1st Value:
2nd Value:
Value Percent: **5.000**
Continuous Index: **F02**
Within 8" of Joint: **NO**
Remarks:

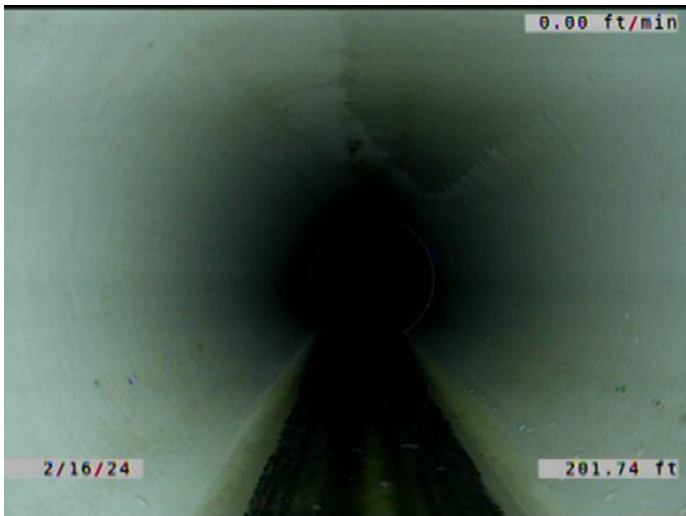
Code:	MWLS
Description:	Miscellaneous Water Level Sag
Distance (ft):	201.7
Structural Grade:	2
O&M Grade:	0
Clock Start/From:	
Clock To:	
1st Value:	
2nd Value:	
Value Percent:	5.000
Continuous Index:	S03
Within 8" of Joint:	NO
Remarks:

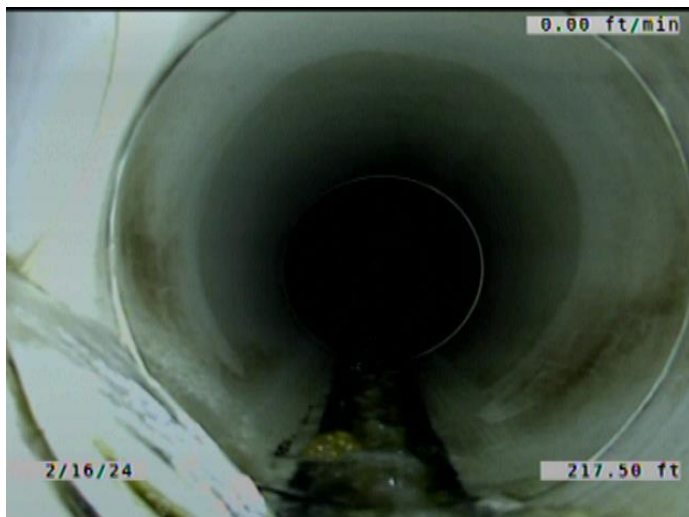
Code: **MWLS**
 Description: **Miscellaneous Water Level Sag**

Distance (ft): **217.5**
 Structural Grade: **2**
 O&M Grade: **0**
 Clock Start/From:
 Clock To:
 1st Value:
 2nd Value:
 Value Percent: **5.000**
 Continuous Index: **F03**
 Within 8" of Joint: **NO**
 Remarks:
