Profile/Photo Observation Report

Date:	04/22/2018	Weather:		Coding:	PACP 6.0
Pipe Length (ft):	148.8	Owner:	NA	Pre Clean:	Not Known
P.O.#:		Surveyor:	Mark Ruby	PSR:	P-504-084-083
Customer:		Clean Date:	01/01/1900	Shape:	C

Street:	ALLEY BETWEEN N WISCONSIN ST &	Flow Control:	Not Controlled
City:	Hobart, IN	Year Renewed:	
Location:	Light Highway	Tape/Media #:	
Purpose:	Not Known	Dia/Height:	12"
Use:	Sanitary	Material:	PVC
Drain Area:	NA	Lining:	
Category:	NA		
Comment:

Location Details:		Direction of Survey:	Downstream
US MH:	M-504-083	DS MH:	M-504-084
		Total Length Surveyed (ft):	110.3

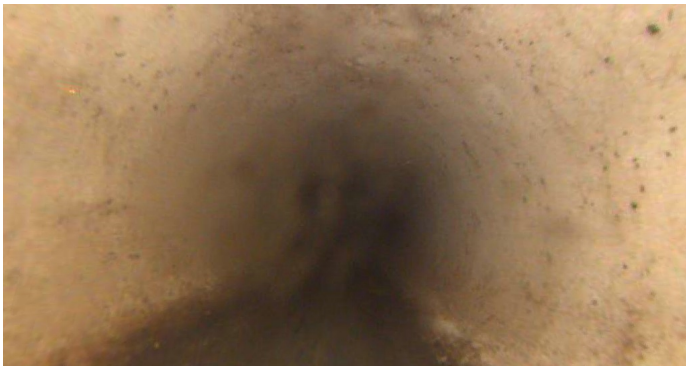
Code:	MWL
Description:	Water Level

Distance (ft):	.0
Structural Grade:	0
O&M Grade:	0
Clock Start/From:	
Clock To:	
1st Value:	
2nd Value:	
Value Percent:	10.000
Continuous Index:	
Within 8" of Joint:	NO
Remarks:

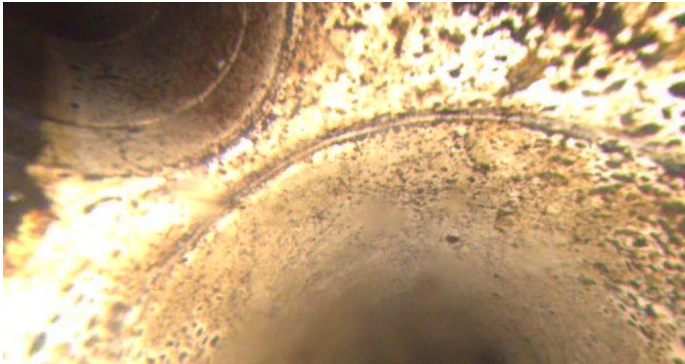
Code:	TF
Description:	Tap Factory

Distance (ft):	7.2
Structural Grade:	0
O&M Grade:	0
Clock Start/From:	10
Clock To:	
1st Value:	4.000
2nd Value:	
Value Percent:	
Continuous Index:	
Within 8" of Joint:	
Remarks:

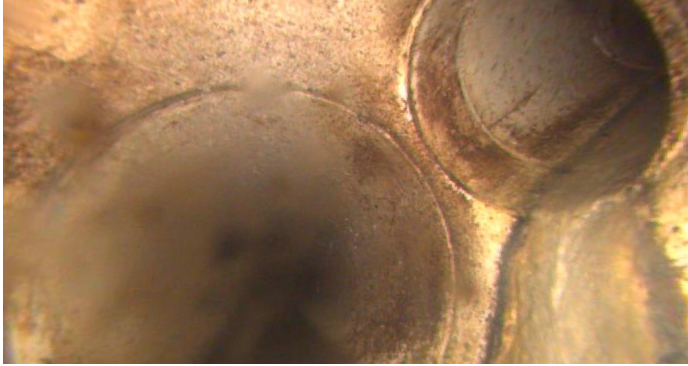
Code: **TF**
Description: **Tap Factory**

Distance (ft): **21.6**
Structural Grade: **0**
O&M Grade: **0**
Clock Start/From: **2**
Clock To:
1st Value: **4.000**
2nd Value:
Value Percent:
Continuous Index:
Within 8" of Joint:
Remarks:

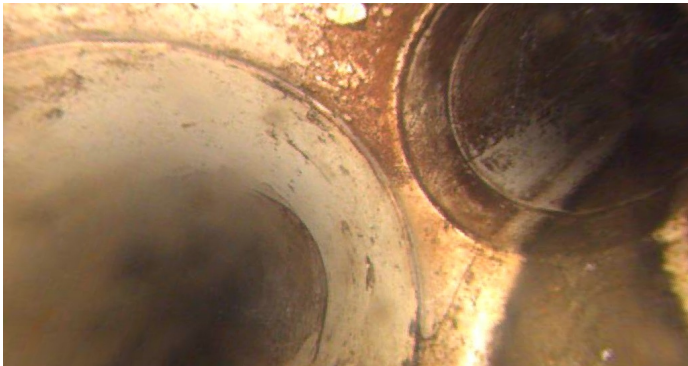
Code: **TF**
Description: **Tap Factory**

Distance (ft): **63.2**
Structural Grade: **0**
O&M Grade: **0**
Clock Start/From: **2**
Clock To:
1st Value: **4.000**
2nd Value:
Value Percent:
Continuous Index:
Within 8" of Joint:
Remarks:

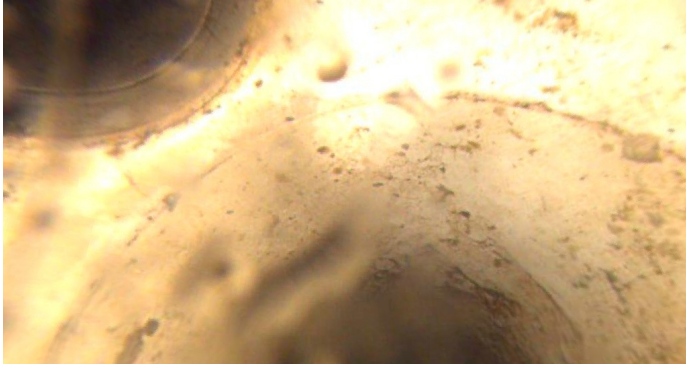
Code: **TF**
Description: **Tap Factory**

Distance (ft): **101.6**
Structural Grade: **0**
O&M Grade: **0**
Clock Start/From: **10**
Clock To:
1st Value: **4.000**
2nd Value:
Value Percent:
Continuous Index:
Within 8" of Joint:
Remarks:

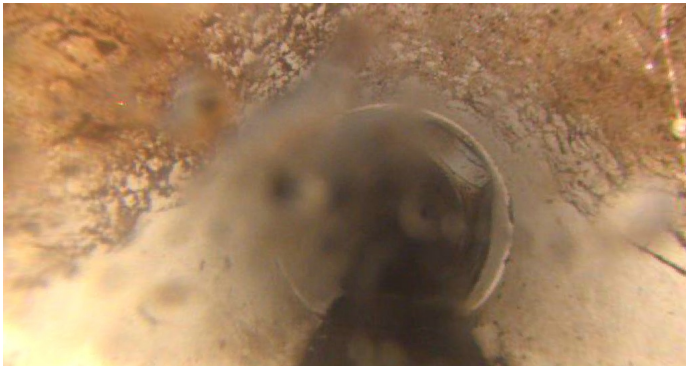
Code: **MSA**
Description: **Abandoned Survey**

Distance (ft): **110.3**
Structural Grade: **0**
O&M Grade: **0**
Clock Start/From:
Clock To:
1st Value:
2nd Value:
Value Percent:
Continuous Index:
Within 8" of Joint: **NO**
Remarks: **No blockage**
