Profile/Photo Observation Report

Street:	ALLEY BETWEEN N WISCONSIN ST &	Flow Control:	Not Controlled
City:	Hobart, IN	Year Renewed:	
Location:	Light Highway	Tape/Media #:	
Purpose:	Not Known	Dia/Height:	12"
Use:	Sanitary	Material:	PVC
Drain Area:	NA	Lining:	
Category:	NA		
Comment:

Location Details:		Direction of Survey:	Downstream
US MH:	M-504-084	DS MH:	M-504-085
		Total Length Surveyed (ft):	287.1

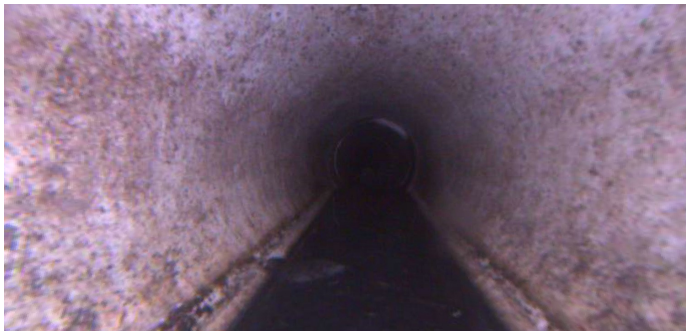
Code: **AMH**
Description: **Manhole**

Distance (ft): **.0**
Structural Grade: **0**
O&M Grade: **0**
Clock Start/From:
Clock To:
1st Value:
2nd Value:
Value Percent:
Continuous Index:
Within 8" of Joint: **NO**
Remarks: **M-504-084**

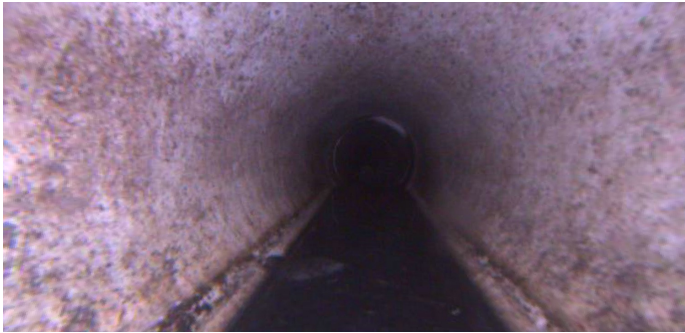
Code:	MWL
Description:	Water Level

Distance (ft):	.0
Structural Grade:	0
O&M Grade:	0
Clock Start/From:	
Clock To:	
1st Value:	
2nd Value:	
Value Percent:	5.000
Continuous Index:	
Within 8" of Joint:	NO
Remarks:

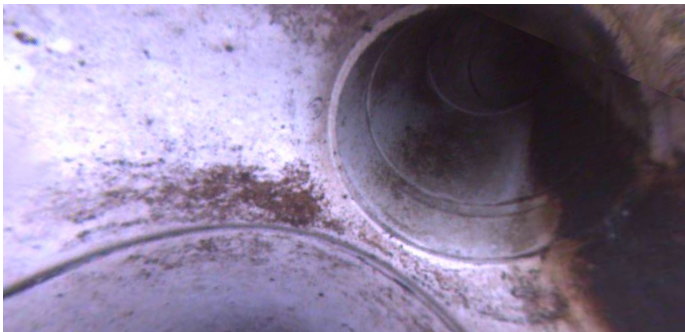
Code:	TFA
Description:	Tap Factory Active

Distance (ft):	4.3
Structural Grade:	0
O&M Grade:	0
Clock Start/From:	1
Clock To:	
1st Value:	4.000
2nd Value:	
Value Percent:	
Continuous Index:	
Within 8" of Joint:	
Remarks:

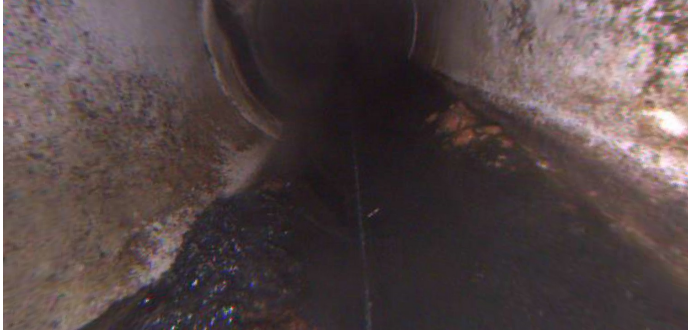
Code: **DSF**
Description: **Deposits Settled Fine**

Distance (ft): **6.1**
Structural Grade: **0**
O&M Grade: **2**
Clock Start/From: **4**
Clock To: **5**
1st Value:
2nd Value:
Value Percent: **10.000**
Continuous Index:
Within 8" of Joint: **NO**
Remarks:

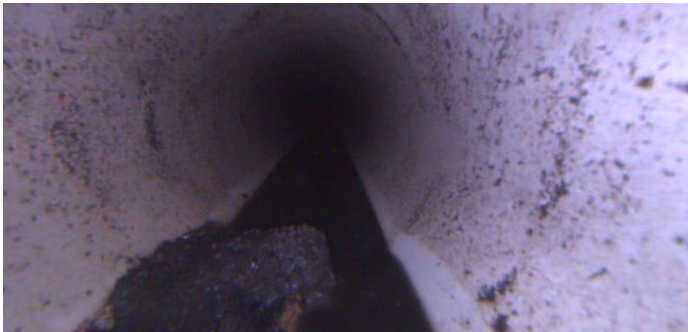
Code: **DSF**
Description: **Deposits Settled Fine**

Distance (ft): **9.7**
Structural Grade: **0**
O&M Grade: **2**
Clock Start/From: **6**
Clock To: **7**
1st Value:
2nd Value:
Value Percent: **5.000**
Continuous Index:
Within 8" of Joint: **NO**
Remarks:

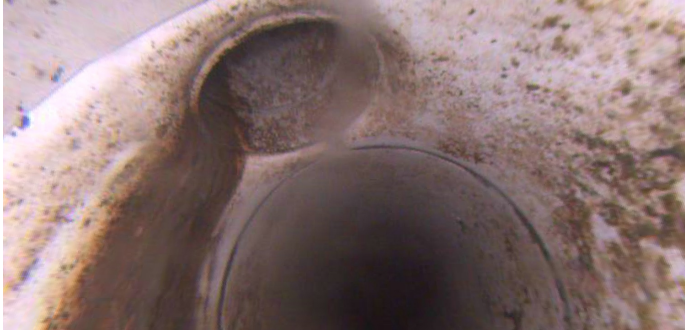
Code: **TF**
Description: **Tap Factory**

Distance (ft): **31.7**
Structural Grade: **0**
O&M Grade: **0**
Clock Start/From: **1**
Clock To:
1st Value: **4.000**
2nd Value:
Value Percent:
Continuous Index:
Within 8" of Joint:
Remarks:

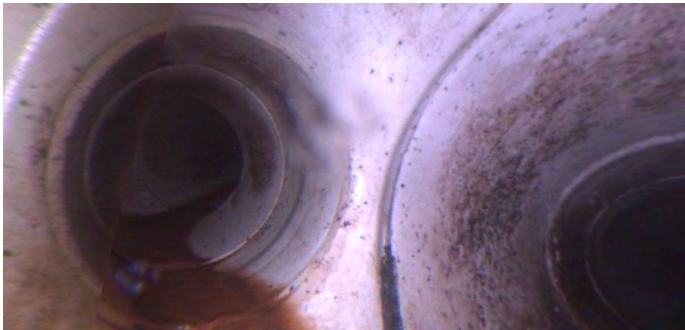
Code: **TFA**
Description: **Tap Factory Active**

Distance (ft): **83.6**
Structural Grade: **0**
O&M Grade: **0**
Clock Start/From: **9**
Clock To:
1st Value: **4.000**
2nd Value:
Value Percent:
Continuous Index:
Within 8" of Joint:
Remarks:

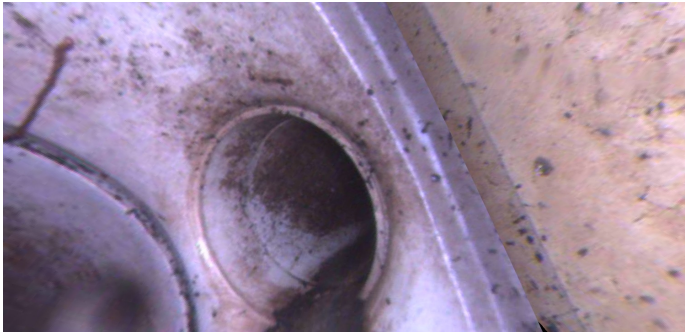
Code: **TFA**
Description: **Tap Factory Active**

Distance (ft): **85.2**
Structural Grade: **0**
O&M Grade: **0**
Clock Start/From: **2**
Clock To:
1st Value: **4.000**
2nd Value:
Value Percent:
Continuous Index:
Within 8" of Joint:
Remarks:

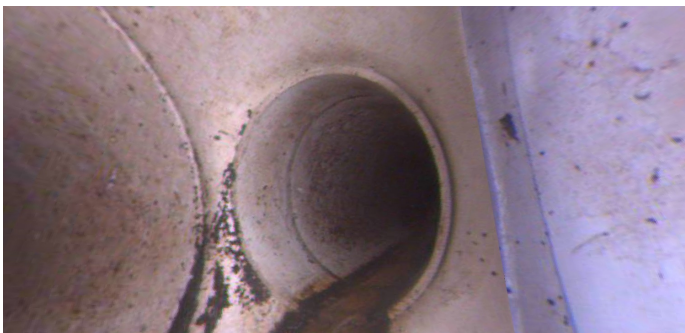
Code: **TFA**
Description: **Tap Factory Active**

Distance (ft): **131.9**
Structural Grade: **0**
O&M Grade: **0**
Clock Start/From: **9**
Clock To:
1st Value: **4.000**
2nd Value:
Value Percent:
Continuous Index:
Within 8" of Joint:
Remarks:

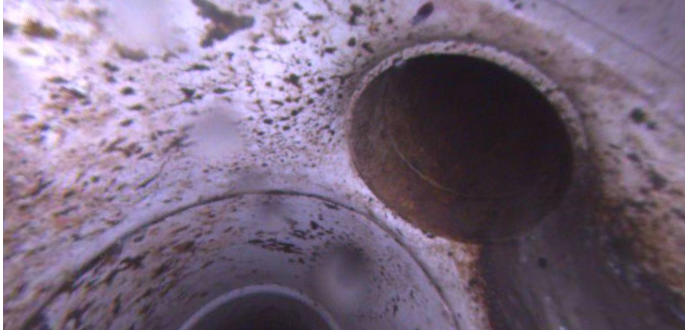
Code: **TF**
Description: **Tap Factory**

Distance (ft): **134.8**
Structural Grade: **0**
O&M Grade: **0**
Clock Start/From: **1**
Clock To:
1st Value: **4.000**
2nd Value:
Value Percent:
Continuous Index:
Within 8" of Joint:
Remarks:

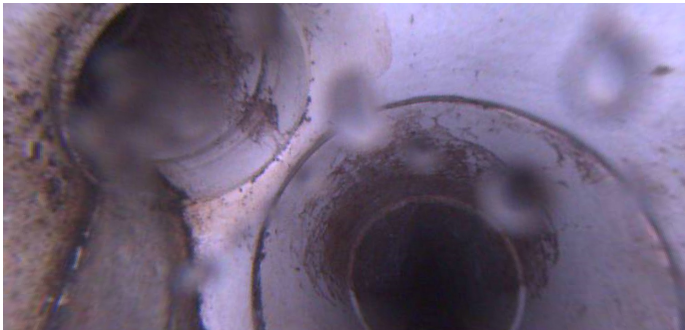
Code: **TFA**
Description: **Tap Factory Active**

Distance (ft): **173.5**
Structural Grade: **0**
O&M Grade: **0**
Clock Start/From: **10**
Clock To:
1st Value: **4.000**
2nd Value:
Value Percent:
Continuous Index:
Within 8" of Joint:
Remarks:

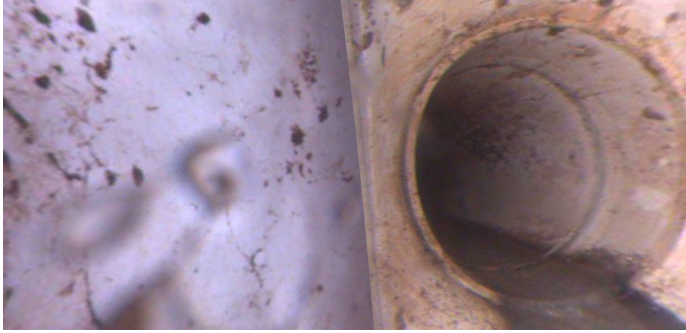
Code: **TFA**
Description: **Tap Factory Active**

Distance (ft): **184.4**
Structural Grade: **0**
O&M Grade: **0**
Clock Start/From: **2**
Clock To:
1st Value: **4.000**
2nd Value:
Value Percent:
Continuous Index:
Within 8" of Joint:
Remarks:

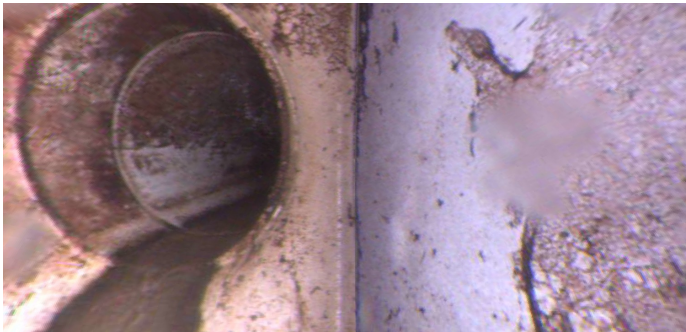
Code: **TFA**
Description: **Tap Factory Active**

Distance (ft): **222.2**
Structural Grade: **0**
O&M Grade: **0**
Clock Start/From: **10**
Clock To:
1st Value: **4.000**
2nd Value:
Value Percent:
Continuous Index:
Within 8" of Joint:
Remarks:

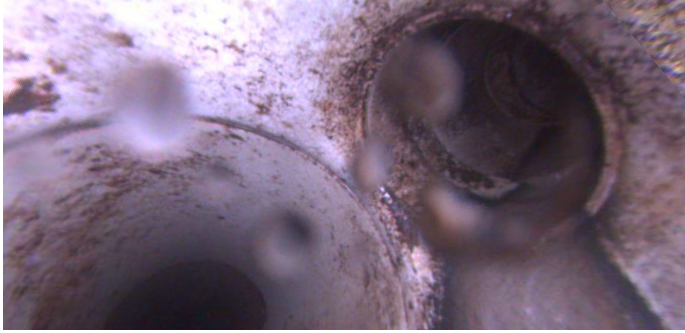
Code: **TFA**
Description: **Tap Factory Active**

Distance (ft): **234.7**
Structural Grade: **0**
O&M Grade: **0**
Clock Start/From: **2**
Clock To:
1st Value: **4.000**
2nd Value:
Value Percent:
Continuous Index:
Within 8" of Joint:
Remarks:

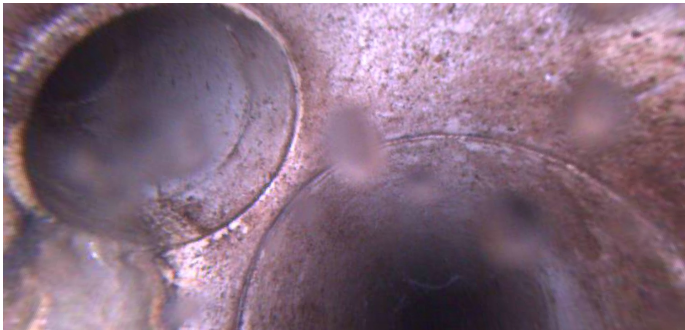
Code: **TFA**
Description: **Tap Factory Active**

Distance (ft): **262.4**
Structural Grade: **0**
O&M Grade: **0**
Clock Start/From: **10**
Clock To:
1st Value: **4.000**
2nd Value:
Value Percent:
Continuous Index:
Within 8" of Joint:
Remarks:

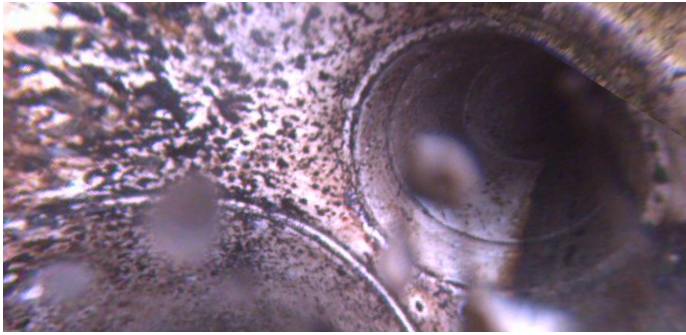
Code: **TF**
Description: **Tap Factory**

Distance (ft): **277.3**
Structural Grade: **0**
O&M Grade: **0**
Clock Start/From: **2**
Clock To:
1st Value: **4.000**
2nd Value:
Value Percent:
Continuous Index:
Within 8" of Joint:
Remarks:

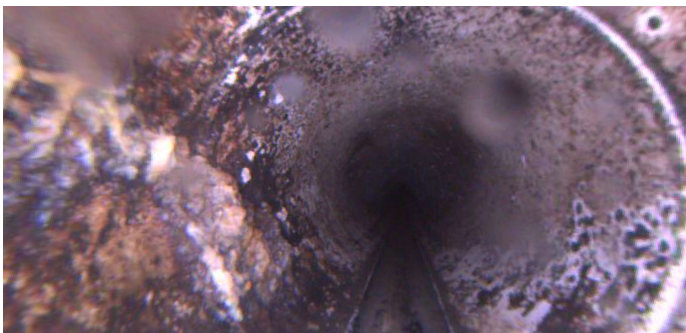
Code: **DAGS**
Description: **Deposits Attached Grease**

Distance (ft): **277.3**
Structural Grade: **0**
O&M Grade: **2**
Clock Start/From: **7**
Clock To: **9**
1st Value:
2nd Value:
Value Percent: **5.000**
Continuous Index:
Within 8" of Joint: **NO**
Remarks:

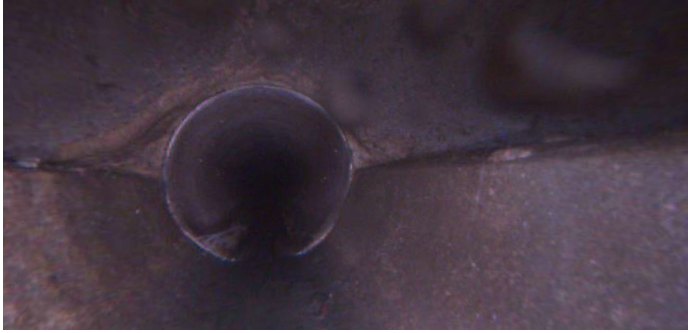
Code:	AMH
Description:	Manhole
Distance (ft):	287.1
Structural Grade:	0
O&M Grade:	0
Clock Start/From:	
Clock To:	
1st Value:	
2nd Value:	
Value Percent:	
Continuous Index:	
Within 8" of Joint:	NO
Remarks:	M-504-085
