## Profile/Photo Observation Report

Street:	<b>Summerlin</b>	Flow Control:	<b>Not Controlled</b>
City:	<b>Hobart, IN</b>	Year Renewed:	
Location:	<b>Light Highway</b>	Tape/Media #:	
Purpose:	<b>Not Known</b>	Dia/Height:	<b>12"</b>
Use:	<b>Sanitary</b>	Material:	<b>PVC</b>
Drain Area:	<b>NA</b>	Lining:	
Category:	<b>NA</b>		
Comment:

Location Details:		Direction of Survey:	<b>Downstream</b>
US MH:	<b>M-504-084</b>	DS MH:	<b>M-504-085</b>
		Total Length Surveyed (ft):	<b>287.1</b>

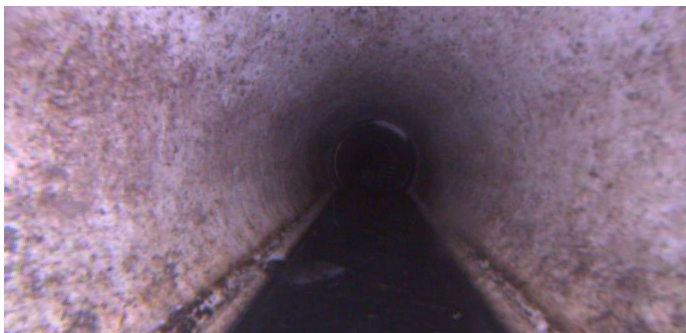
Code: **AMH**  
Description: **Manhole**

Distance (ft): **.0**  
Structural Grade: **0**  
O&M Grade: **0**  
Clock Start/From:  
Clock To:  
1st Value:  
2nd Value:  
Value Percent:  
Continuous Index:  
Within 8" of Joint: **NO**  
Remarks: **M-504-084**

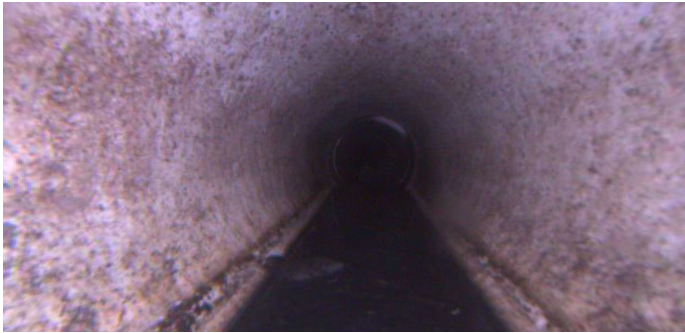
Code: **MWL**  
Description: **Water Level**

Distance (ft): **.0**  
Structural Grade: **0**  
O&M Grade: **0**  
Clock Start/From:  
Clock To:  
1st Value:  
2nd Value:  
Value Percent: **5.000**  
Continuous Index:  
Within 8" of Joint: **NO**  
Remarks:

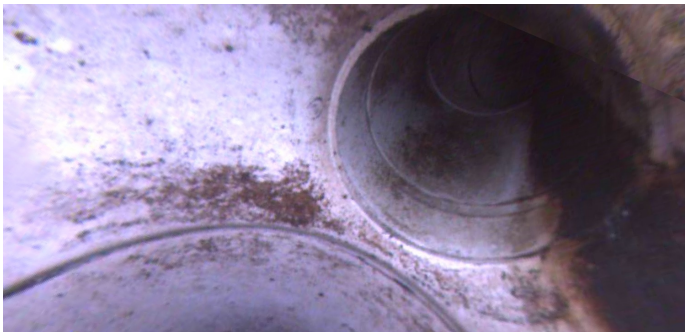
Code: **TFA**  
Description: **Tap Factory Active**

Distance (ft): **4.3**  
Structural Grade: **0**  
O&M Grade: **0**  
Clock Start/From: **1**  
Clock To:  
1st Value: **4.000**  
2nd Value:  
Value Percent:  
Continuous Index:  
Within 8" of Joint:  
Remarks:

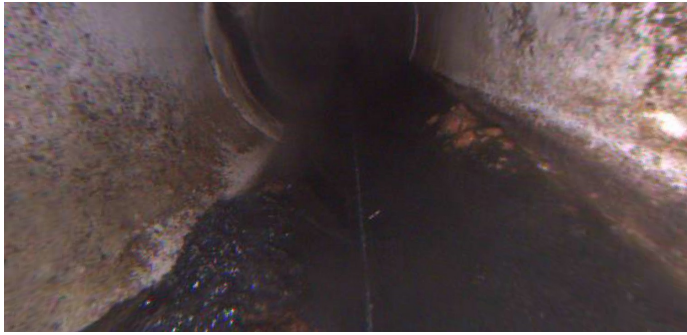
Code: **DSF**  
Description: **Deposits Settled Fine**

Distance (ft): **6.1**  
Structural Grade: **0**  
O&M Grade: **2**  
Clock Start/From: **4**  
Clock To: **5**  
1st Value:  
2nd Value:  
Value Percent: **10.000**  
Continuous Index:  
Within 8" of Joint: **NO**  
Remarks:

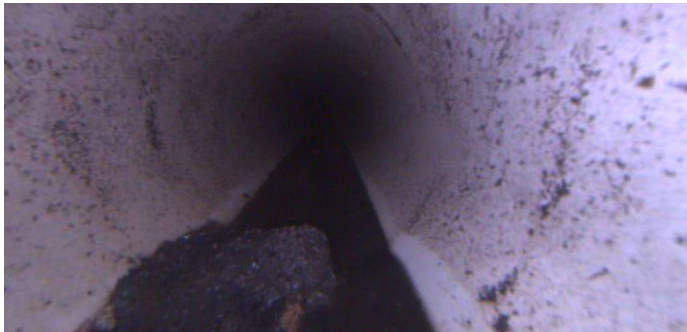
Code: **DSF**  
Description: **Deposits Settled Fine**

Distance (ft): **9.7**  
Structural Grade: **0**  
O&M Grade: **2**  
Clock Start/From: **6**  
Clock To: **7**  
1st Value:  
2nd Value:  
Value Percent: **5.000**  
Continuous Index:  
Within 8" of Joint: **NO**  
Remarks:

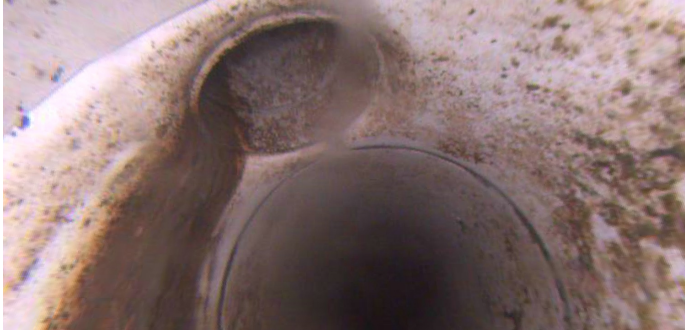
Code: **TF**  
Description: **Tap Factory**

Distance (ft): **31.7**  
Structural Grade: **0**  
O&M Grade: **0**  
Clock Start/From: **1**  
Clock To:  
1st Value: **4.000**  
2nd Value:  
Value Percent:  
Continuous Index:  
Within 8" of Joint:  
Remarks:

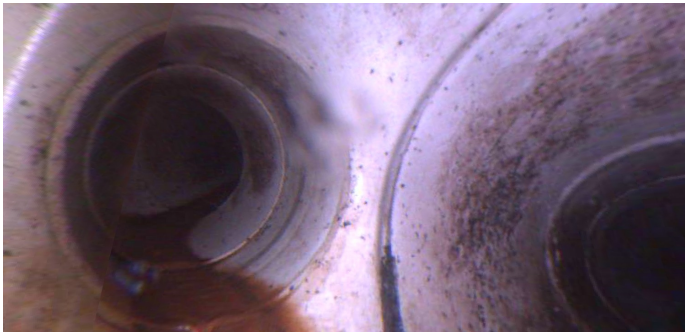
Code: **TFA**  
Description: **Tap Factory Active**

Distance (ft): **83.6**  
Structural Grade: **0**  
O&M Grade: **0**  
Clock Start/From: **9**  
Clock To:  
1st Value: **4.000**  
2nd Value:  
Value Percent:  
Continuous Index:  
Within 8" of Joint:  
Remarks:

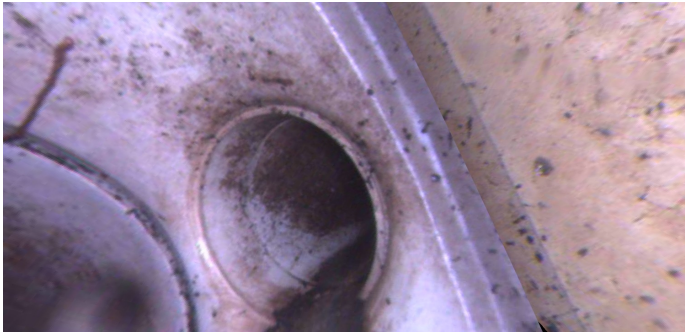
Code: **TFA**  
Description: **Tap Factory Active**

Distance (ft): **85.2**  
Structural Grade: **0**  
O&M Grade: **0**  
Clock Start/From: **2**  
Clock To:  
1st Value: **4.000**  
2nd Value:  
Value Percent:  
Continuous Index:  
Within 8" of Joint:  
Remarks:

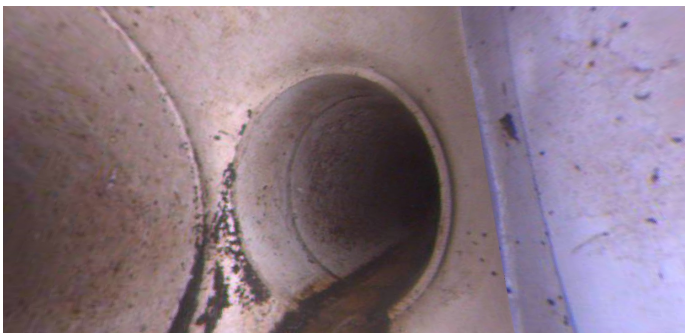
Code: **TFA**  
Description: **Tap Factory Active**

Distance (ft): **131.9**  
Structural Grade: **0**  
O&M Grade: **0**  
Clock Start/From: **9**  
Clock To:  
1st Value: **4.000**  
2nd Value:  
Value Percent:  
Continuous Index:  
Within 8" of Joint:  
Remarks:

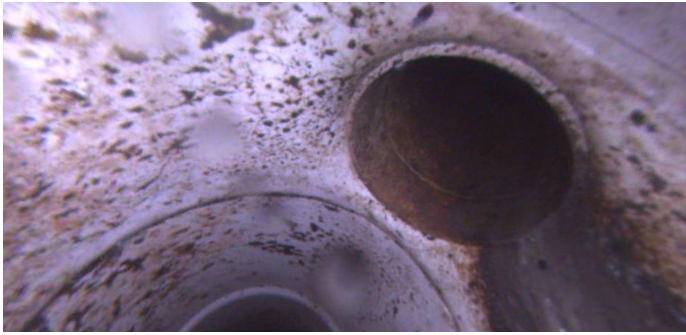
Code: **TF**  
Description: **Tap Factory**

Distance (ft): **134.8**  
Structural Grade: **0**  
O&M Grade: **0**  
Clock Start/From: **1**  
Clock To:  
1st Value: **4.000**  
2nd Value:  
Value Percent:  
Continuous Index:  
Within 8" of Joint:  
Remarks:

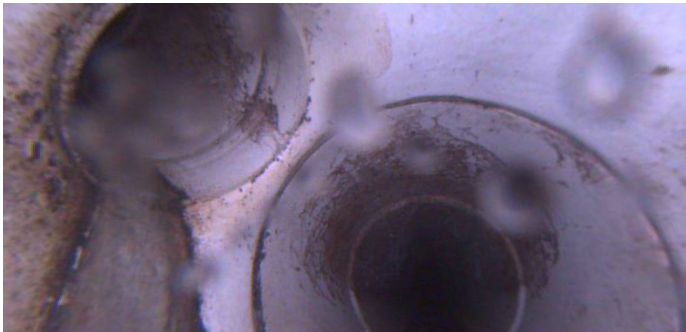
Code: **TFA**  
Description: **Tap Factory Active**

Distance (ft): **173.5**  
Structural Grade: **0**  
O&M Grade: **0**  
Clock Start/From: **10**  
Clock To:  
1st Value: **4.000**  
2nd Value:  
Value Percent:  
Continuous Index:  
Within 8" of Joint:  
Remarks:

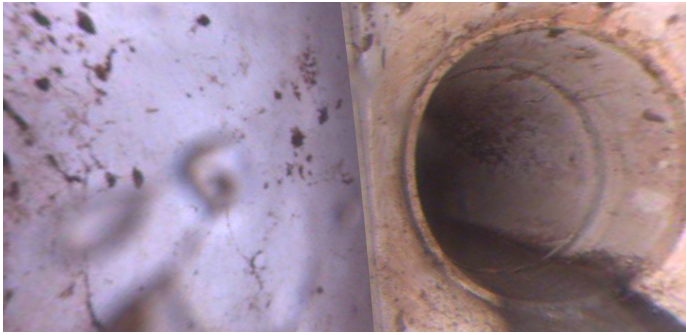
Code: **TFA**  
Description: **Tap Factory Active**

Distance (ft): **184.4**  
Structural Grade: **0**  
O&M Grade: **0**  
Clock Start/From: **2**  
Clock To:  
1st Value: **4.000**  
2nd Value:  
Value Percent:  
Continuous Index:  
Within 8" of Joint:  
Remarks:

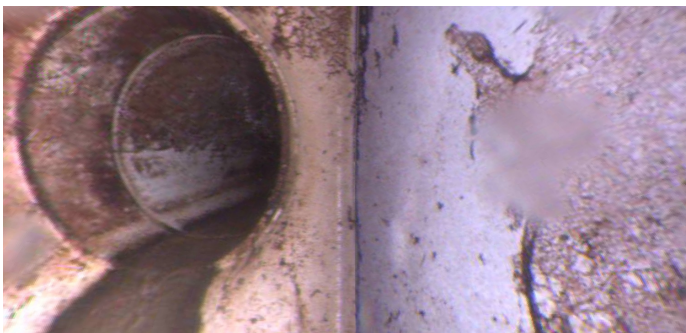
Code: **TFA**  
Description: **Tap Factory Active**

Distance (ft): **222.2**  
Structural Grade: **0**  
O&M Grade: **0**  
Clock Start/From: **10**  
Clock To:  
1st Value: **4.000**  
2nd Value:  
Value Percent:  
Continuous Index:  
Within 8" of Joint:  
Remarks:

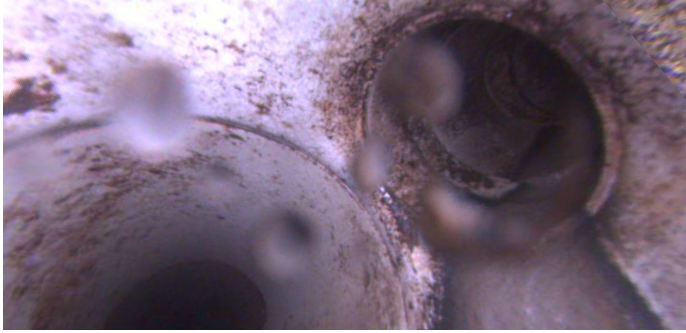
Code: **TFA**  
Description: **Tap Factory Active**

Distance (ft): **234.7**  
Structural Grade: **0**  
O&M Grade: **0**  
Clock Start/From: **2**  
Clock To:  
1st Value: **4.000**  
2nd Value:  
Value Percent:  
Continuous Index:  
Within 8" of Joint:  
Remarks:

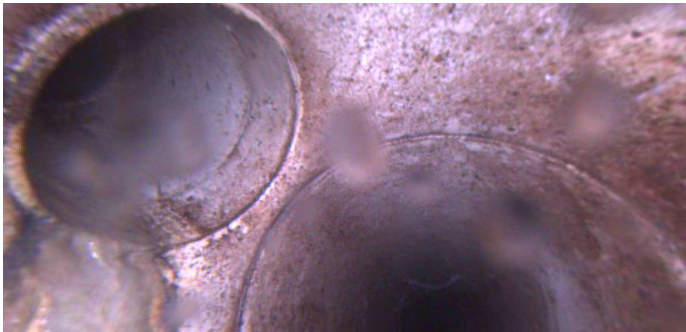
Code: **TFA**  
Description: **Tap Factory Active**

Distance (ft): **262.4**  
Structural Grade: **0**  
O&M Grade: **0**  
Clock Start/From: **10**  
Clock To:  
1st Value: **4.000**  
2nd Value:  
Value Percent:  
Continuous Index:  
Within 8" of Joint:  
Remarks:

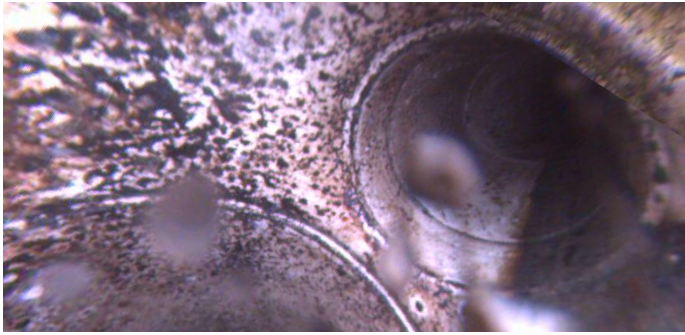
Code: **TF**  
Description: **Tap Factory**

Distance (ft): **277.3**  
Structural Grade: **0**  
O&M Grade: **0**  
Clock Start/From: **2**  
Clock To:  
1st Value: **4.000**  
2nd Value:  
Value Percent:  
Continuous Index:  
Within 8" of Joint:  
Remarks:

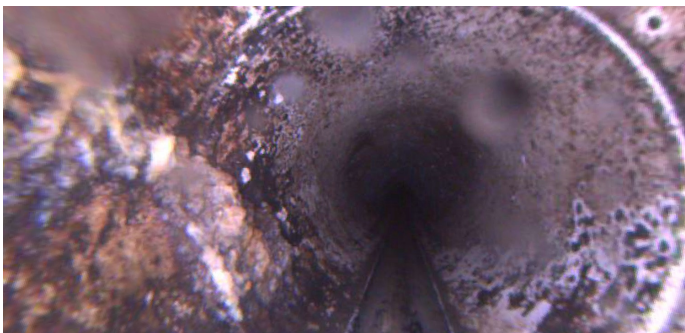
Code: **DAGS**  
Description: **Deposits Attached Grease**

Distance (ft): **277.3**  
Structural Grade: **0**  
O&M Grade: **2**  
Clock Start/From: **7**  
Clock To: **9**  
1st Value:  
2nd Value:  
Value Percent: **5.000**  
Continuous Index:  
Within 8" of Joint: **NO**  
Remarks:

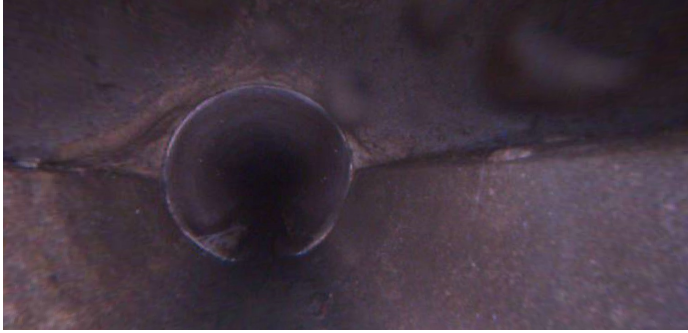
Code:	<b>AMH</b>
Description:	<b>Manhole</b>
Distance (ft):	<b>287.1</b>
Structural Grade:	<b>0</b>
O&M Grade:	<b>0</b>
Clock Start/From:	
Clock To:	
1st Value:	
2nd Value:	
Value Percent:	
Continuous Index:	
Within 8" of Joint:	<b>NO</b>
Remarks:	<b>M-504-085</b>
