Profile/Photo Observation Report

Street:	ALLEY BETWEEN N VIRGINIA ST & N	Flow Control:	Not Controlled
City:	Hobart, IN	Year Renewed:	
Location:	Light Highway	Tape/Media #:	
Purpose:	Not Known	Dia/Height:	12"
Use:	Sanitary	Material:	PVC
Drain Area:	NA	Lining:	
Category:	NA		
Comment:

Location Details:		Direction of Survey:	Downstream
US MH:	M-504-086	DS MH:	M-504-087
		Total Length Surveyed (ft):	192.4

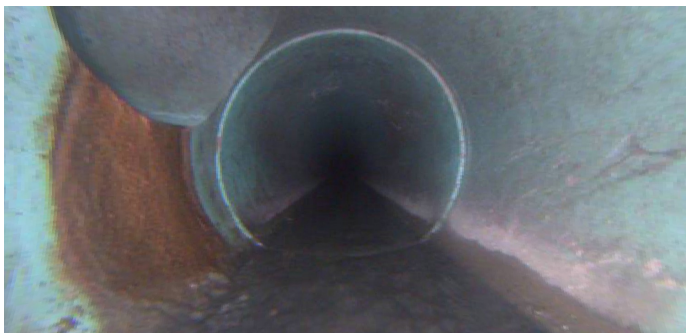
Code: **AMH**
Description: **Manhole**

Distance (ft): **.0**
Structural Grade: **0**
O&M Grade: **0**
Clock Start/From:
Clock To:
1st Value:
2nd Value:
Value Percent:
Continuous Index:
Within 8" of Joint: **NO**
Remarks: **M-504-086**

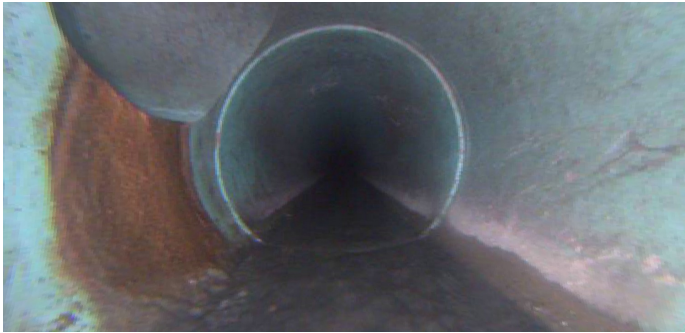
Code:	MWL
Description:	Water Level

Distance (ft):	.0
Structural Grade:	0
O&M Grade:	0
Clock Start/From:	
Clock To:	
1st Value:	
2nd Value:	
Value Percent:	5.000
Continuous Index:	
Within 8" of Joint:	NO
Remarks:

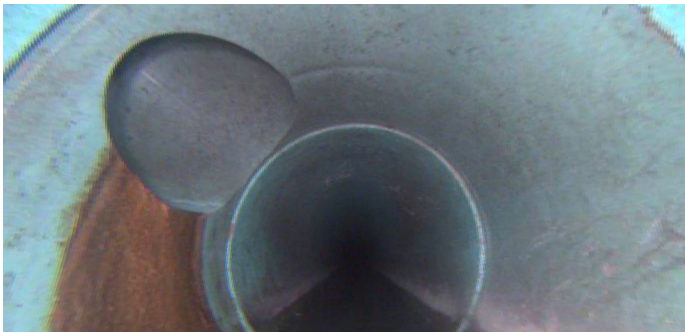
Code:	TF
Description:	Tap Factory

Distance (ft):	.0
Structural Grade:	0
O&M Grade:	0
Clock Start/From:	11
Clock To:	
1st Value:	4.000
2nd Value:	
Value Percent:	
Continuous Index:	
Within 8" of Joint:	YES
Remarks:

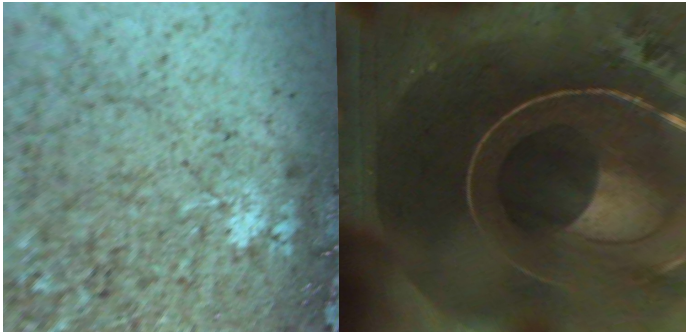
Code: **TF**
Description: **Tap Factory**

Distance (ft): **12.0**
Structural Grade: **0**
O&M Grade: **0**
Clock Start/From: **2**
Clock To:
1st Value: **4.000**
2nd Value:
Value Percent:
Continuous Index:
Within 8" of Joint: **YES**
Remarks:

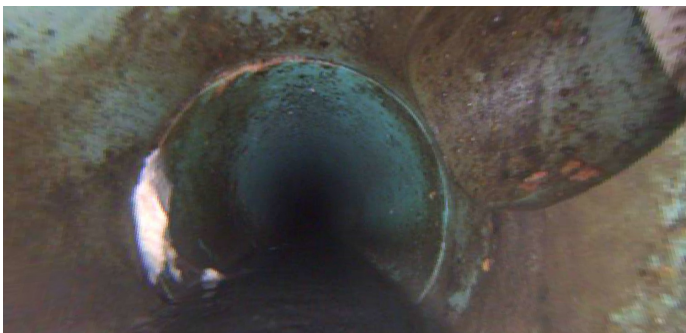
Code: **DAZ**
Description: **Deposits Attached Other**

Distance (ft): **40.5**
Structural Grade: **0**
O&M Grade: **2**
Clock Start/From: **9**
Clock To:
1st Value:
2nd Value:
Value Percent: **5.000**
Continuous Index:
Within 8" of Joint: **NO**
Remarks: **tissue**

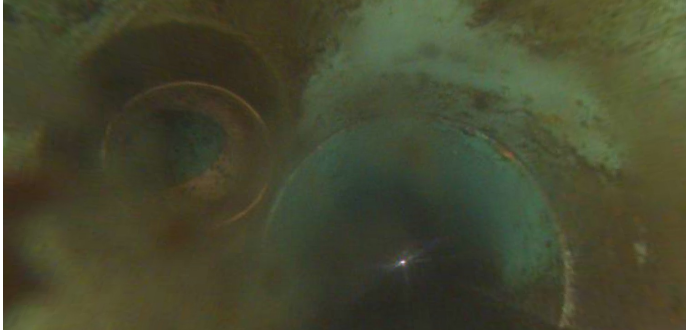
Code: **TF**
Description: **Tap Factory**

Distance (ft): **41.6**
Structural Grade: **0**
O&M Grade: **0**
Clock Start/From: **2**
Clock To:
1st Value: **4.000**
2nd Value:
Value Percent:
Continuous Index:
Within 8" of Joint:
Remarks:

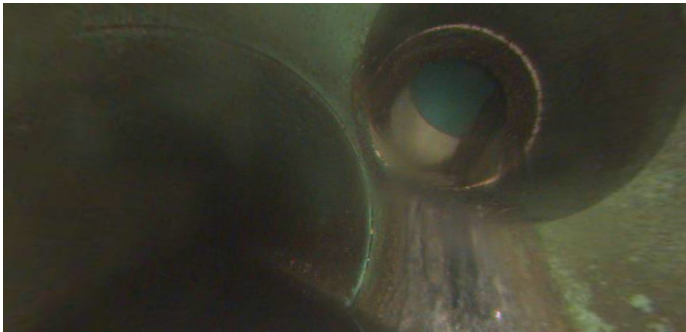
Code: **TFA**
Description: **Tap Factory Active**

Distance (ft): **117.1**
Structural Grade: **0**
O&M Grade: **0**
Clock Start/From: **10**
Clock To:
1st Value: **4.000**
2nd Value:
Value Percent:
Continuous Index:
Within 8" of Joint:
Remarks:

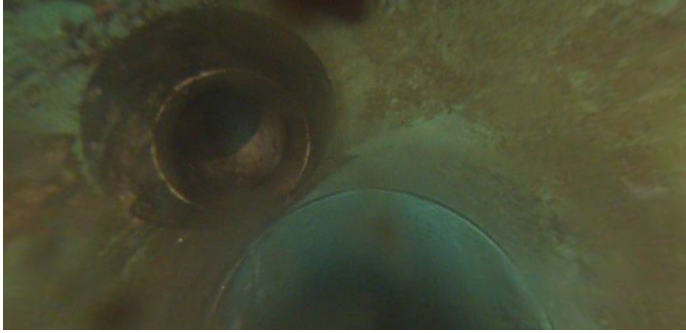
Code: **TF**
Description: **Tap Factory**

Distance (ft): **124.1**
Structural Grade: **0**
O&M Grade: **0**
Clock Start/From: **1**
Clock To:
1st Value: **4.000**
2nd Value:
Value Percent:
Continuous Index:
Within 8" of Joint:
Remarks:

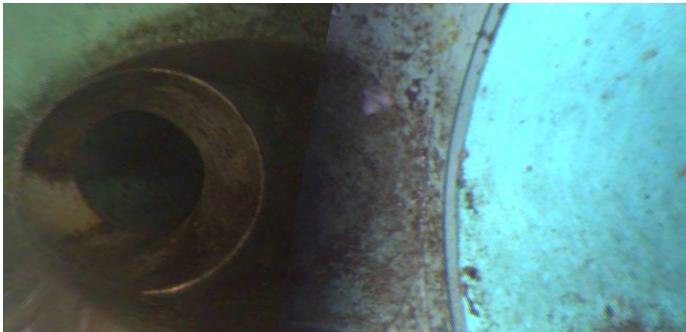
Code: **TF**
Description: **Tap Factory**

Distance (ft): **166.8**
Structural Grade: **0**
O&M Grade: **0**
Clock Start/From: **10**
Clock To:
1st Value: **4.000**
2nd Value:
Value Percent:
Continuous Index:
Within 8" of Joint: **YES**
Remarks:

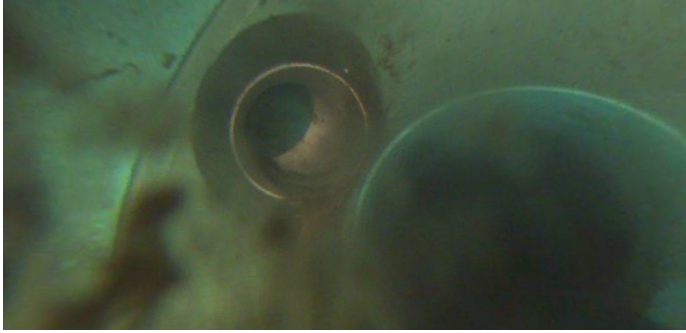
Code: **TF**
Description: **Tap Factory**

Distance (ft): **180.7**
Structural Grade: **0**
O&M Grade: **0**
Clock Start/From: **2**
Clock To:
1st Value: **4.000**
2nd Value:
Value Percent:
Continuous Index:
Within 8" of Joint:
Remarks:

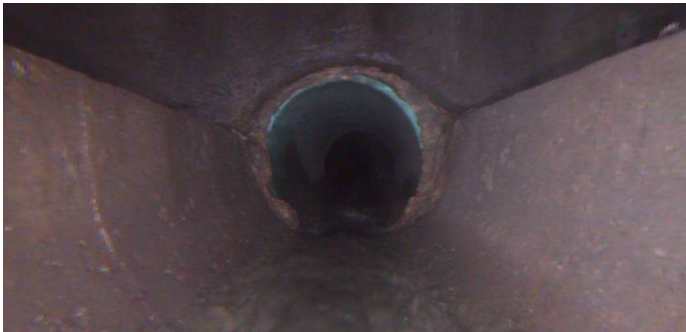
Code: **AMH**
Description: **Manhole**

Distance (ft): **192.4**
Structural Grade: **0**
O&M Grade: **0**
Clock Start/From:
Clock To:
1st Value:
2nd Value:
Value Percent:
Continuous Index:
Within 8" of Joint: **NO**
Remarks: **M-504-087**
