Profile/Photo Observation Report

Street:	W 42ND AVE	Flow Control:	Not Controlled
City:	Hobart, IN	Year Renewed:	
Location:	Light Highway	Tape/Media #:	
Purpose:	Not Known	Dia/Height:	12"
Use:	Sanitary	Material:	PVC
Drain Area:	NA	Lining:	
Category:	NA		
Comment:

Location Details:		Direction of Survey:	Downstream
US MH:	M-504-087	DS MH:	M-504-130
		Total Length Surveyed (ft):	28.7

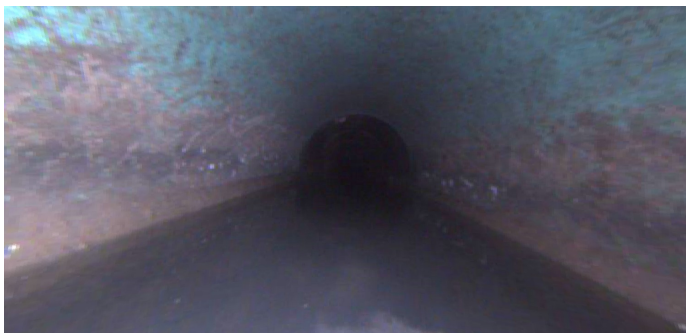
Code: **AMH**
Description: **Manhole**

Distance (ft): **.0**
Structural Grade: **0**
O&M Grade: **0**
Clock Start/From:
Clock To:
1st Value:
2nd Value:
Value Percent:
Continuous Index:
Within 8" of Joint: **NO**
Remarks: **M-504-087**

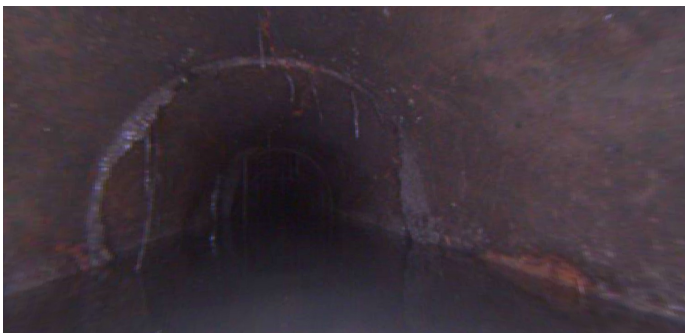
Code: **RFJ**
Description: **Roots Fine Joint**

Distance (ft): **10.3**
Structural Grade: **0**
O&M Grade: **1**
Clock Start/From: **8**
Clock To: **4**
1st Value:
2nd Value:
Value Percent:
Continuous Index: **S02**
Within 8" of Joint: **YES**
Remarks: **wandering**

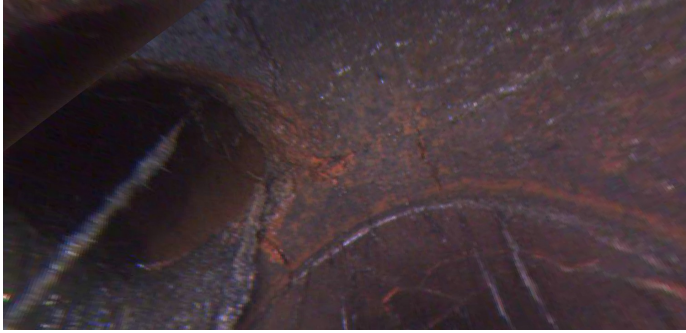
Code: **TBD**
Description: **Tap Break-in Defective**

Distance (ft): **12.7**
Structural Grade: **0**
O&M Grade: **3**
Clock Start/From: **11**
Clock To:
1st Value: **4.000**
2nd Value:
Value Percent:
Continuous Index:
Within 8" of Joint:
Remarks: **roots**

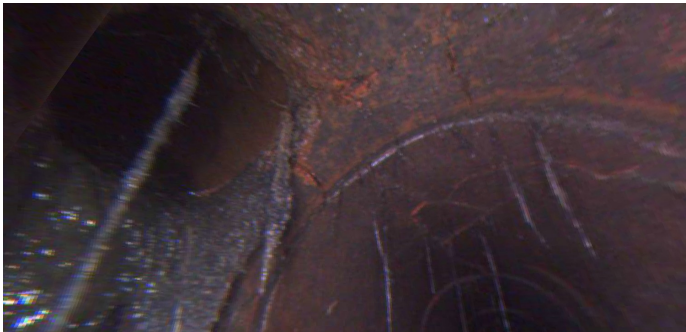
Code: **RFC**
Description: **Roots Fine Connection**

Distance (ft): **12.7**
Structural Grade: **0**
O&M Grade: **1**
Clock Start/From: **12**
Clock To:
1st Value:
2nd Value:
Value Percent:
Continuous Index:
Within 8" of Joint: **NO**
Remarks:

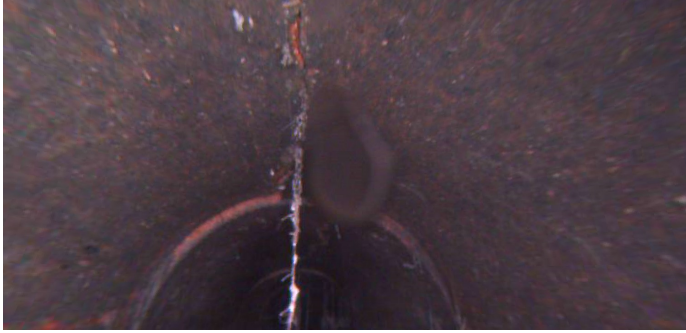
Code: **RFB**
Description: **Roots Fine Barrel**

Distance (ft): **18.2**
Structural Grade: **0**
O&M Grade: **2**
Clock Start/From: **12**
Clock To:
1st Value:
2nd Value:
Value Percent:
Continuous Index:
Within 8" of Joint: **NO**
Remarks:

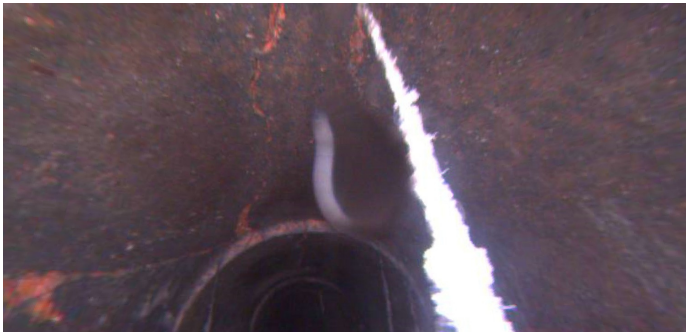
Code: **RFB**
Description: **Roots Fine Barrel**

Distance (ft): **23.8**
Structural Grade: **0**
O&M Grade: **2**
Clock Start/From: **12**
Clock To:
1st Value:
2nd Value:
Value Percent:
Continuous Index:
Within 8" of Joint: **NO**
Remarks:

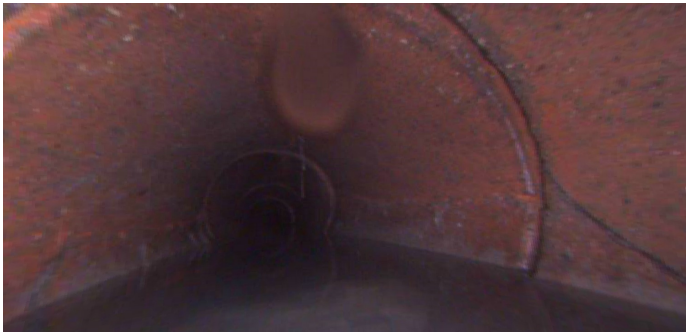
Code: **FM**
Description: **Fracture Multiple**

Distance (ft): **28.7**
Structural Grade: **4**
O&M Grade: **0**
Clock Start/From: **8**
Clock To: **12**
1st Value:
2nd Value:
Value Percent:
Continuous Index: **F01**
Within 8" of Joint: **YES**
Remarks: **wandering**

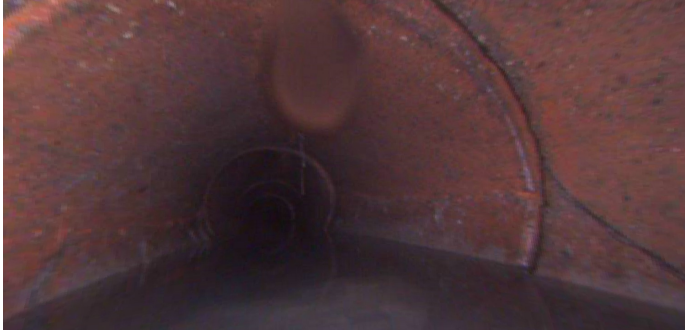
Code: **MSA**
Description: **Abandoned Survey**

Distance (ft): **28.7**
Structural Grade: **0**
O&M Grade: **0**
Clock Start/From:
Clock To:
1st Value:
2nd Value:
Value Percent:
Continuous Index:
Within 8" of Joint: **NO**
Remarks: **no blockage**

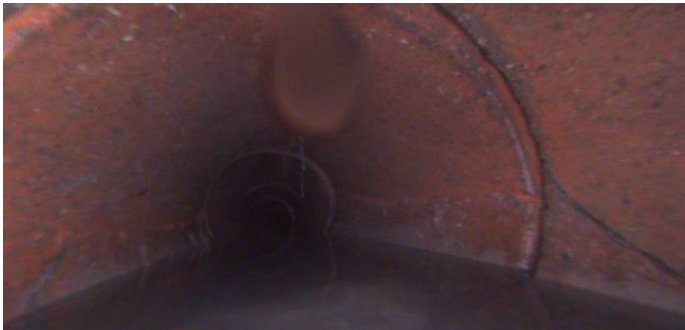
Code: **RFJ**
Description: **Roots Fine Joint**

Distance (ft): **28.7**
Structural Grade: **0**
O&M Grade: **1**
Clock Start/From: **8**
Clock To: **4**
1st Value:
2nd Value:
Value Percent:
Continuous Index: **F02**
Within 8" of Joint: **YES**
Remarks: **wandering**
