## Profile/Photo Observation Report

Date:	<b>04/18/2018</b>	Weather:		Coding:	<b>PACP 6.0</b>
Pipe Length (ft):	<b>150.4</b>	Owner:	<b>NA</b>	Pre Clean:	<b>Not Known</b>
P.O.#:		Surveyor:	<b>Byrd Fitzgerald</b>	PSR:	<b>P-504-089-088</b>
Customer:		Clean Date:	<b>01/01/1900</b>	Shape:	<b>C</b>

Street:	<b>Summerlin</b>	Flow Control:	<b>Not Controlled</b>
City:	<b>Hobart, IN</b>	Year Renewed:	
Location:	<b>Light Highway</b>	Tape/Media #:	
Purpose:	<b>Not Known</b>	Dia/Height:	<b>12"</b>
Use:	<b>Sanitary</b>	Material:	<b>VCP</b>
Drain Area:	<b>NA</b>	Lining:	
Category:	<b>NA</b>		
Comment:

Location Details:		Direction of Survey:	<b>Downstream</b>
US MH:	<b>M-504-088</b>	DS MH:	<b>M-504-089</b>
		Total Length Surveyed (ft):	<b>157.4</b>

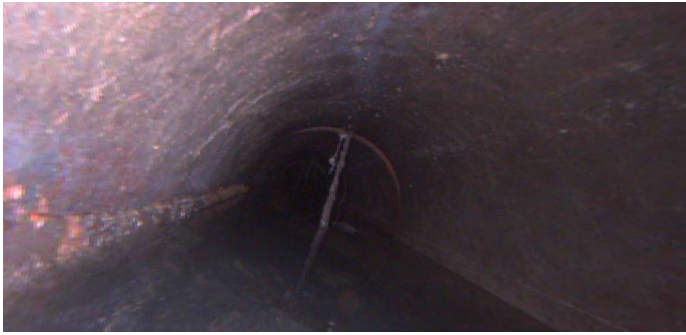
Code: **FM**  
Description: **Fracture Multiple**

Distance (ft): **.0**  
Structural Grade: **4**  
O&M Grade: **0**  
Clock Start/From: **7**  
Clock To: **12**  
1st Value:  
2nd Value:  
Value Percent:  
Continuous Index: **S01**  
Within 8" of Joint:  
Remarks: **wandering**

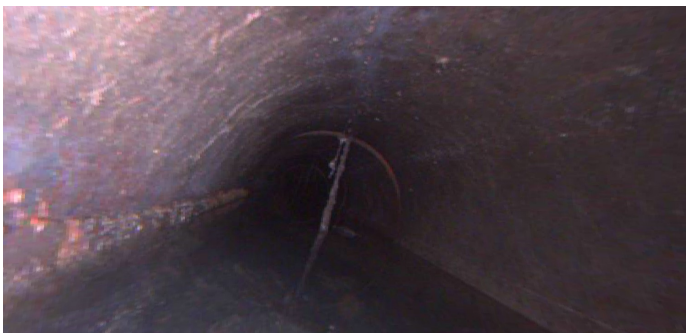
Code: **AMH**  
Description: **Manhole**

Distance (ft): **.0**  
Structural Grade: **0**  
O&M Grade: **0**  
Clock Start/From:  
Clock To:  
1st Value:  
2nd Value:  
Value Percent:  
Continuous Index:  
Within 8" of Joint: **NO**  
Remarks: **M-504-088**

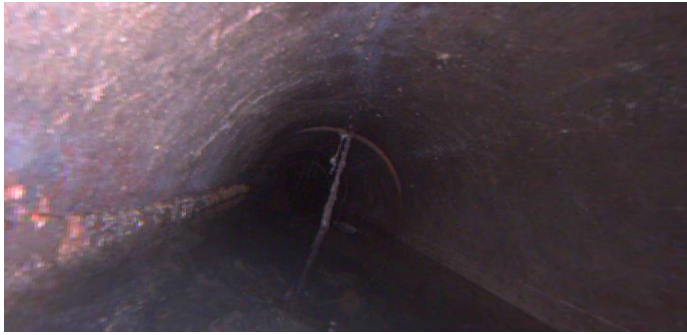
Code:	<b>MWL</b>
Description:	<b>Water Level</b>
Distance (ft):	<b>.0</b>
Structural Grade:	<b>0</b>
O&M Grade:	<b>0</b>
Clock Start/From:	
Clock To:	
1st Value:	
2nd Value:	
Value Percent:	<b>5.000</b>
Continuous Index:	
Within 8" of Joint:	<b>NO</b>
Remarks:

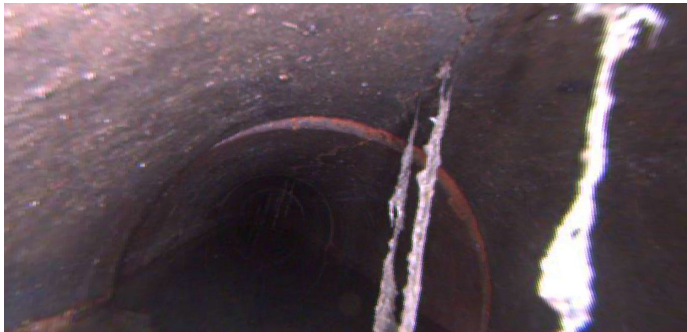
Code:	<b>RFB</b>
Description:	<b>Roots Fine Barrel</b>
Distance (ft):	<b>2.5</b>
Structural Grade:	<b>0</b>
O&M Grade:	<b>2</b>
Clock Start/From:	<b>12</b>
Clock To:	
1st Value:	
2nd Value:	
Value Percent:	
Continuous Index:	<b>S02</b>
Within 8" of Joint:	<b>NO</b>
Remarks:	<b>wandering</b>

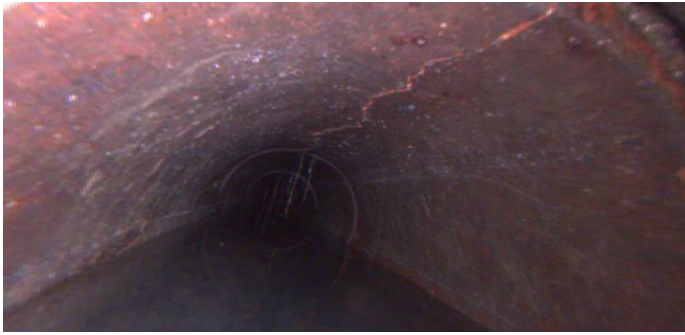
Code: **FL**  
Description: **Fracture Longitudinal**

Distance (ft): **3.1**  
Structural Grade: **3**  
O&M Grade: **0**  
Clock Start/From: **12**  
Clock To:  
1st Value:  
2nd Value:  
Value Percent:  
Continuous Index: **S03**  
Within 8" of Joint: **YES**  
Remarks:

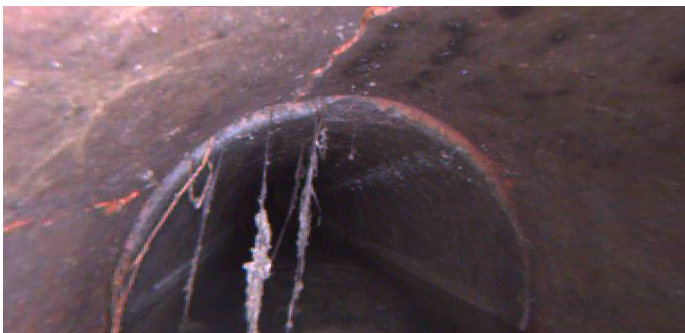
Code: **RMJ**  
Description: **Roots Medium Joint**

Distance (ft): **6.7**  
Structural Grade: **0**  
O&M Grade: **3**  
Clock Start/From: **11**  
Clock To: **12**  
1st Value:  
2nd Value:  
Value Percent: **5.000**  
Continuous Index:  
Within 8" of Joint: **YES**  
Remarks:

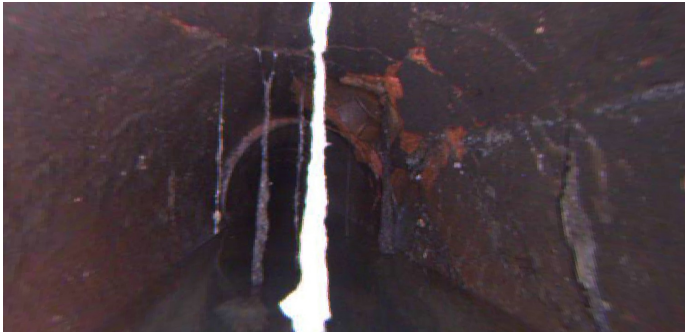
Code: **FM**  
Description: **Fracture Multiple**

Distance (ft): **19.0**  
Structural Grade: **4**  
O&M Grade: **0**  
Clock Start/From: **11**  
Clock To: **3**  
1st Value:  
2nd Value:  
Value Percent:  
Continuous Index:  
Within 8" of Joint:  
Remarks:

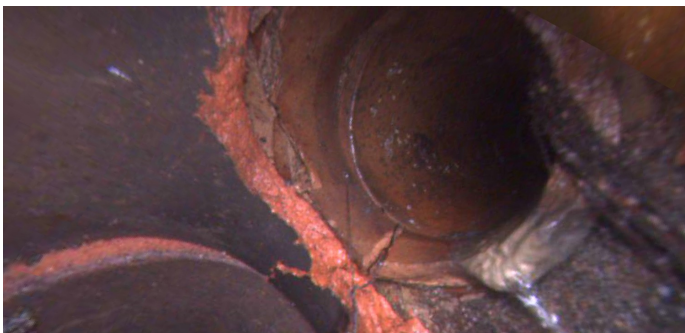
Code: **TBD**  
Description: **Tap Break-in Defective**

Distance (ft): **20.2**  
Structural Grade: **0**  
O&M Grade: **3**  
Clock Start/From: **2**  
Clock To:  
1st Value: **4.000**  
2nd Value:  
Value Percent:  
Continuous Index:  
Within 8" of Joint:  
Remarks: **roos**

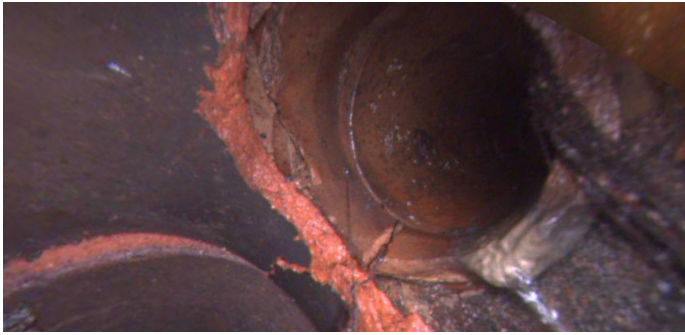
Code: **RFL**  
Description: **Roots Fine Lateral**

Distance (ft): **20.2**  
Structural Grade: **0**  
O&M Grade: **1**  
Clock Start/From: **2**  
Clock To:  
1st Value:  
2nd Value:  
Value Percent:  
Continuous Index:  
Within 8" of Joint: **NO**  
Remarks:

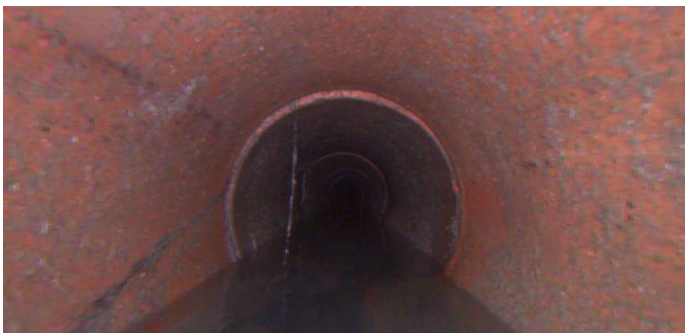
Code: **FL**  
Description: **Fracture Longitudinal**

Distance (ft): **24.0**  
Structural Grade: **3**  
O&M Grade: **0**  
Clock Start/From: **12**  
Clock To:  
1st Value:  
2nd Value:  
Value Percent:  
Continuous Index: **F03**  
Within 8" of Joint: **YES**  
Remarks:

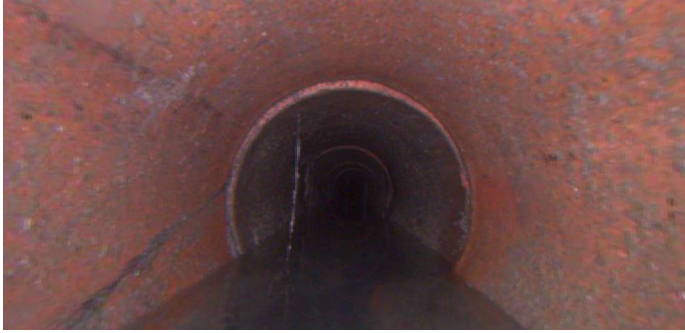
Code: **RFJ**  
Description: **Roots Fine Joint**

Distance (ft): **24.0**  
Structural Grade: **0**  
O&M Grade: **1**  
Clock Start/From: **9**  
Clock To: **11**  
1st Value:  
2nd Value:  
Value Percent:  
Continuous Index: **S04**  
Within 8" of Joint: **YES**  
Remarks: **wandering**

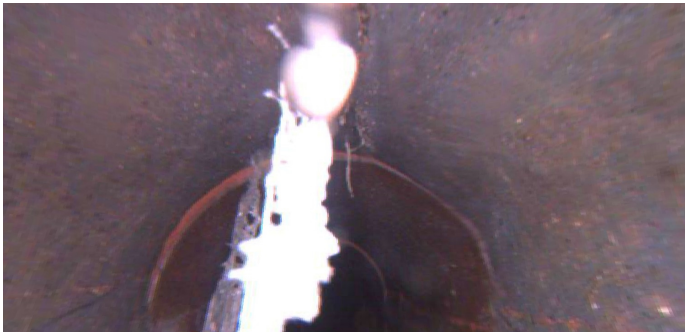
Code: **RMB**  
Description: **Roots Medium Barrel**

Distance (ft): **40.4**  
Structural Grade: **0**  
O&M Grade: **4**  
Clock Start/From: **12**  
Clock To:  
1st Value:  
2nd Value:  
Value Percent: **5.000**  
Continuous Index:  
Within 8" of Joint: **NO**  
Remarks:

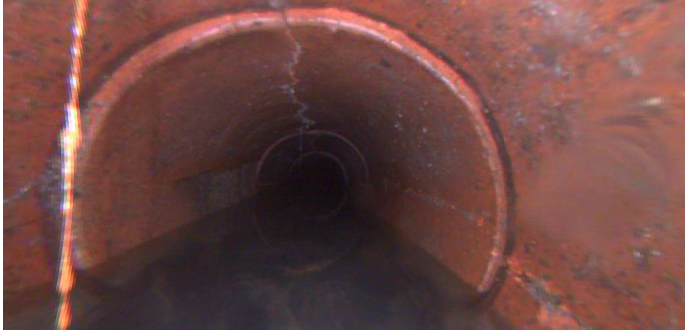
Code: **FM**  
Description: **Fracture Multiple**

Distance (ft): **44.8**  
Structural Grade: **4**  
O&M Grade: **0**  
Clock Start/From: **9**  
Clock To: **3**  
1st Value:  
2nd Value:  
Value Percent:  
Continuous Index: **S05**  
Within 8" of Joint: **YES**  
Remarks:

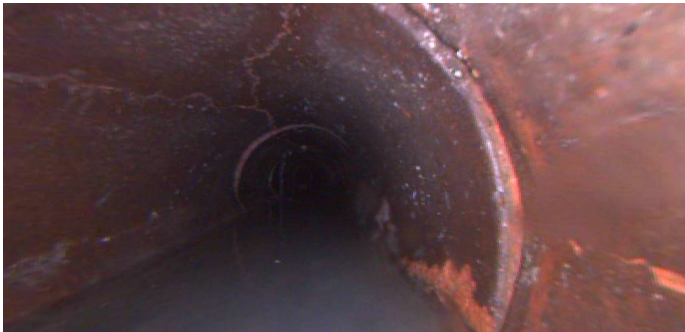
Code: **FM**  
Description: **Fracture Multiple**

Distance (ft): **55.2**  
Structural Grade: **4**  
O&M Grade: **0**  
Clock Start/From: **9**  
Clock To: **3**  
1st Value:  
2nd Value:  
Value Percent:  
Continuous Index: **F05**  
Within 8" of Joint: **YES**  
Remarks:

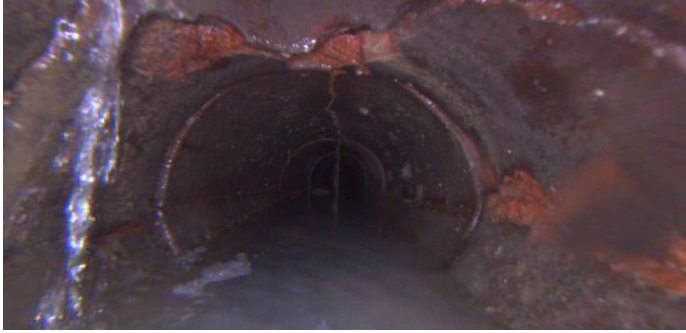
Code: **B**  
Description: **Broken**

Distance (ft): **58.7**  
Structural Grade: **5**  
O&M Grade: **0**  
Clock Start/From: **10**  
Clock To: **12**  
1st Value:  
2nd Value:  
Value Percent:  
Continuous Index:  
Within 8" of Joint: **YES**  
Remarks:

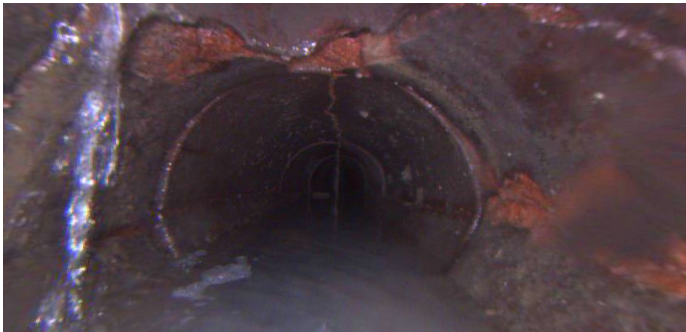
Code: **FM**  
Description: **Fracture Multiple**

Distance (ft): **58.7**  
Structural Grade: **4**  
O&M Grade: **0**  
Clock Start/From: **8**  
Clock To: **4**  
1st Value:  
2nd Value:  
Value Percent:  
Continuous Index: **S06**  
Within 8" of Joint: **YES**  
Remarks:

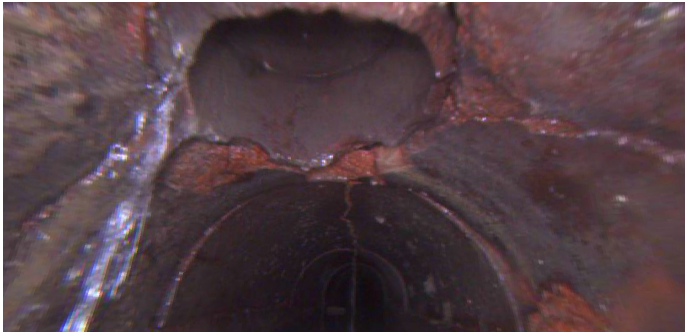
Code: **TBA**  
Description: **Tap Break-in Active**

Distance (ft): **58.7**  
Structural Grade: **0**  
O&M Grade: **0**  
Clock Start/From: **12**  
Clock To:  
1st Value: **4.000**  
2nd Value:  
Value Percent:  
Continuous Index:  
Within 8" of Joint: **YES**  
Remarks:

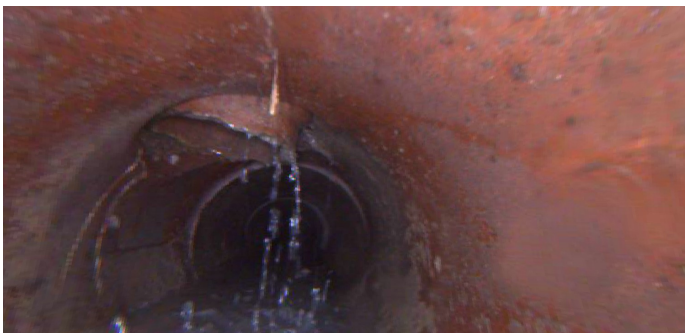
Code: **TBI**  
Description: **Tap Break-in Intruding**

Distance (ft): **80.0**  
Structural Grade: **0**  
O&M Grade: **2**  
Clock Start/From: **11**  
Clock To:  
1st Value: **4.000**  
2nd Value: **1.000**  
Value Percent:  
Continuous Index:  
Within 8" of Joint:  
Remarks:

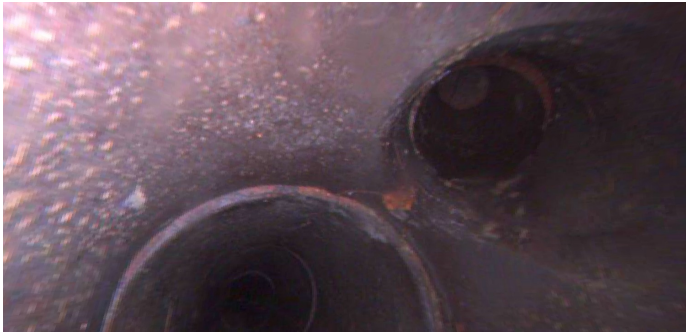
Code: **TF**  
Description: **Tap Factory**

Distance (ft): **82.8**  
Structural Grade: **0**  
O&M Grade: **0**  
Clock Start/From: **1**  
Clock To:  
1st Value: **4.000**  
2nd Value:  
Value Percent:  
Continuous Index:  
Within 8" of Joint: **YES**  
Remarks:

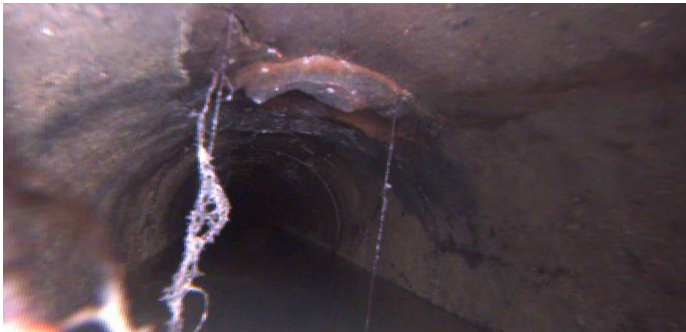
Code: **TB**  
Description: **Tap Break-in**

Distance (ft): **89.9**  
Structural Grade: **0**  
O&M Grade: **0**  
Clock Start/From: **12**  
Clock To:  
1st Value: **6.000**  
2nd Value:  
Value Percent:  
Continuous Index:  
Within 8" of Joint:  
Remarks:

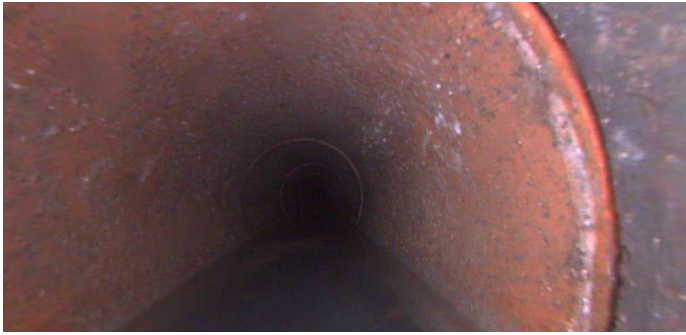
Code: **FM**  
Description: **Fracture Multiple**

Distance (ft): **101.5**  
Structural Grade: **4**  
O&M Grade: **0**  
Clock Start/From: **8**  
Clock To: **4**  
1st Value:  
2nd Value:  
Value Percent:  
Continuous Index: **F06**  
Within 8" of Joint: **YES**  
Remarks:

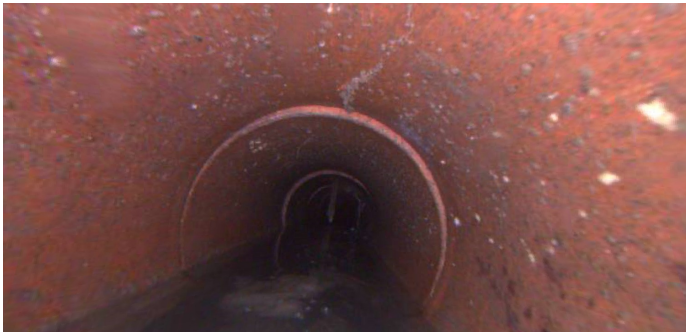
Code: **FL**  
Description: **Fracture Longitudinal**

Distance (ft): **115.1**  
Structural Grade: **3**  
O&M Grade: **0**  
Clock Start/From: **12**  
Clock To:  
1st Value:  
2nd Value:  
Value Percent:  
Continuous Index:  
Within 8" of Joint: **YES**  
Remarks:

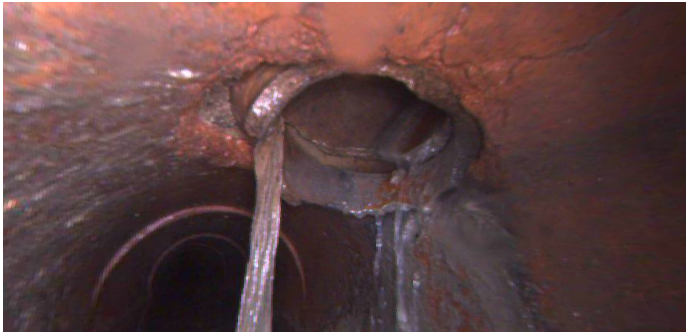
Code: **TBD**  
Description: **Tap Break-in Defective**

Distance (ft): **118.5**  
Structural Grade: **0**  
O&M Grade: **3**  
Clock Start/From: **1**  
Clock To:  
1st Value: **4.000**  
2nd Value:  
Value Percent:  
Continuous Index:  
Within 8" of Joint:  
Remarks: **dar**

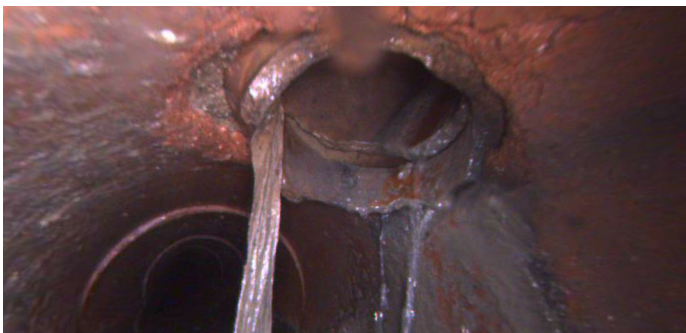
Code: **DAR**  
Description: **Deposits Attached Ragging**

Distance (ft): **118.5**  
Structural Grade: **0**  
O&M Grade: **2**  
Clock Start/From: **12**  
Clock To:  
1st Value:  
2nd Value:  
Value Percent: **5.000**  
Continuous Index:  
Within 8" of Joint: **NO**  
Remarks:

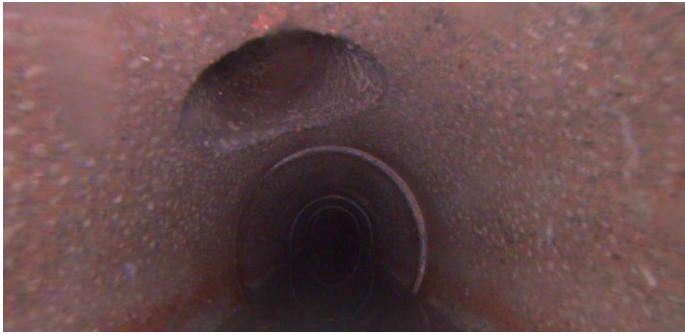
Code: **TF**  
Description: **Tap Factory**

Distance (ft): **129.0**  
Structural Grade: **0**  
O&M Grade: **0**  
Clock Start/From: **11**  
Clock To:  
1st Value: **4.000**  
2nd Value:  
Value Percent:  
Continuous Index:  
Within 8" of Joint:  
Remarks:

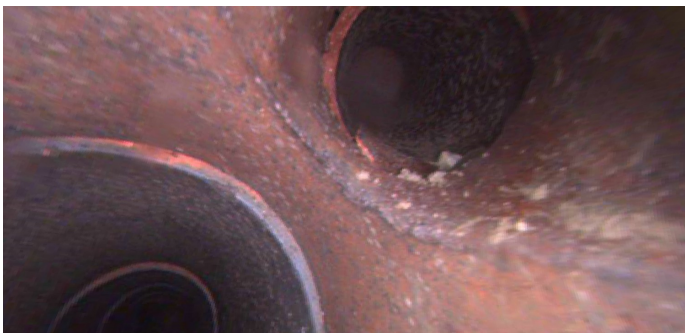
Code: **TF**  
Description: **Tap Factory**

Distance (ft): **131.7**  
Structural Grade: **0**  
O&M Grade: **0**  
Clock Start/From: **1**  
Clock To:  
1st Value: **4.000**  
2nd Value:  
Value Percent:  
Continuous Index:  
Within 8" of Joint: **YES**  
Remarks:

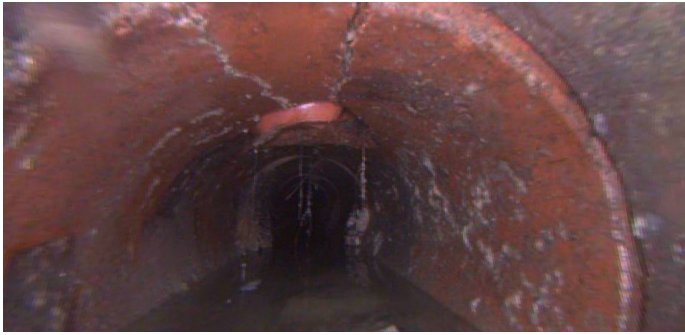
Code: **TBD**  
Description: **Tap Break-in Defective**

Distance (ft): **140.1**  
Structural Grade: **0**  
O&M Grade: **3**  
Clock Start/From: **12**  
Clock To:  
1st Value: **4.000**  
2nd Value:  
Value Percent:  
Continuous Index:  
Within 8" of Joint:  
Remarks: **rfl**

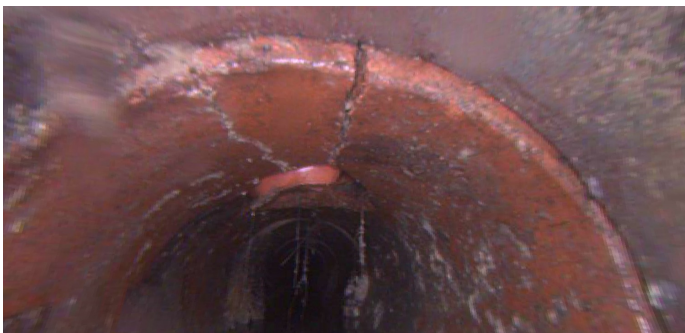
Code: **FM**  
Description: **Fracture Multiple**

Distance (ft): **140.1**  
Structural Grade: **4**  
O&M Grade: **0**  
Clock Start/From: **11**  
Clock To: **12**  
1st Value:  
2nd Value:  
Value Percent:  
Continuous Index:  
Within 8" of Joint: **YES**  
Remarks:

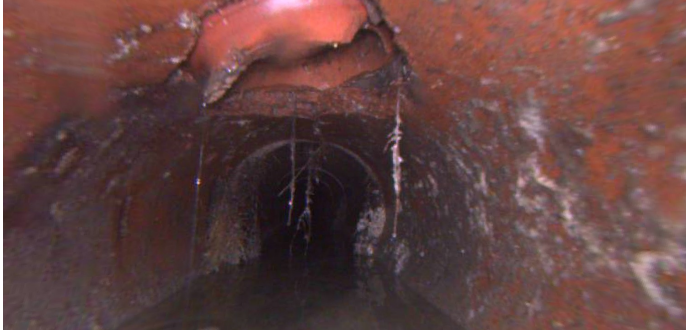
Code: **RFC**  
Description: **Roots Fine Connection**

Distance (ft): **140.7**  
Structural Grade: **0**  
O&M Grade: **1**  
Clock Start/From: **11**  
Clock To: **1**  
1st Value:  
2nd Value:  
Value Percent:  
Continuous Index:  
Within 8" of Joint: **NO**  
Remarks:

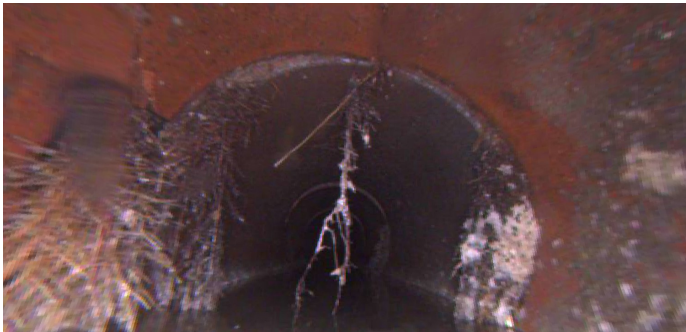
Code: **RMJ**  
Description: **Roots Medium Joint**

Distance (ft): **141.7**  
Structural Grade: **0**  
O&M Grade: **3**  
Clock Start/From: **7**  
Clock To: **5**  
1st Value:  
2nd Value:  
Value Percent: **20.000**  
Continuous Index:  
Within 8" of Joint: **YES**  
Remarks:

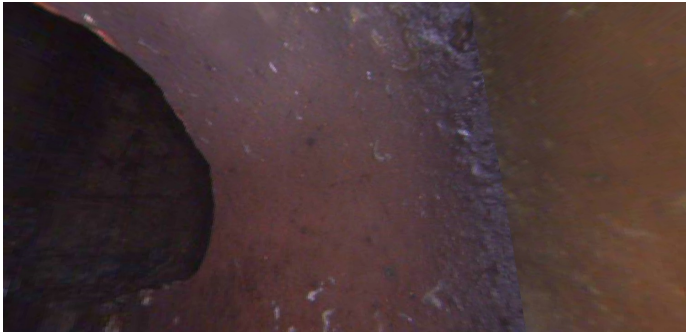
Code: **RFJ**  
Description: **Roots Fine Joint**

Distance (ft): **155.3**  
Structural Grade: **0**  
O&M Grade: **1**  
Clock Start/From: **9**  
Clock To: **11**  
1st Value:  
2nd Value:  
Value Percent:  
Continuous Index: **F04**  
Within 8" of Joint: **YES**  
Remarks: **wandering**

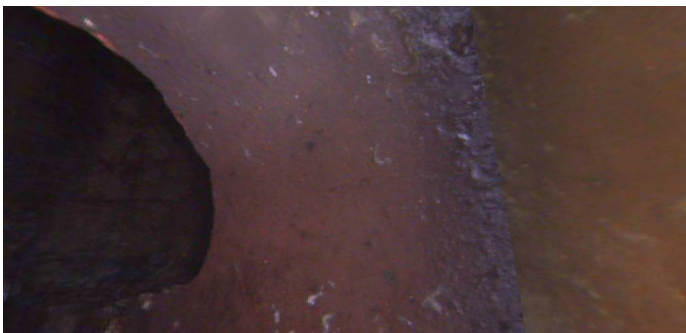
Code: **CM**  
Description: **Crack Multiple**

Distance (ft): **155.3**  
Structural Grade: **3**  
O&M Grade: **0**  
Clock Start/From: **7**  
Clock To: **12**  
1st Value:  
2nd Value:  
Value Percent:  
Continuous Index: **F01**  
Within 8" of Joint:  
Remarks: **wandering**

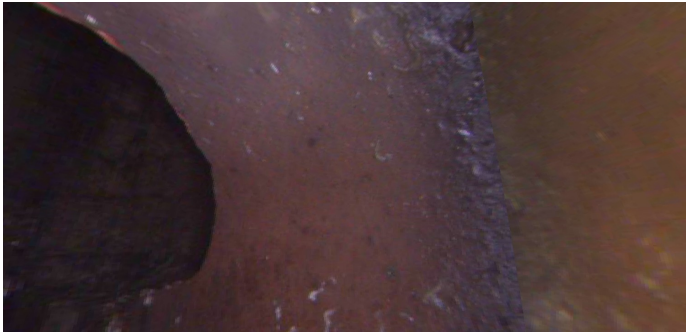
Code: **RFB**  
Description: **Roots Fine Barrel**

Distance (ft): **155.3**  
Structural Grade: **0**  
O&M Grade: **2**  
Clock Start/From: **12**  
Clock To:  
1st Value:  
2nd Value:  
Value Percent:  
Continuous Index: **F02**  
Within 8" of Joint: **NO**  
Remarks: **wandering**

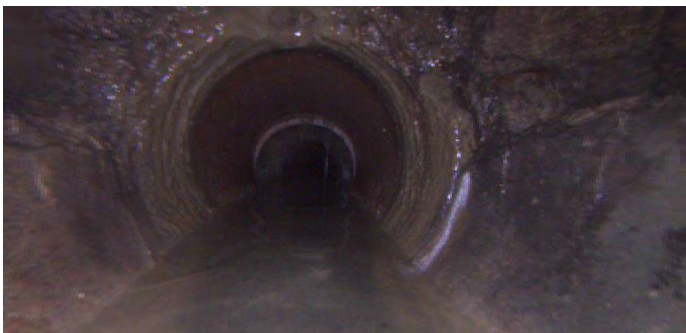
Code: **AMH**  
Description: **Manhole**

Distance (ft): **157.4**  
Structural Grade: **0**  
O&M Grade: **0**  
Clock Start/From:  
Clock To:  
1st Value:  
2nd Value:  
Value Percent:  
Continuous Index:  
Within 8" of Joint: **NO**  
Remarks: **M-504-089**
