## Profile/Photo Observation Report

Street:	<b>ALLEY BETWEEN N VIRGINIA ST &amp; N</b>	Flow Control:	<b>Not Controlled</b>
City:	<b>Hobart, IN</b>	Year Renewed:	
Location:	<b>Light Highway</b>	Tape/Media #:	
Purpose:	<b>Not Known</b>	Dia/Height:	<b>12"</b>
Use:	<b>Sanitary</b>	Material:	<b>VCP</b>
Drain Area:	<b>NA</b>	Lining:	
Category:	<b>NA</b>		
Comment:

Location Details:		Direction of Survey:	<b>Downstream</b>
US MH:	<b>M-504-089</b>	DS MH:	<b>M-504-090</b>
		Total Length Surveyed (ft):	<b>165.2</b>

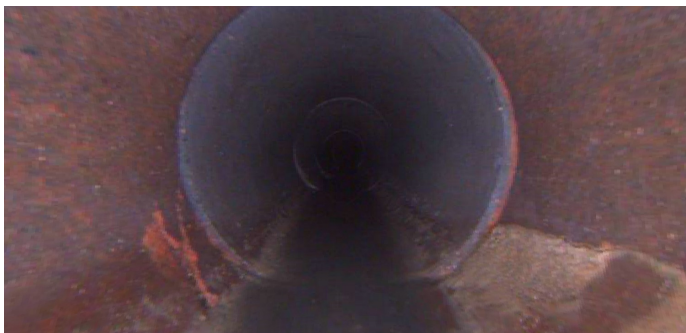
Code: **FM**  
Description: **Fracture Multiple**

Distance (ft): **.0**  
Structural Grade: **4**  
O&M Grade: **0**  
Clock Start/From: **7**  
Clock To: **5**  
1st Value:  
2nd Value:  
Value Percent:  
Continuous Index: **S01**  
Within 8" of Joint: **YES**  
Remarks: **wandering**

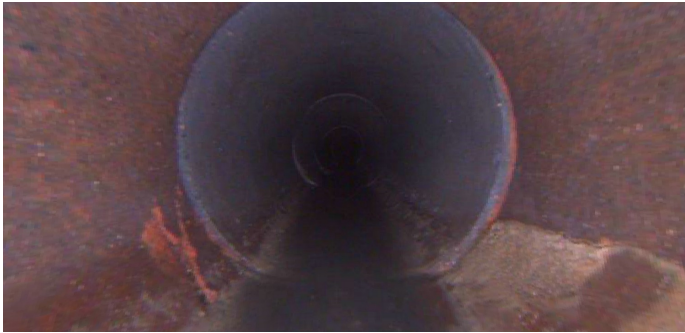
Code:	<b>AMH</b>
Description:	<b>Manhole</b>

Distance (ft):	<b>.0</b>
Structural Grade:	<b>0</b>
O&M Grade:	<b>0</b>
Clock Start/From:	
Clock To:	
1st Value:	
2nd Value:	
Value Percent:	
Continuous Index:	
Within 8" of Joint:	<b>NO</b>
Remarks:	<b>M-504-089</b>

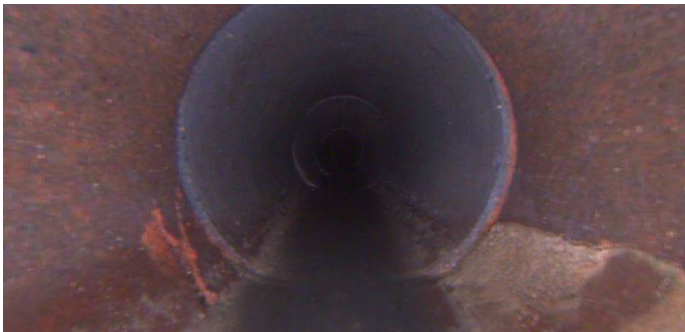
Code:	<b>MWL</b>
Description:	<b>Water Level</b>

Distance (ft):	<b>.0</b>
Structural Grade:	<b>0</b>
O&M Grade:	<b>0</b>
Clock Start/From:	
Clock To:	
1st Value:	
2nd Value:	
Value Percent:	<b>5.000</b>
Continuous Index:	
Within 8" of Joint:	<b>NO</b>
Remarks:

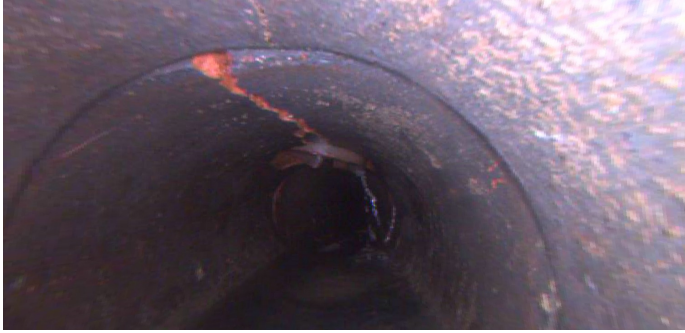
Code: **FL**  
Description: **Fracture Longitudinal**

Distance (ft): **24.7**  
Structural Grade: **3**  
O&M Grade: **0**  
Clock Start/From: **12**  
Clock To:  
1st Value:  
2nd Value:  
Value Percent:  
Continuous Index:  
Within 8" of Joint: **YES**  
Remarks:

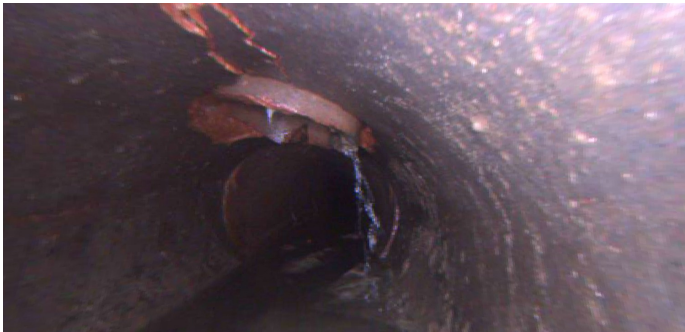
Code: **TBI**  
Description: **Tap Break-in Intruding**

Distance (ft): **25.5**  
Structural Grade: **0**  
O&M Grade: **2**  
Clock Start/From: **12**  
Clock To:  
1st Value: **4.000**  
2nd Value: **1.000**  
Value Percent:  
Continuous Index:  
Within 8" of Joint:  
Remarks:

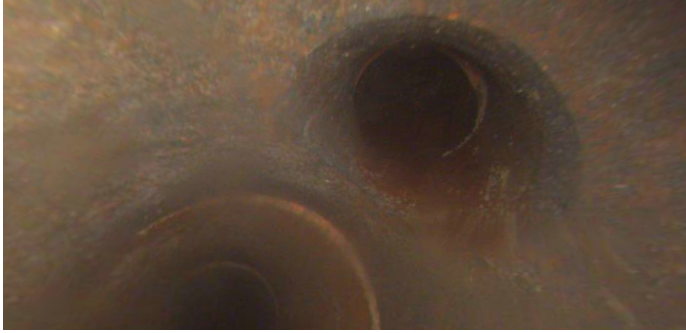
Code: **TF**  
Description: **Tap Factory**

Distance (ft): **42.6**  
Structural Grade: **0**  
O&M Grade: **0**  
Clock Start/From: **11**  
Clock To:  
1st Value: **4.000**  
2nd Value:  
Value Percent:  
Continuous Index:  
Within 8" of Joint:  
Remarks:

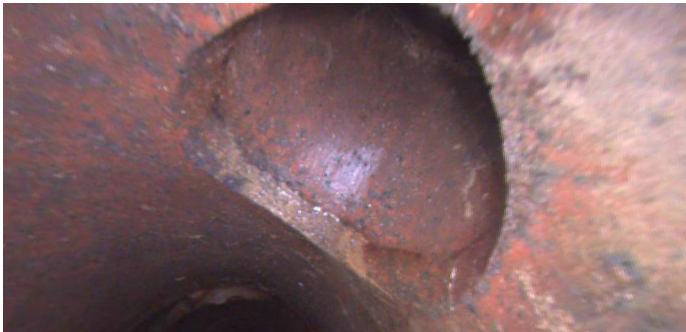
Code: **TF**  
Description: **Tap Factory**

Distance (ft): **43.8**  
Structural Grade: **0**  
O&M Grade: **0**  
Clock Start/From: **1**  
Clock To:  
1st Value: **4.000**  
2nd Value:  
Value Percent:  
Continuous Index:  
Within 8" of Joint: **YES**  
Remarks:

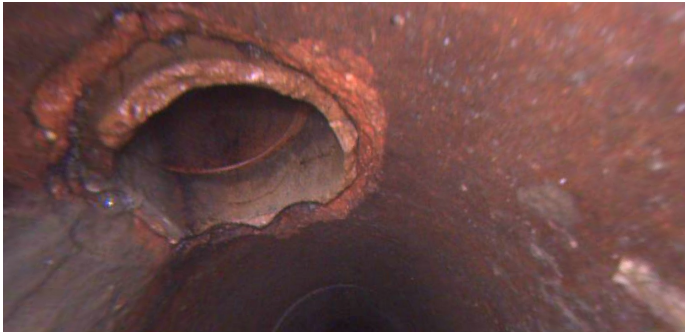
Code: **TBI**  
Description: **Tap Break-in Intruding**

Distance (ft): **45.4**  
Structural Grade: **0**  
O&M Grade: **2**  
Clock Start/From: **11**  
Clock To:  
1st Value: **4.000**  
2nd Value: **1.000**  
Value Percent:  
Continuous Index:  
Within 8" of Joint:  
Remarks:

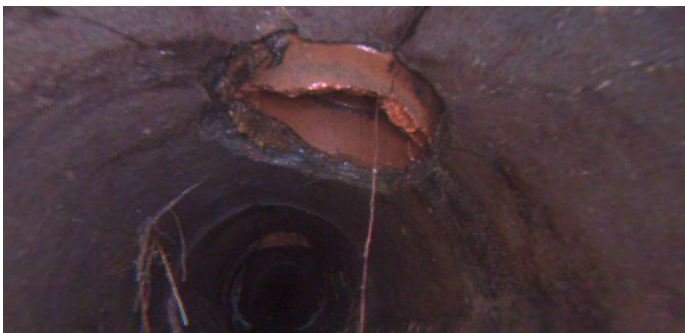
Code: **TBI**  
Description: **Tap Break-in Intruding**

Distance (ft): **79.6**  
Structural Grade: **0**  
O&M Grade: **2**  
Clock Start/From: **12**  
Clock To:  
1st Value: **4.000**  
2nd Value: **1.000**  
Value Percent:  
Continuous Index:  
Within 8" of Joint:  
Remarks:

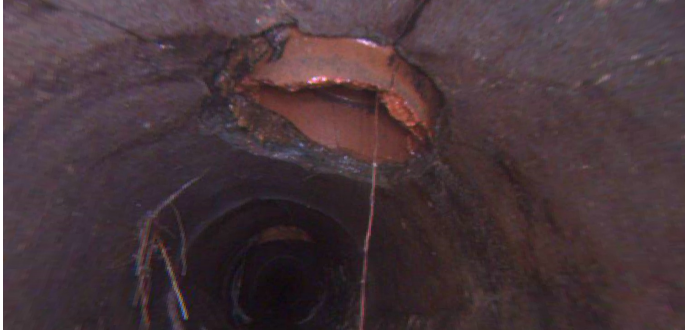
Code: **RFC**  
Description: **Roots Fine Connection**

Distance (ft): **79.6**  
Structural Grade: **0**  
O&M Grade: **1**  
Clock Start/From: **12**  
Clock To:  
1st Value:  
2nd Value:  
Value Percent:  
Continuous Index:  
Within 8" of Joint: **NO**  
Remarks:

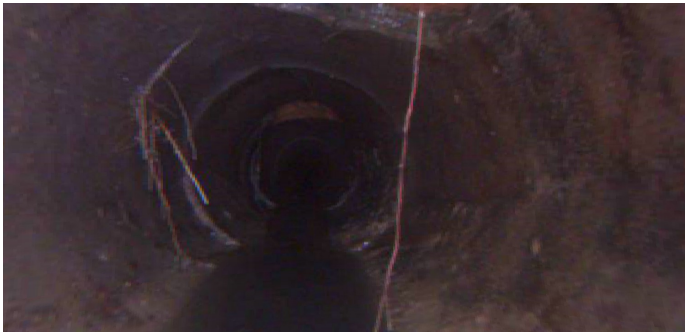
Code: **RFB**  
Description: **Roots Fine Barrel**

Distance (ft): **79.6**  
Structural Grade: **0**  
O&M Grade: **2**  
Clock Start/From: **10**  
Clock To:  
1st Value:  
2nd Value:  
Value Percent:  
Continuous Index:  
Within 8" of Joint: **NO**  
Remarks:

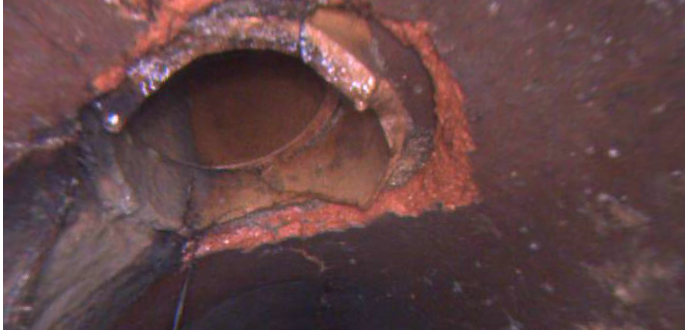
Code: **TBI**  
Description: **Tap Break-in Intruding**

Distance (ft): **82.1**  
Structural Grade: **0**  
O&M Grade: **2**  
Clock Start/From: **12**  
Clock To:  
1st Value: **4.000**  
2nd Value: **1.000**  
Value Percent:  
Continuous Index:  
Within 8" of Joint:  
Remarks:

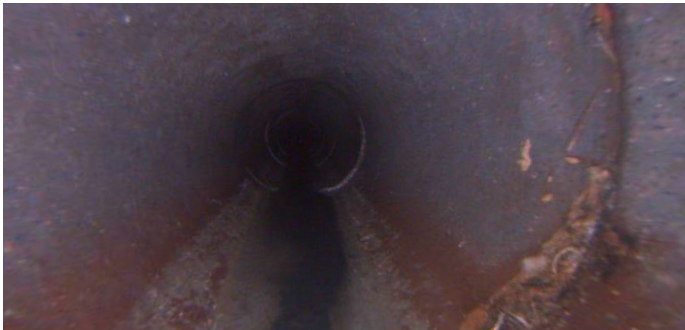
Code: **RFJ**  
Description: **Roots Fine Joint**

Distance (ft): **84.8**  
Structural Grade: **0**  
O&M Grade: **1**  
Clock Start/From: **3**  
Clock To: **4**  
1st Value:  
2nd Value:  
Value Percent:  
Continuous Index:  
Within 8" of Joint: **YES**  
Remarks:

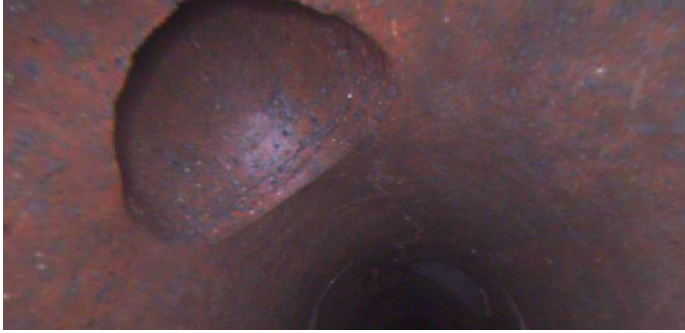
Code: **TF**  
Description: **Tap Factory**

Distance (ft): **89.4**  
Structural Grade: **0**  
O&M Grade: **0**  
Clock Start/From: **11**  
Clock To:  
1st Value: **4.000**  
2nd Value:  
Value Percent:  
Continuous Index:  
Within 8" of Joint:  
Remarks:

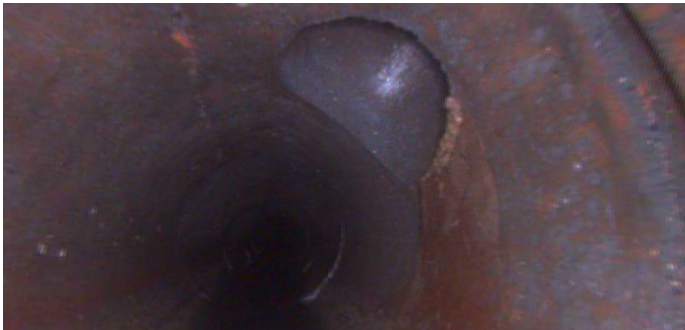
Code: **TF**  
Description: **Tap Factory**

Distance (ft): **91.0**  
Structural Grade: **0**  
O&M Grade: **0**  
Clock Start/From: **1**  
Clock To:  
1st Value: **4.000**  
2nd Value:  
Value Percent:  
Continuous Index:  
Within 8" of Joint:  
Remarks:

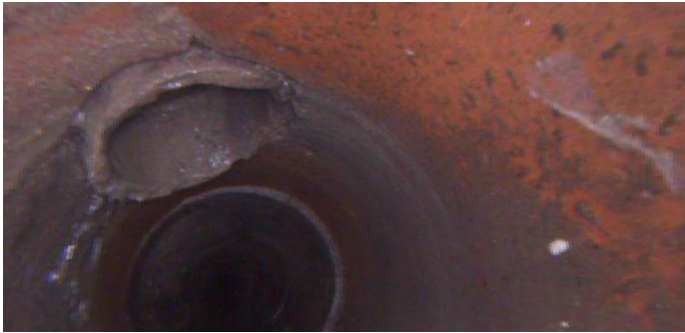
Code: **TBI**  
Description: **Tap Break-in Intruding**

Distance (ft): **135.7**  
Structural Grade: **0**  
O&M Grade: **2**  
Clock Start/From: **11**  
Clock To:  
1st Value: **4.000**  
2nd Value: **1.000**  
Value Percent:  
Continuous Index:  
Within 8" of Joint: **YES**  
Remarks:

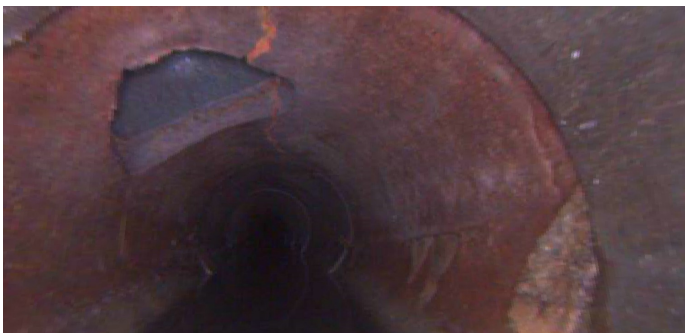
Code: **TF**  
Description: **Tap Factory**

Distance (ft): **139.0**  
Structural Grade: **0**  
O&M Grade: **0**  
Clock Start/From: **11**  
Clock To:  
1st Value: **4.000**  
2nd Value:  
Value Percent:  
Continuous Index:  
Within 8" of Joint:  
Remarks:

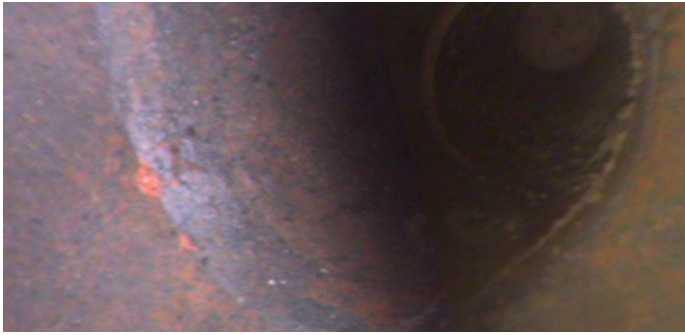
Code: **TF**  
Description: **Tap Factory**

Distance (ft): **142.4**  
Structural Grade: **0**  
O&M Grade: **0**  
Clock Start/From: **2**  
Clock To:  
1st Value: **4.000**  
2nd Value:  
Value Percent:  
Continuous Index:  
Within 8" of Joint:  
Remarks:

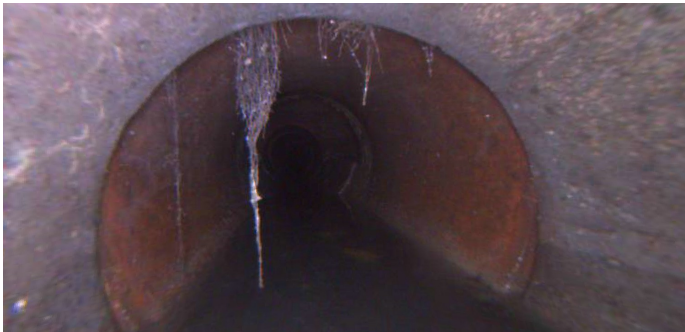
Code: **RFJ**  
Description: **Roots Fine Joint**

Distance (ft): **161.0**  
Structural Grade: **0**  
O&M Grade: **1**  
Clock Start/From: **11**  
Clock To: **1**  
1st Value:  
2nd Value:  
Value Percent:  
Continuous Index:  
Within 8" of Joint: **YES**  
Remarks:

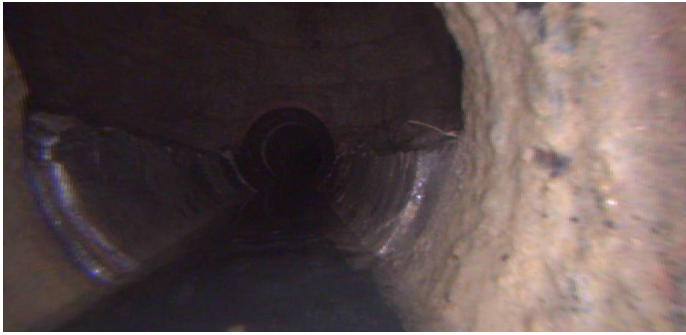
Code: **CM**  
Description: **Crack Multiple**

Distance (ft): **162.8**  
Structural Grade: **3**  
O&M Grade: **0**  
Clock Start/From: **7**  
Clock To: **5**  
1st Value:  
2nd Value:  
Value Percent:  
Continuous Index: **F01**  
Within 8" of Joint: **YES**  
Remarks: **wandering**
