Profile/Photo Observation Report

Date:	04/18/2018	Weather:		Coding:	PACP 6.0
Pipe Length (ft):	167.1	Owner:	NA	Pre Clean:	Not Known
P.O.#:		Surveyor:	Byrd Fitzgerald	PSR:	P-504-090-089
Customer:		Clean Date:	01/01/1900	Shape:	C

Street:	Summerlin	Flow Control:	Not Controlled
City:	Hobart, IN	Year Renewed:	
Location:	Light Highway	Tape/Media #:	
Purpose:	Not Known	Dia/Height:	12"
Use:	Sanitary	Material:	VCP
Drain Area:	NA	Lining:	
Category:	NA		
Comment:

Location Details:		Direction of Survey:	Downstream
US MH:	M-504-089	DS MH:	M-504-090
		Total Length Surveyed (ft):	165.2

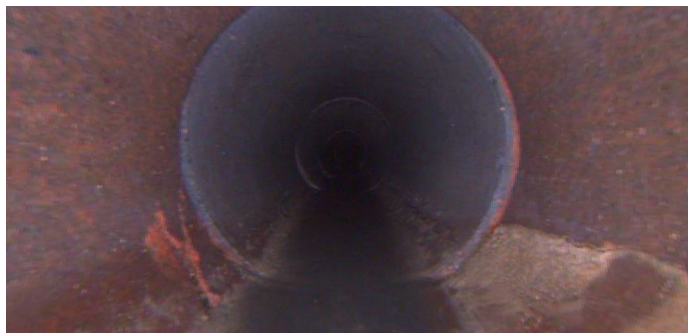
Code: **FM**
Description: **Fracture Multiple**

Distance (ft): **.0**
Structural Grade: **4**
O&M Grade: **0**
Clock Start/From: **7**
Clock To: **5**
1st Value:
2nd Value:
Value Percent:
Continuous Index: **S01**
Within 8" of Joint: **YES**
Remarks: **wandering**

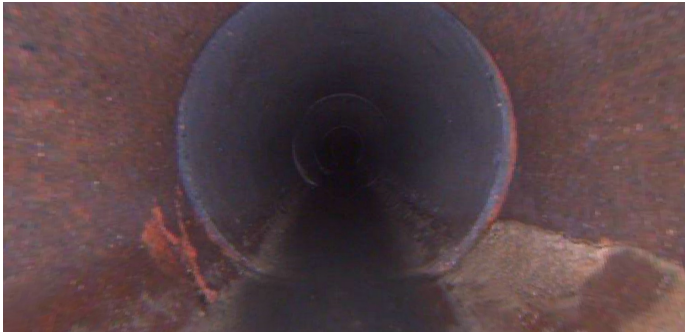
Code:	AMH
Description:	Manhole

Distance (ft):	.0
Structural Grade:	0
O&M Grade:	0
Clock Start/From:	
Clock To:	
1st Value:	
2nd Value:	
Value Percent:	
Continuous Index:	
Within 8" of Joint:	NO
Remarks:	M-504-089

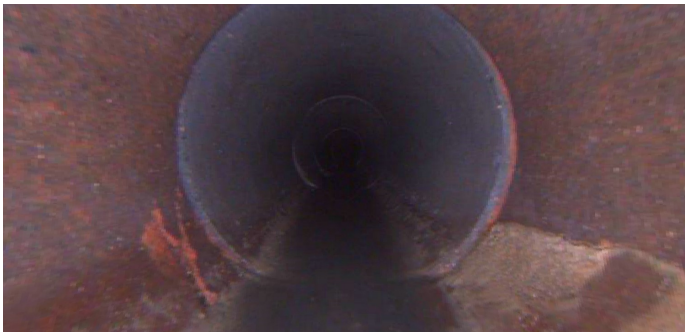
Code:	MWL
Description:	Water Level

Distance (ft):	.0
Structural Grade:	0
O&M Grade:	0
Clock Start/From:	
Clock To:	
1st Value:	
2nd Value:	
Value Percent:	5.000
Continuous Index:	
Within 8" of Joint:	NO
Remarks:

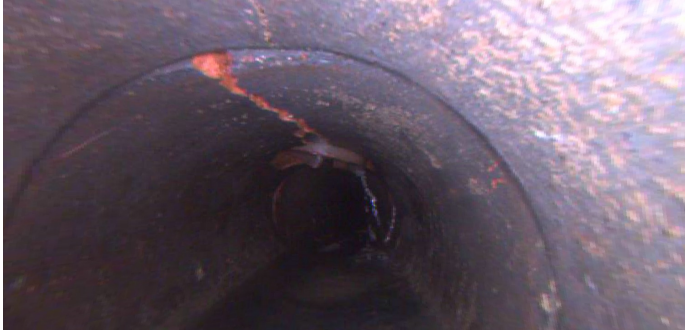
Code: **FL**
Description: **Fracture Longitudinal**

Distance (ft): **24.7**
Structural Grade: **3**
O&M Grade: **0**
Clock Start/From: **12**
Clock To:
1st Value:
2nd Value:
Value Percent:
Continuous Index:
Within 8" of Joint: **YES**
Remarks:

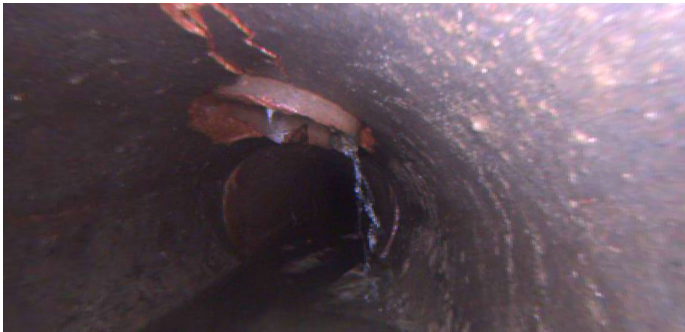
Code: **TBI**
Description: **Tap Break-in Intruding**

Distance (ft): **25.5**
Structural Grade: **0**
O&M Grade: **2**
Clock Start/From: **12**
Clock To:
1st Value: **4.000**
2nd Value: **1.000**
Value Percent:
Continuous Index:
Within 8" of Joint:
Remarks:

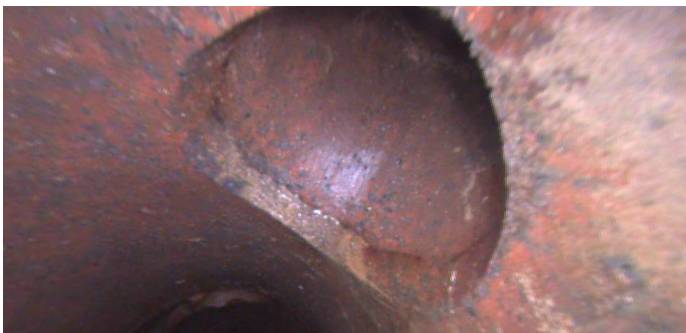
Code: **TF**
Description: **Tap Factory**

Distance (ft): **43.8**
Structural Grade: **0**
O&M Grade: **0**
Clock Start/From: **1**
Clock To:
1st Value: **4.000**
2nd Value:
Value Percent:
Continuous Index:
Within 8" of Joint: **YES**
Remarks:

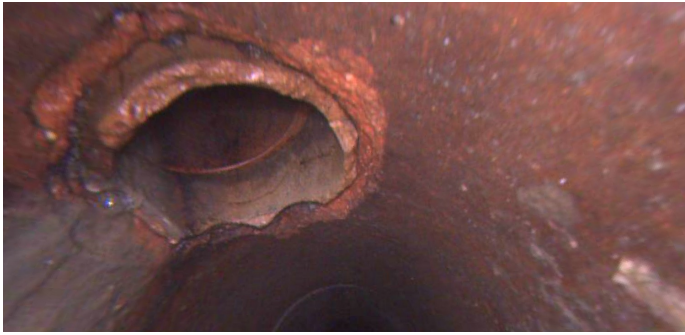
Code: **TBI**
Description: **Tap Break-in Intruding**

Distance (ft): **45.4**
Structural Grade: **0**
O&M Grade: **2**
Clock Start/From: **11**
Clock To:
1st Value: **4.000**
2nd Value: **1.000**
Value Percent:
Continuous Index:
Within 8" of Joint:
Remarks:

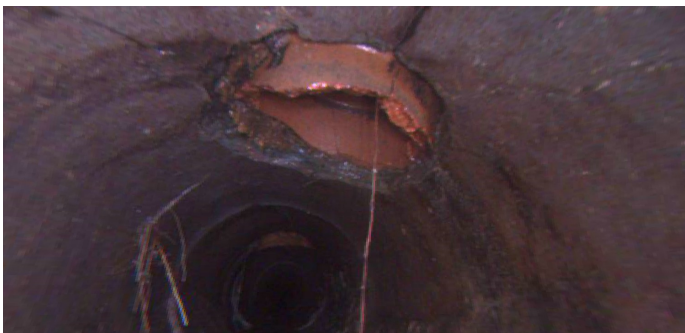
Code: **TBI**
Description: **Tap Break-in Intruding**

Distance (ft): **79.6**
Structural Grade: **0**
O&M Grade: **2**
Clock Start/From: **12**
Clock To:
1st Value: **4.000**
2nd Value: **1.000**
Value Percent:
Continuous Index:
Within 8" of Joint:
Remarks:

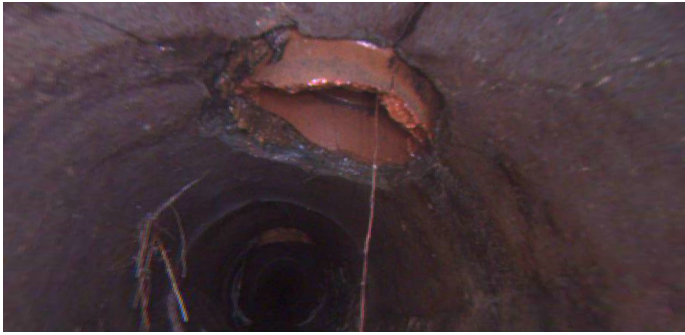
Code: **RFC**
Description: **Roots Fine Connection**

Distance (ft): **79.6**
Structural Grade: **0**
O&M Grade: **1**
Clock Start/From: **12**
Clock To:
1st Value:
2nd Value:
Value Percent:
Continuous Index:
Within 8" of Joint: **NO**
Remarks:

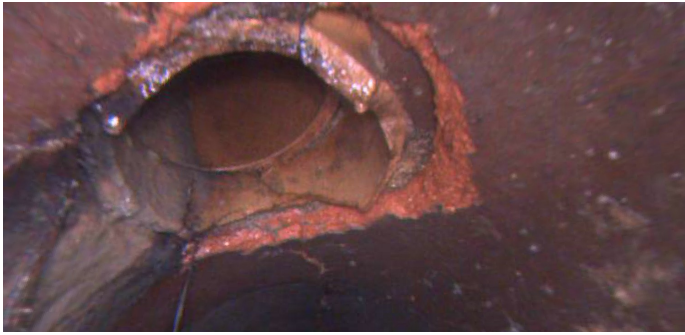
Code: **TBI**
Description: **Tap Break-in Intruding**

Distance (ft): **82.1**
Structural Grade: **0**
O&M Grade: **2**
Clock Start/From: **12**
Clock To:
1st Value: **4.000**
2nd Value: **1.000**
Value Percent:
Continuous Index:
Within 8" of Joint:
Remarks:

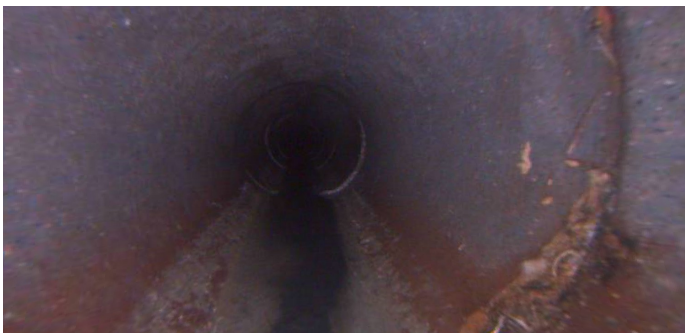
Code: **RFJ**
Description: **Roots Fine Joint**

Distance (ft): **84.8**
Structural Grade: **0**
O&M Grade: **1**
Clock Start/From: **3**
Clock To: **4**
1st Value:
2nd Value:
Value Percent:
Continuous Index:
Within 8" of Joint: **YES**
Remarks:

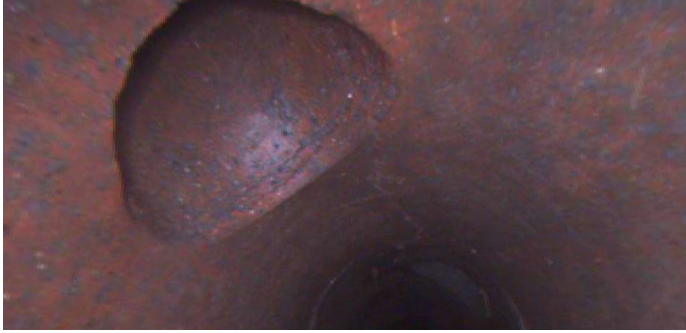
Code: **TF**
Description: **Tap Factory**

Distance (ft): **89.4**
Structural Grade: **0**
O&M Grade: **0**
Clock Start/From: **11**
Clock To:
1st Value: **4.000**
2nd Value:
Value Percent:
Continuous Index:
Within 8" of Joint:
Remarks:

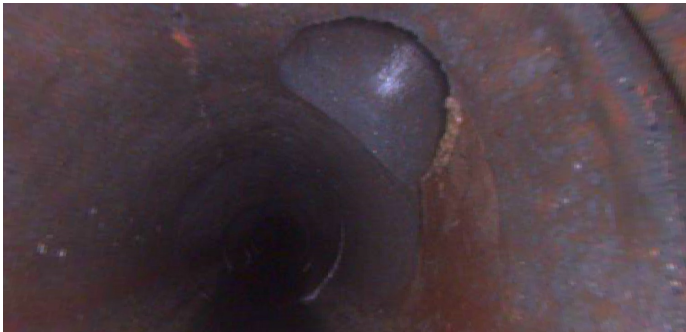
Code: **TF**
Description: **Tap Factory**

Distance (ft): **91.0**
Structural Grade: **0**
O&M Grade: **0**
Clock Start/From: **1**
Clock To:
1st Value: **4.000**
2nd Value:
Value Percent:
Continuous Index:
Within 8" of Joint:
Remarks:

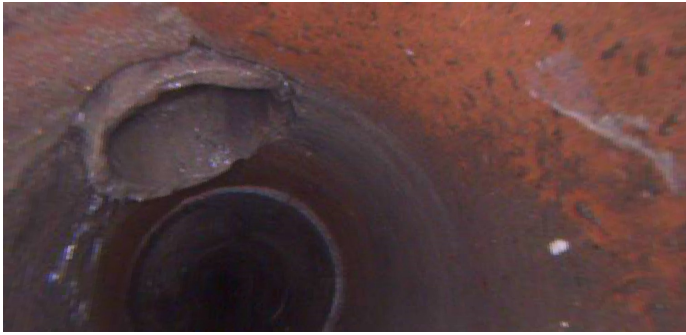
Code: **TBI**
Description: **Tap Break-in Intruding**

Distance (ft): **135.7**
Structural Grade: **0**
O&M Grade: **2**
Clock Start/From: **11**
Clock To:
1st Value: **4.000**
2nd Value: **1.000**
Value Percent:
Continuous Index:
Within 8" of Joint: **YES**
Remarks:

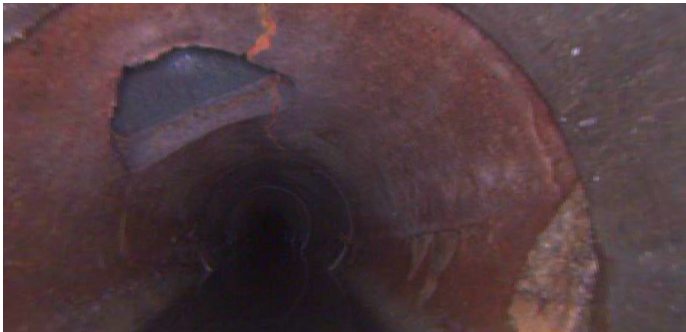
Code: **TF**
Description: **Tap Factory**

Distance (ft): **139.0**
Structural Grade: **0**
O&M Grade: **0**
Clock Start/From: **11**
Clock To:
1st Value: **4.000**
2nd Value:
Value Percent:
Continuous Index:
Within 8" of Joint:
Remarks:

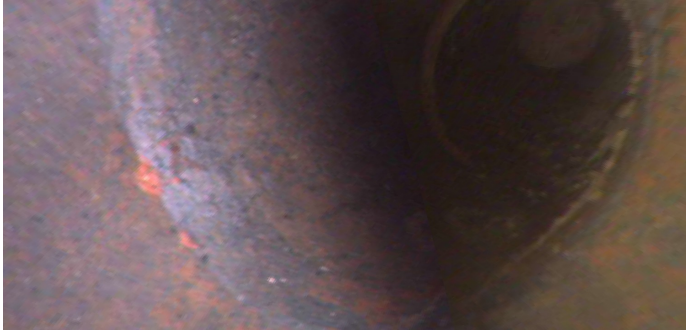
Code: **TF**
Description: **Tap Factory**

Distance (ft): **142.4**
Structural Grade: **0**
O&M Grade: **0**
Clock Start/From: **2**
Clock To:
1st Value: **4.000**
2nd Value:
Value Percent:
Continuous Index:
Within 8" of Joint:
Remarks:

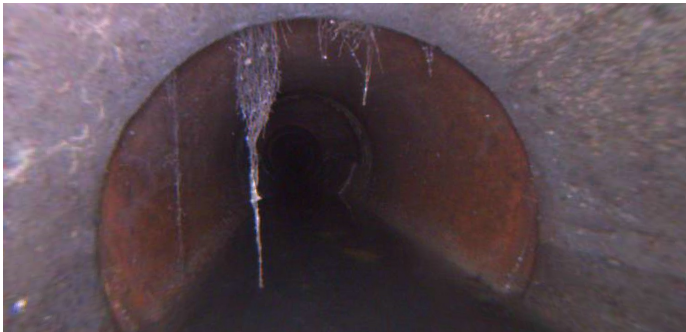
Code: **RFJ**
Description: **Roots Fine Joint**

Distance (ft): **161.0**
Structural Grade: **0**
O&M Grade: **1**
Clock Start/From: **11**
Clock To: **1**
1st Value:
2nd Value:
Value Percent:
Continuous Index:
Within 8" of Joint: **YES**
Remarks:

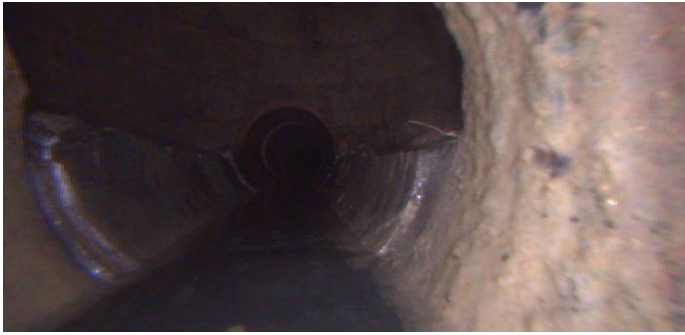
Code: **CM**
Description: **Crack Multiple**

Distance (ft): **162.8**
Structural Grade: **3**
O&M Grade: **0**
Clock Start/From: **7**
Clock To: **5**
1st Value:
2nd Value:
Value Percent:
Continuous Index: **F01**
Within 8" of Joint: **YES**
Remarks: **wandering**
