Profile/Photo Observation Report

Street:	OFF N VIRGINIA ST	Flow Control:	Not Controlled
City:	Hobart, IN	Year Renewed:	
Location:	Light Highway	Tape/Media #:	
Purpose:	Not Known	Dia/Height:	12"
Use:	Sanitary	Material:	VCP
Drain Area:	NA	Lining:	
Category:	NA		
Comment:

Location Details:		Direction of Survey:	Downstream
US MH:	M-504-105	DS MH:	M-504-106
		Total Length Surveyed (ft):	124.8

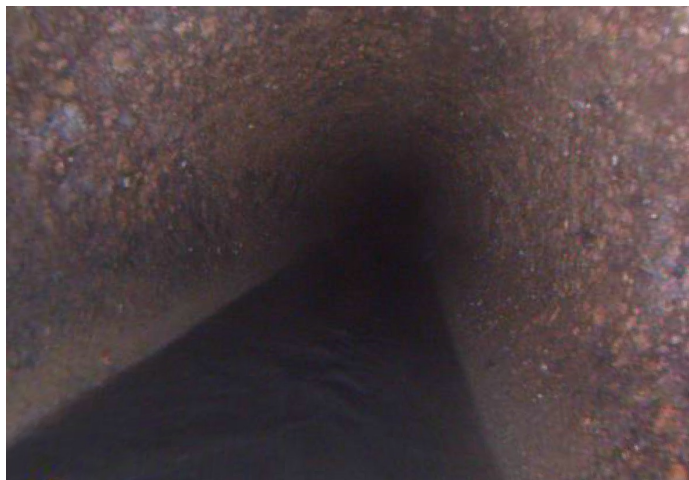
Code: **AMH**
 Description: **Manhole**

Distance (ft): **.0**
 Structural Grade: **0**
 O&M Grade: **0**
 Clock Start/From:
 Clock To:
 1st Value:
 2nd Value:
 Value Percent:
 Continuous Index:
 Within 8" of Joint: **NO**
 Remarks: **M-504-105**

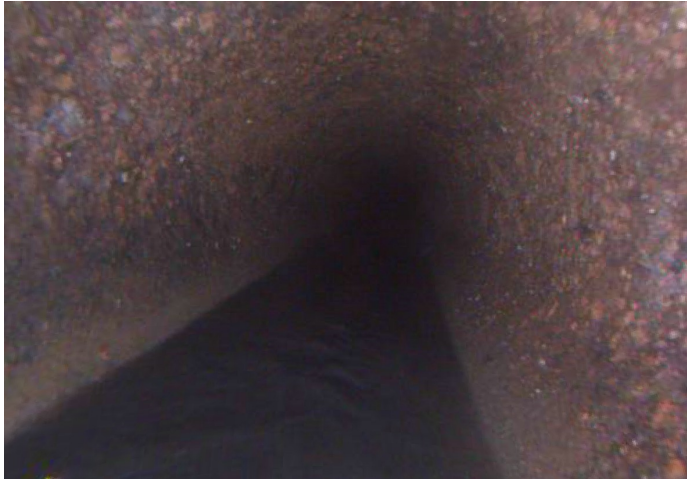
Code: **MWL**
Description: **Water Level**

Distance (ft): **.0**
Structural Grade: **0**
O&M Grade: **0**
Clock Start/From:
Clock To:
1st Value:
2nd Value:
Value Percent: **10.000**
Continuous Index:
Within 8" of Joint: **NO**
Remarks:

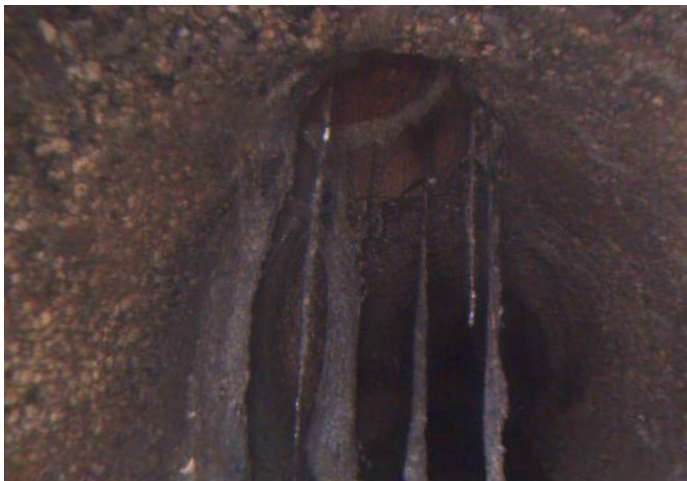
Code: **TBD**
Description: **Tap Break-in Defective**

Distance (ft): **28.7**
Structural Grade: **0**
O&M Grade: **3**
Clock Start/From: **11**
Clock To:
1st Value: **6.000**
2nd Value:
Value Percent:
Continuous Index:
Within 8" of Joint:
Remarks: **RFC**

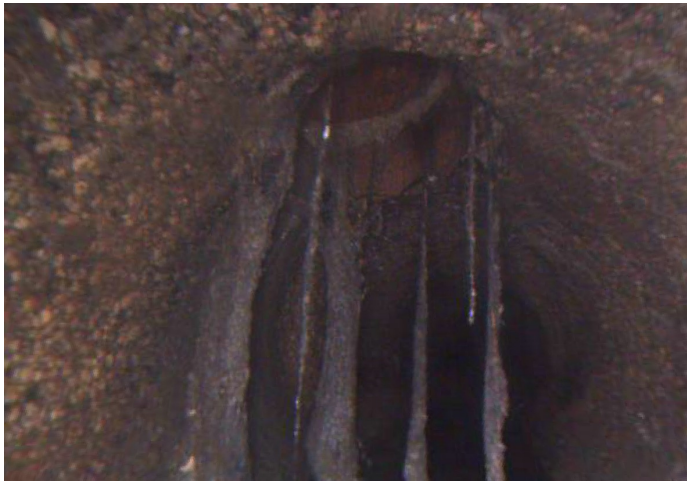
Code:	RFC
Description:	Roots Fine Connection
Distance (ft):	28.7
Structural Grade:	0
O&M Grade:	1
Clock Start/From:	11
Clock To:	
1st Value:	
2nd Value:	
Value Percent:	
Continuous Index:	
Within 8" of Joint:	NO
Remarks:

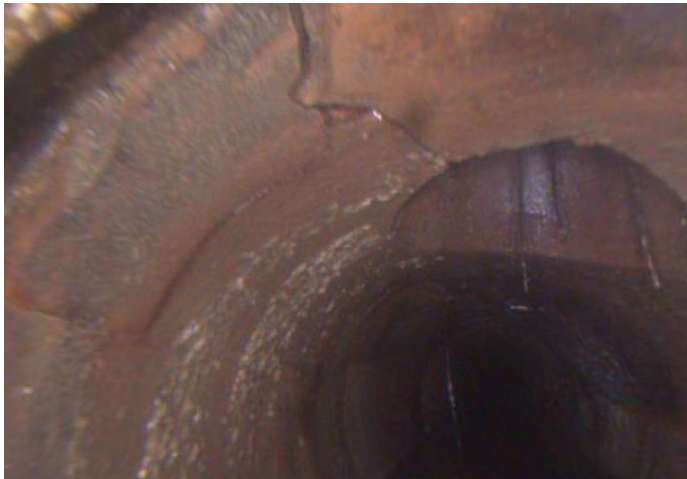
Code:	FM
Description:	Fracture Multiple
Distance (ft):	52.2
Structural Grade:	4
O&M Grade:	0
Clock Start/From:	10
Clock To:	12
1st Value:	
2nd Value:	
Value Percent:	
Continuous Index:	
Within 8" of Joint:	YES
Remarks:

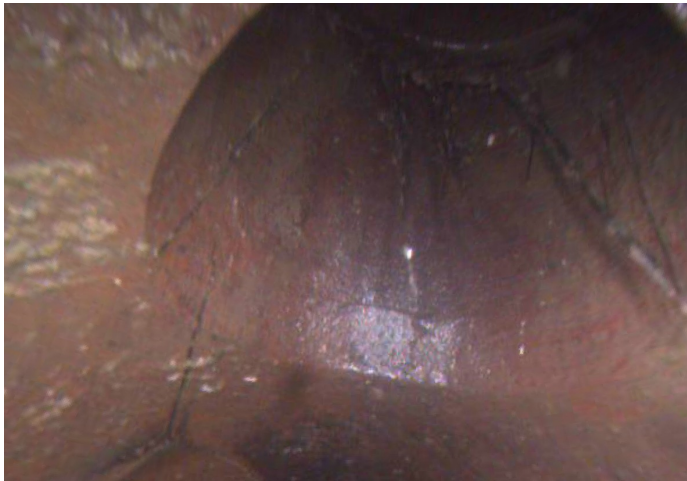
Code: **TFD**
Description: **Tap Factory Defective**

Distance (ft): **52.7**
Structural Grade: **0**
O&M Grade: **2**
Clock Start/From: **12**
Clock To:
1st Value: **6.000**
2nd Value:
Value Percent:
Continuous Index:
Within 8" of Joint:
Remarks: **FM; RFL**

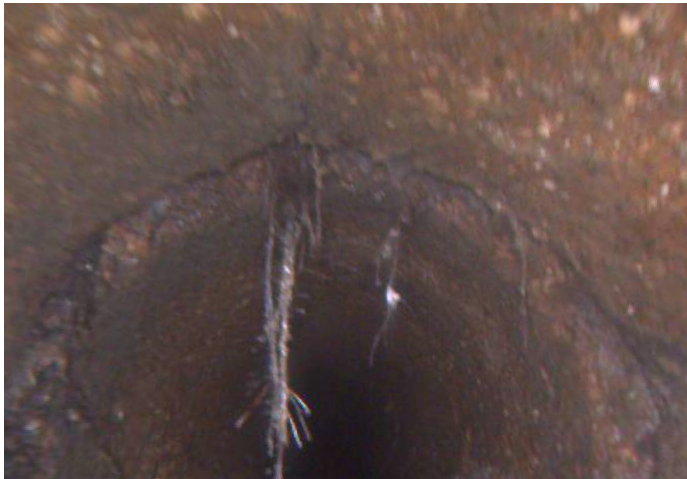
Code: **RFJ**
Description: **Roots Fine Joint**

Distance (ft): **60.4**
Structural Grade: **0**
O&M Grade: **1**
Clock Start/From: **12**
Clock To:
1st Value:
2nd Value:
Value Percent:
Continuous Index:
Within 8" of Joint: **YES**
Remarks:

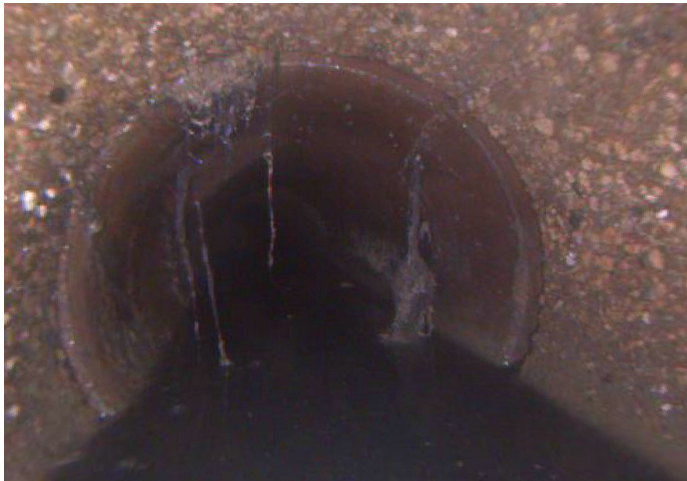
Code: **RFJ**
Description: **Roots Fine Joint**

Distance (ft): **84.3**
Structural Grade: **0**
O&M Grade: **1**
Clock Start/From: **10**
Clock To: **12**
1st Value:
2nd Value:
Value Percent:
Continuous Index:
Within 8" of Joint: **YES**
Remarks:

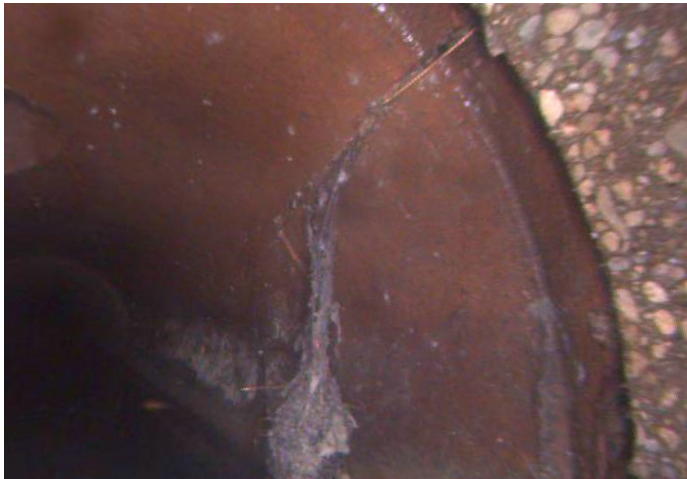
Code: **FL**
Description: **Fracture Longitudinal**

Distance (ft): **85.0**
Structural Grade: **3**
O&M Grade: **0**
Clock Start/From: **2**
Clock To:
1st Value:
2nd Value:
Value Percent:
Continuous Index:
Within 8" of Joint: **YES**
Remarks:

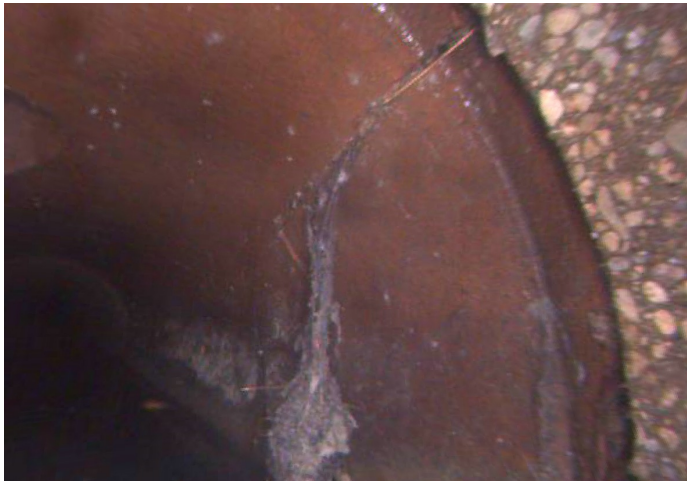
Code: **RFB**
Description: **Roots Fine Barrel**

Distance (ft): **85.0**
Structural Grade: **0**
O&M Grade: **2**
Clock Start/From: **2**
Clock To:
1st Value:
2nd Value:
Value Percent:
Continuous Index:
Within 8" of Joint: **NO**
Remarks:

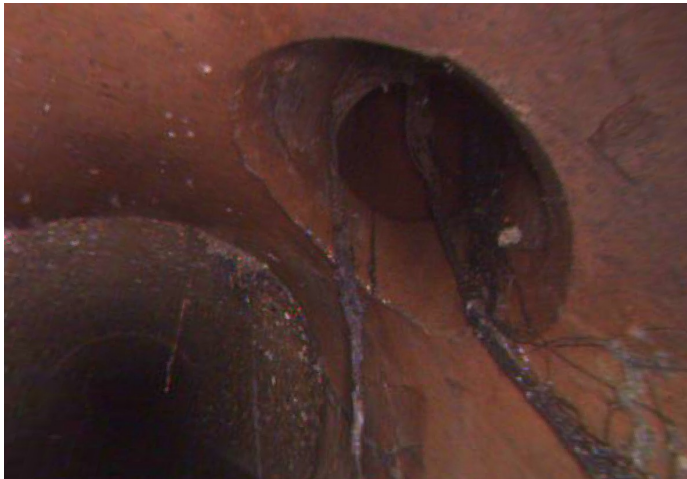
Code: **RFL**
Description: **Roots Fine Lateral**

Distance (ft): **86.4**
Structural Grade: **0**
O&M Grade: **1**
Clock Start/From: **2**
Clock To:
1st Value:
2nd Value:
Value Percent:
Continuous Index:
Within 8" of Joint: **NO**
Remarks:

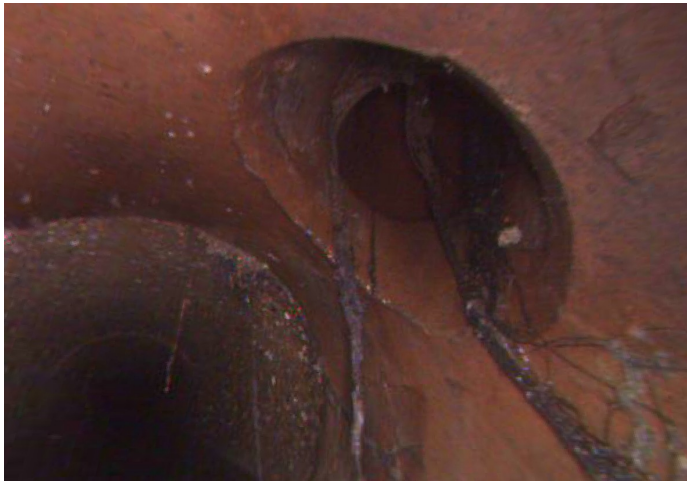
Code:	TFD
Description:	Tap Factory Defective
Distance (ft):	86.4
Structural Grade:	0
O&M Grade:	2
Clock Start/From:	2
Clock To:	
1st Value:	6.000
2nd Value:	
Value Percent:	
Continuous Index:	
Within 8" of Joint:	
Remarks:	RFL

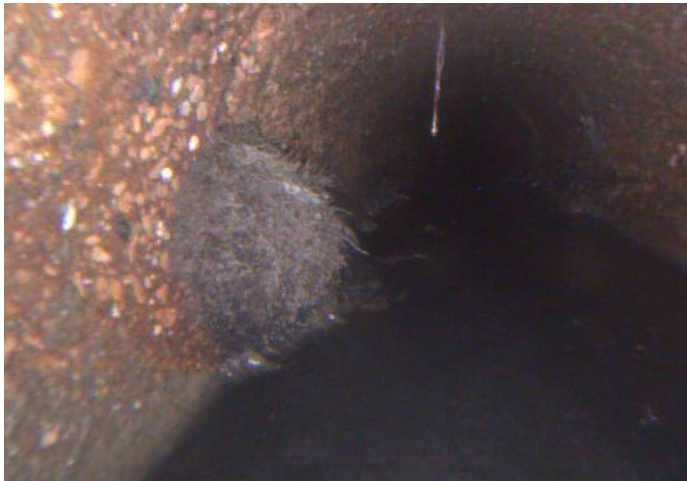
Code:	RFJ
Description:	Roots Fine Joint
Distance (ft):	123.7
Structural Grade:	0
O&M Grade:	1
Clock Start/From:	9
Clock To:	
1st Value:	
2nd Value:	
Value Percent:	
Continuous Index:	
Within 8" of Joint:	YES
Remarks:

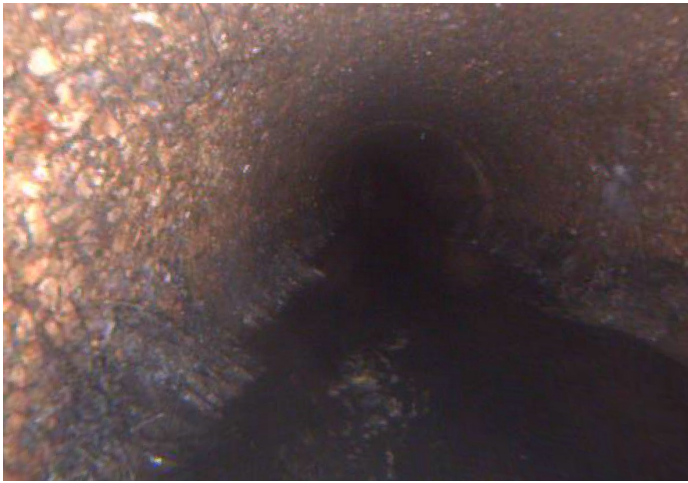
Code:	MSA
Description:	Abandoned Survey
Distance (ft):	124.8
Structural Grade:	0
O&M Grade:	0
Clock Start/From:	
Clock To:	
1st Value:	
2nd Value:	
Value Percent:	
Continuous Index:	
Within 8" of Joint:	NO
Remarks:	RFJ
