RedZone
ROBOTICS

Street:	42nd Avenue	Flow Control:	Not Controlled
City:	Hobart, IN	Year Renewed:	
Location:	Alley	Tape/Media #:	
Purpose:	Routine Assessment	Dia/Height:	12"
Use:	Sanitary Sewage Pipe	Material:	CP
Drain Area:		Lining:	
Category:	NA		
Comment:			
Location Details:		Direction of Survey:	Downstream
US MH:	M-504-105	DS MH:	M-504-106
		Total Length Surveyed (ft):	160.3

Wednesday, October 13, 2021

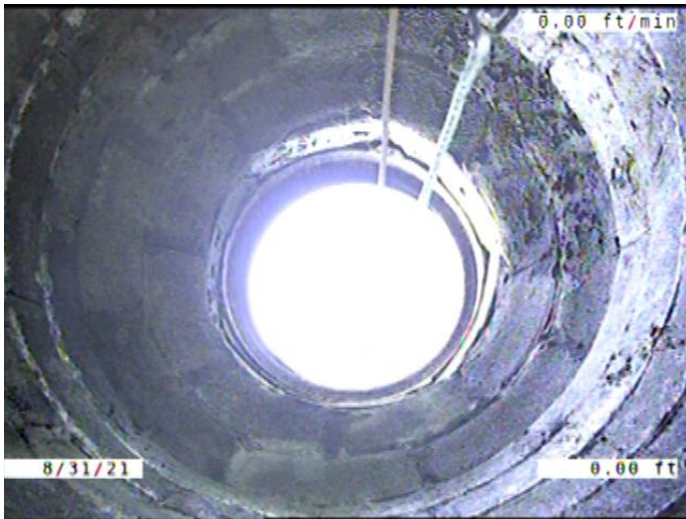
Code: **AMH**
Description: **Manhole**

Distance (ft): **.0**
Structural Grade: **0**
O&M Grade: **0**
Clock Start/From:
Clock To:
1st Value:
2nd Value:
Value Percent:
Continuous Index:
Within 8" of Joint: **NO**
Remarks: **M-504-105**

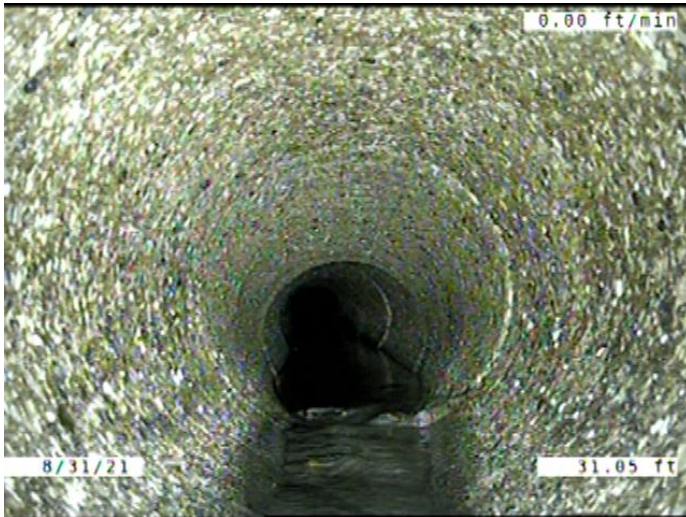
Code: **MWLS**
 Description: **Miscellaneous Water Level Sag**

Distance (ft): **31.1**
 Structural Grade: **2**
 O&M Grade: **0**
 Clock Start/From:
 Clock To:
 1st Value:
 2nd Value:
 Value Percent: **5.000**
 Continuous Index: **F02**
 Within 8" of Joint: **NO**
 Remarks:

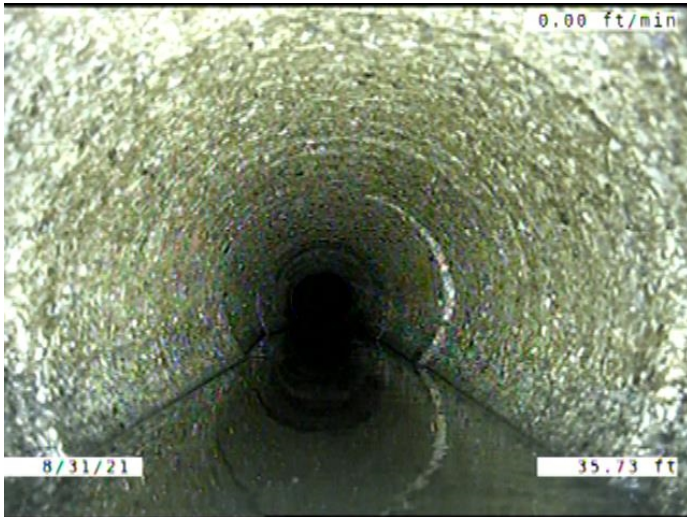
Code: **MWLS**
 Description: **Miscellaneous Water Level Sag**

Distance (ft): **35.7**
 Structural Grade: **2**
 O&M Grade: **0**
 Clock Start/From:
 Clock To:
 1st Value:
 2nd Value:
 Value Percent: **10.000**
 Continuous Index: **S03**
 Within 8" of Joint: **NO**
 Remarks:

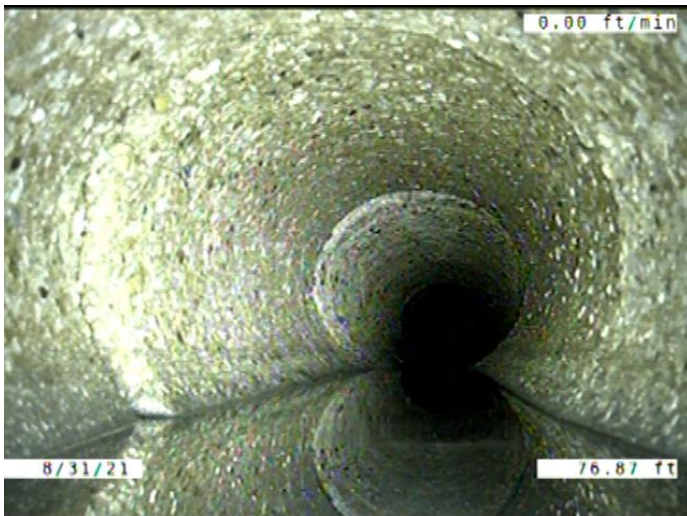
Code: **LR**
 Description: **Line Right**

Distance (ft): **76.9**
 Structural Grade: **0**
 O&M Grade: **1**
 Clock Start/From:
 Clock To:
 1st Value:
 2nd Value:
 Value Percent: **5.000**
 Continuous Index:
 Within 8" of Joint: **NO**
 Remarks:

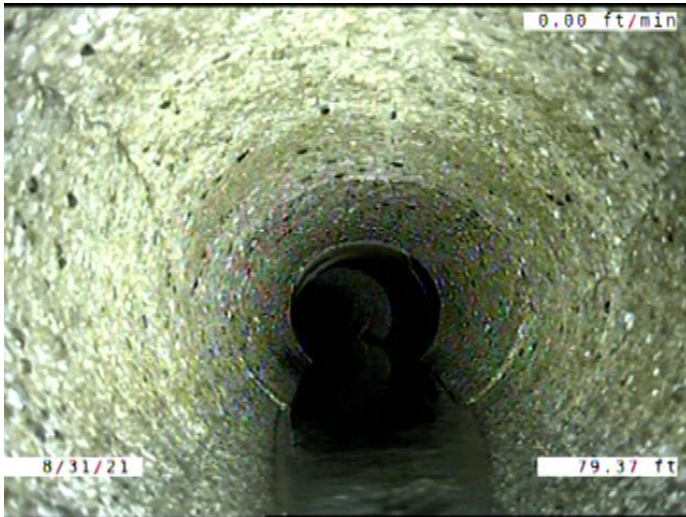
Code: **MWLS**
 Description: **Miscellaneous Water Level Sag**

Distance (ft): **79.4**
 Structural Grade: **2**
 O&M Grade: **0**
 Clock Start/From:
 Clock To:
 1st Value:
 2nd Value:
 Value Percent: **5.000**
 Continuous Index: **F05**
 Within 8" of Joint: **NO**
 Remarks:
