## Profile/Photo Observation Report

Street:	<b>N DELAWARE ST</b>	Flow Control:	<b>Not Controlled</b>
City:	<b>Hobart, IN</b>	Year Renewed:	
Location:	<b>Light Highway</b>	Tape/Media #:	
Purpose:	<b>Not Known</b>	Dia/Height:	<b>12"</b>
Use:	<b>Sanitary</b>	Material:	<b>CP</b>
Drain Area:	<b>NA</b>	Lining:	
Category:	<b>NA</b>		
Comment:

Location Details:		Direction of Survey:	<b>Downstream</b>
US MH:	<b>M-504-106</b>	DS MH:	<b>M-504-108</b>
		Total Length Surveyed (ft):	<b>11.7</b>

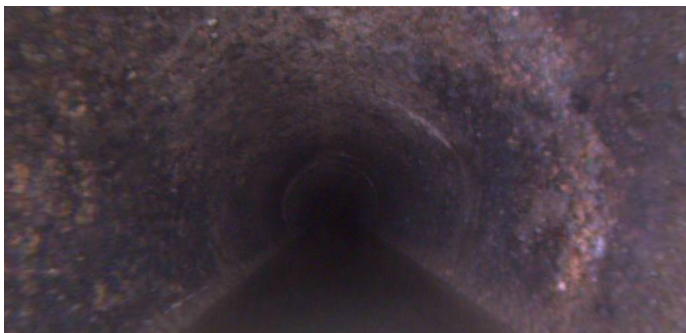
Code: **SAP**  
Description: **Surface Aggregate Projecting**

Distance (ft): **.0**  
Structural Grade: **3**  
O&M Grade: **0**  
Clock Start/From: **8**  
Clock To: **4**  
1st Value:  
2nd Value:  
Value Percent:  
Continuous Index: **S01**  
Within 8" of Joint:  
Remarks:

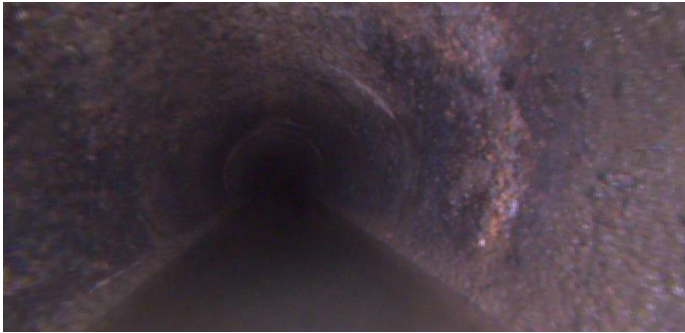
Code:	<b>AMH</b>
Description:	<b>Manhole</b>

Distance (ft):	<b>.0</b>
Structural Grade:	<b>0</b>
O&M Grade:	<b>0</b>
Clock Start/From:	
Clock To:	
1st Value:	
2nd Value:	
Value Percent:	
Continuous Index:	
Within 8" of Joint:	<b>NO</b>
Remarks:	<b>M-504-106</b>

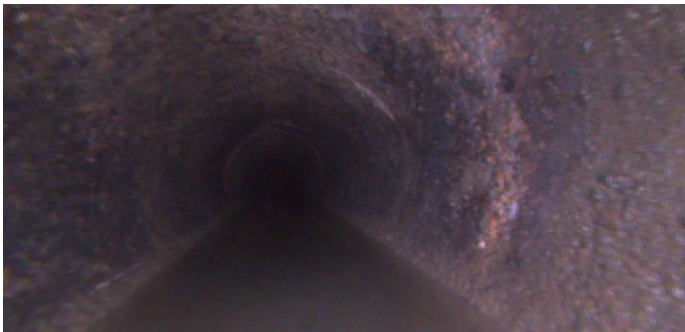
Code:	<b>MWL</b>
Description:	<b>Water Level</b>

Distance (ft):	<b>.0</b>
Structural Grade:	<b>0</b>
O&M Grade:	<b>0</b>
Clock Start/From:	
Clock To:	
1st Value:	
2nd Value:	
Value Percent:	<b>5.000</b>
Continuous Index:	
Within 8" of Joint:	<b>NO</b>
Remarks:

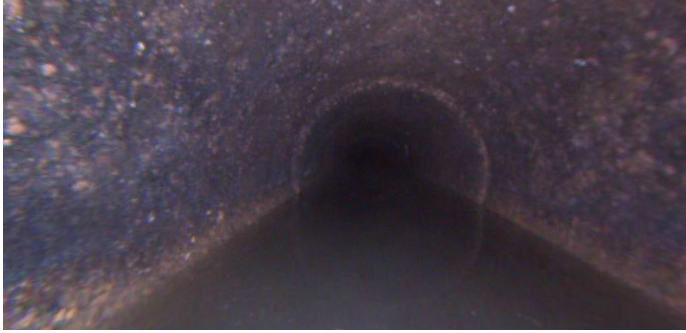
Code: **SAP**  
Description: **Surface Aggregate Projecting**

Distance (ft): **11.7**  
Structural Grade: **3**  
O&M Grade: **0**  
Clock Start/From: **8**  
Clock To: **4**  
1st Value:  
2nd Value:  
Value Percent:  
Continuous Index: **F01**  
Within 8" of Joint:  
Remarks:

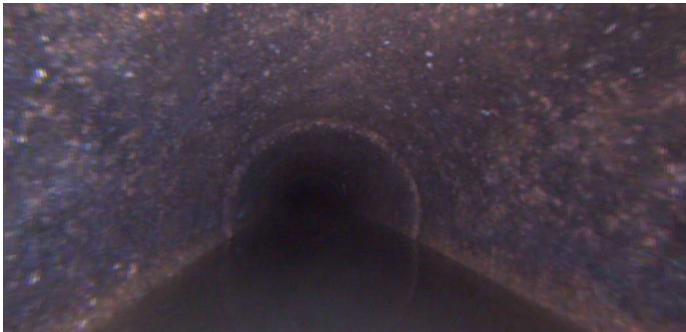
Code: **MSA**  
Description: **Abandoned Survey**

Distance (ft): **11.7**  
Structural Grade: **0**  
O&M Grade: **0**  
Clock Start/From:  
Clock To:  
1st Value:  
2nd Value:  
Value Percent:  
Continuous Index:  
Within 8" of Joint: **NO**  
Remarks: **no blockage**
