Profile/Photo Observation Report

Location Details:		Direction of Survey:	Downstream
US MH:	M-504-106	DS MH:	M-504-108
		Total Length Surveyed (ft):	11.7

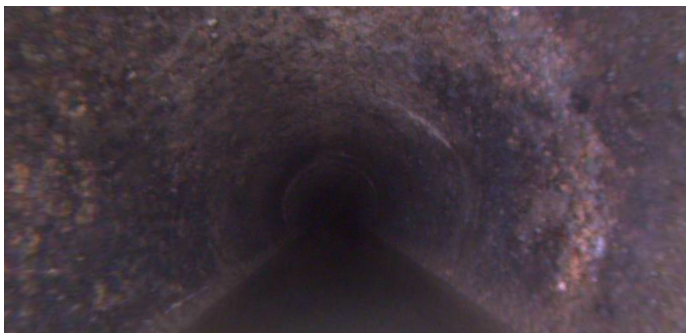
Code: **SAP**
Description: **Surface Aggregate Projecting**

Distance (ft): **.0**
Structural Grade: **3**
O&M Grade: **0**
Clock Start/From: **8**
Clock To: **4**
1st Value:
2nd Value:
Value Percent:
Continuous Index: **S01**
Within 8" of Joint:
Remarks:

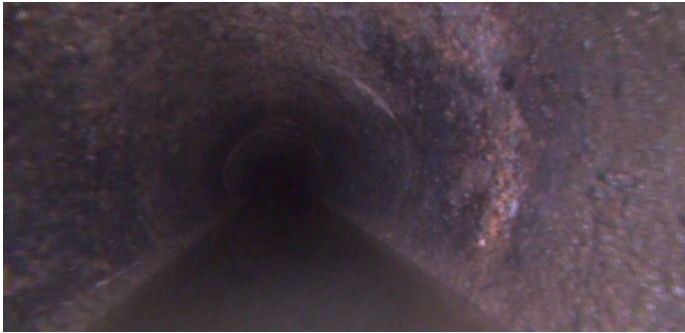
Code:	AMH
Description:	Manhole

Distance (ft):	.0
Structural Grade:	0
O&M Grade:	0
Clock Start/From:	
Clock To:	
1st Value:	
2nd Value:	
Value Percent:	
Continuous Index:	
Within 8" of Joint:	NO
Remarks:	M-504-106

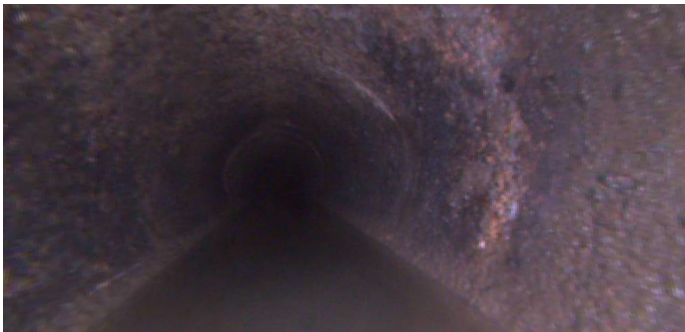
Code:	MWL
Description:	Water Level

Distance (ft):	.0
Structural Grade:	0
O&M Grade:	0
Clock Start/From:	
Clock To:	
1st Value:	
2nd Value:	
Value Percent:	5.000
Continuous Index:	
Within 8" of Joint:	NO
Remarks:

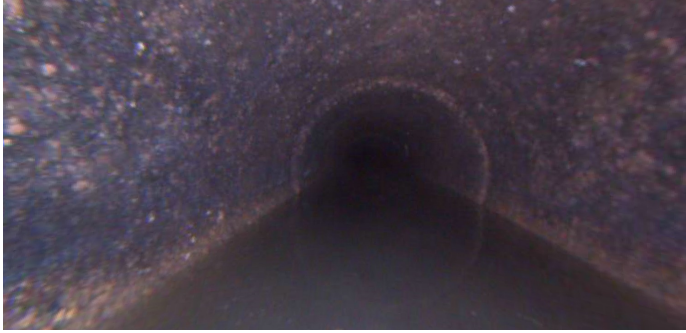
Code: **SAP**
Description: **Surface Aggregate Projecting**

Distance (ft): **11.7**
Structural Grade: **3**
O&M Grade: **0**
Clock Start/From: **8**
Clock To: **4**
1st Value:
2nd Value:
Value Percent:
Continuous Index: **F01**
Within 8" of Joint:
Remarks:

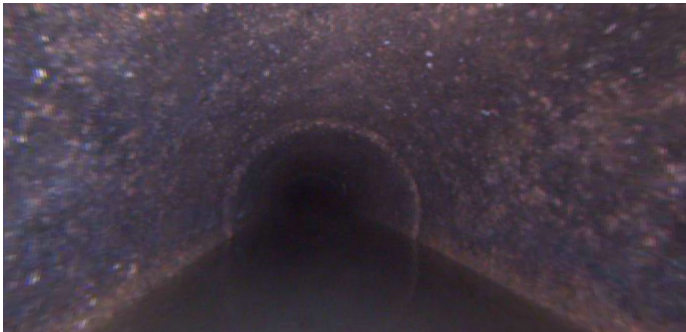
Code: **MSA**
Description: **Abandoned Survey**

Distance (ft): **11.7**
Structural Grade: **0**
O&M Grade: **0**
Clock Start/From:
Clock To:
1st Value:
2nd Value:
Value Percent:
Continuous Index:
Within 8" of Joint: **NO**
Remarks: **no blockage**
