Profile/Photo Observation Report

Date:	09/01/2021	Weather:		Coding:	PACP 7.0
Pipe Length (ft):	217.0	Owner:	City of Hobart	Pre Clean:	Heavy Cleaning
P.O.#:	YES502259	Surveyor:	S. Bucklin	PSR:	P-504-108-106
Customer:	City of Hobart	Clean Date:	08/28/2021	Shape:	C

Street:	North Virginia Street	Flow Control:	Not Controlled
City:	Hobart, IN	Year Renewed:	
Location:	Alley	Tape/Media #:	
Purpose:	Routine Assessment	Dia/Height:	12"
Use:	Sanitary Sewage Pipe	Material:	CP
Drain Area:		Lining:

US MH: **M-504-106** DS MH: **M-504-108** Total Length Surveyed (ft): **16.7**

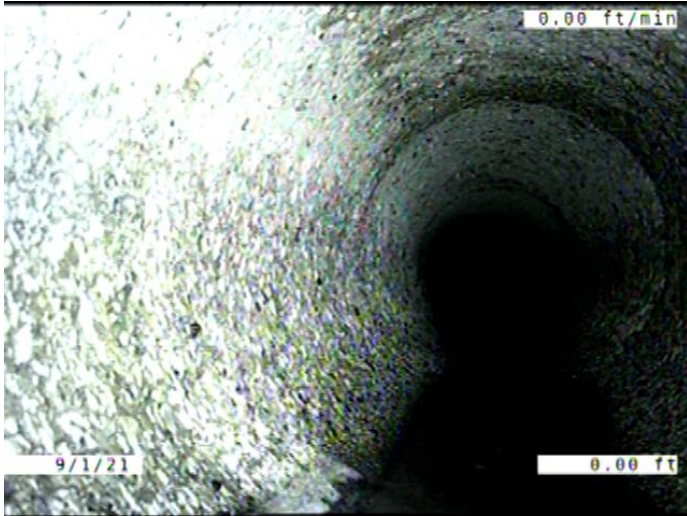
Code: **MWL**
Description: **Miscellaneous Water Level**

Distance (ft): **.0**
Structural Grade: **0**
O&M Grade: **0**
Clock Start/From:
Clock To:
1st Value:
2nd Value:
Value Percent: **5.000**
Continuous Index:
Within 8" of Joint: **NO**
Remarks:

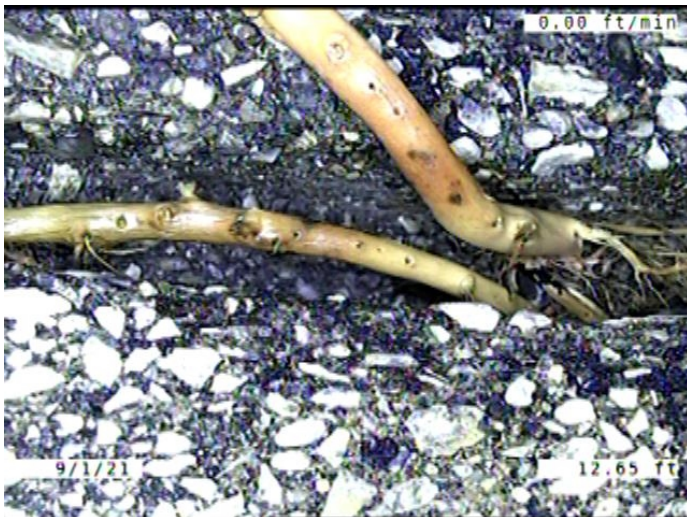
Code: **RFJ**
Description: **Roots Fine Joint**

Distance (ft): **12.6**
Structural Grade: **0**
O&M Grade: **1**
Clock Start/From: **3**
Clock To:
1st Value:
2nd Value:
Value Percent:
Continuous Index:
Within 8" of Joint: **YES**
Remarks:

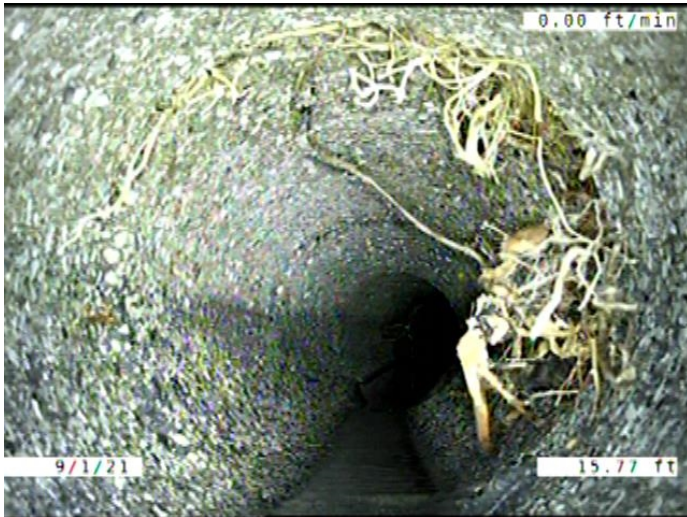
Code: **RMJ**
 Description: **Roots Medium Joint**

Distance (ft): **15.8**
 Structural Grade: **0**
 O&M Grade: **3**
 Clock Start/From: **9**
 Clock To: **4**
 1st Value:
 2nd Value:
 Value Percent: **5.000**
 Continuous Index:
 Within 8" of Joint: **YES**
 Remarks:

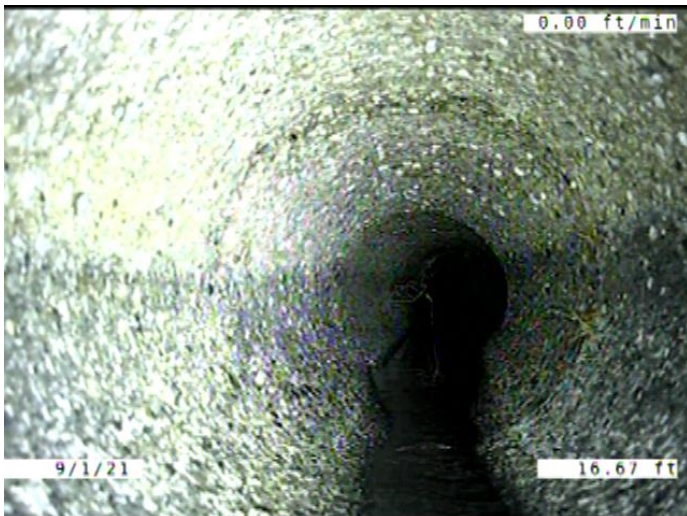
Code: **MSA**
 Description: **Miscellaneous Survey Abandoned**

Distance (ft): **16.7**
 Structural Grade: **0**
 O&M Grade: **0**
 Clock Start/From:
 Clock To:
 1st Value:
 2nd Value:
 Value Percent:
 Continuous Index:
 Within 8" of Joint: **NO**
 Remarks: **MADE IT TO THE POINT OF OVERLAP.
 REVERSAL COMPLETE.**
