## Profile/Photo Observation Report

Date:	<b>09/01/2021</b>	Weather:		Coding:	<b>PACP 7.0</b>
Pipe Length (ft):	<b>217.0</b>	Owner:	<b>City of Hobart</b>	Pre Clean:	<b>Heavy Cleaning</b>
P.O.#:	<b>YES502259</b>	Surveyor:	<b>S. Bucklin</b>	PSR:	<b>P-504-108-106</b>
Customer:	<b>City of Hobart</b>	Clean Date:	<b>08/28/2021</b>	Shape:	<b>C</b>

US MH: **M-504-106** DS MH: **M-504-108** Total Length Surveyed (ft): **16.7**

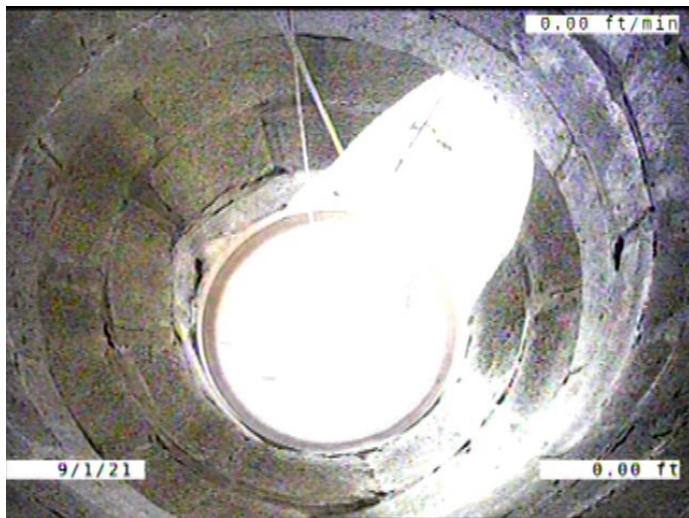
Code: **AMH**  
Description: **Manhole**

Distance (ft): **.0**  
Structural Grade: **0**  
O&M Grade: **0**  
Clock Start/From:  
Clock To:  
1st Value:  
2nd Value:  
Value Percent:  
Continuous Index:  
Within 8" of Joint: **NO**  
Remarks: **M-504-106**

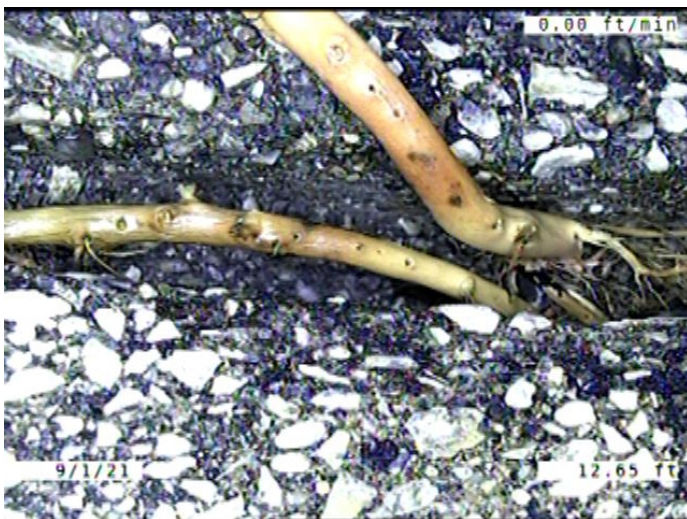
Code: **RFJ**  
Description: **Roots Fine Joint**

Distance (ft): **12.6**  
Structural Grade: **0**  
O&M Grade: **1**  
Clock Start/From: **3**  
Clock To:  
1st Value:  
2nd Value:  
Value Percent:  
Continuous Index:  
Within 8" of Joint: **YES**  
Remarks:
