RedZone
ROBOTICS

Street:	41st Avenue	Flow Control:	Not Controlled
City:	Hobart, IN	Year Renewed:	
Location:	Alley	Tape/Media #:	
Purpose:	Routine Assessment	Dia/Height:	10"
Use:	Sanitary Sewage Pipe	Material:	CP
Drain Area:		Lining:	None
Category:	NA		
Comment:			
Location Details:		Direction of Survey:	Upstream
US MH:	M-504-110	DS MH:	M-504-110.1
			Total Length Surveyed (ft)

O&M Index:	1.94	O&M Quick:	4134	O&M Rating:	122.00
Structural Index:	2.69	Structural Quick:	4333	Structural Rating:	35.00
Overall Index:	2.07	Overall Quick:	4437	Overall Rating:	157.00

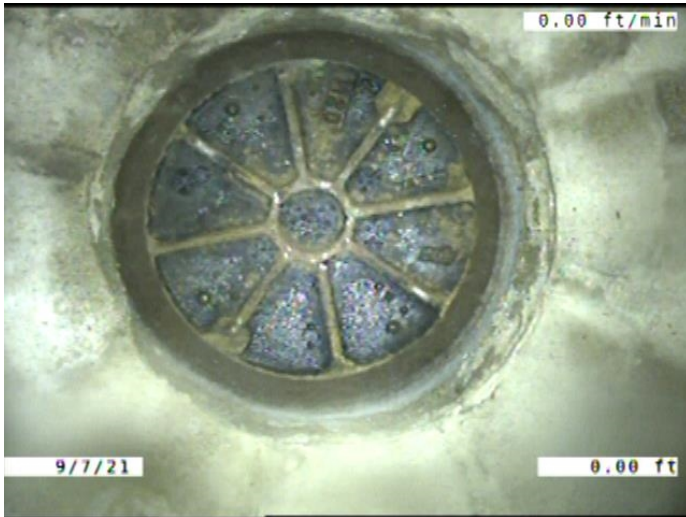
Code: **AMH**
Description: **Manhole**

Distance (ft): **.0**
Structural Grade: **0**
O&M Grade: **0**
Clock Start/From:
Clock To:
1st Value:
2nd Value:
Value Percent:
Continuous Index:
Within 8" of Joint: **NO**
Remarks: **M-504-110.1**

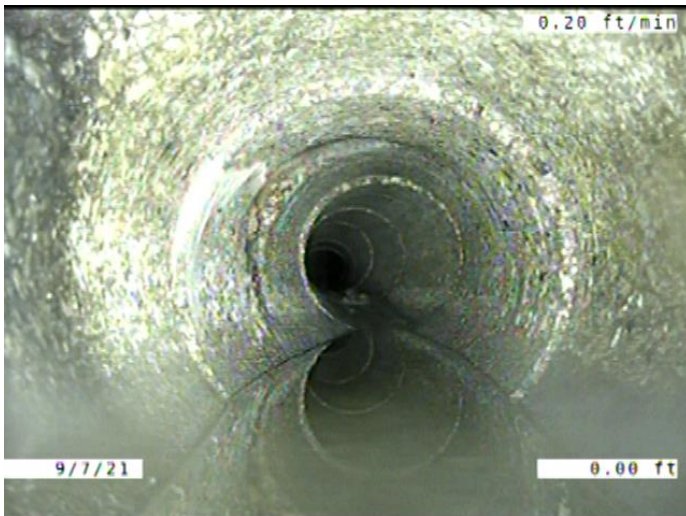
Code: **MWL**
Description: **Miscellaneous Water Level**

Distance (ft): **.0**
Structural Grade: **0**
O&M Grade: **0**
Clock Start/From:
Clock To:
1st Value:
2nd Value:
Value Percent: **5.000**
Continuous Index:
Within 8" of Joint: **NO**
Remarks:

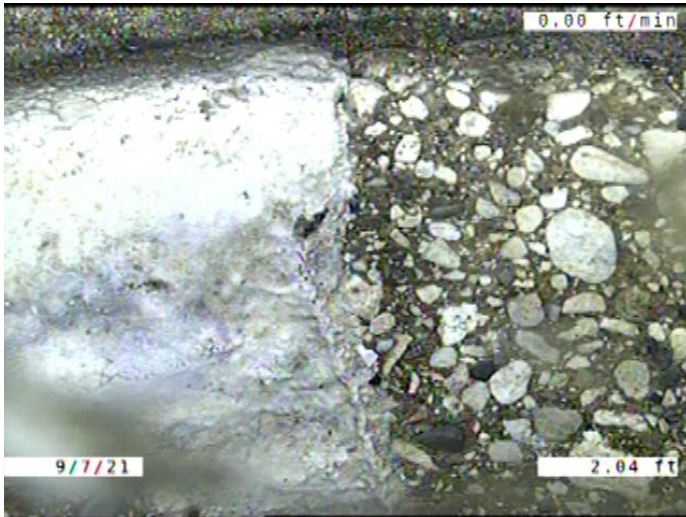
Code: **CM**
 Description: **Crack Multiple**

Distance (ft): **2.0**
 Structural Grade: **3**
 O&M Grade: **0**
 Clock Start/From: **10**
 Clock To: **12**
 1st Value:
 2nd Value:
 Value Percent:
 Continuous Index:
 Within 8" of Joint: **YES**
 Remarks:

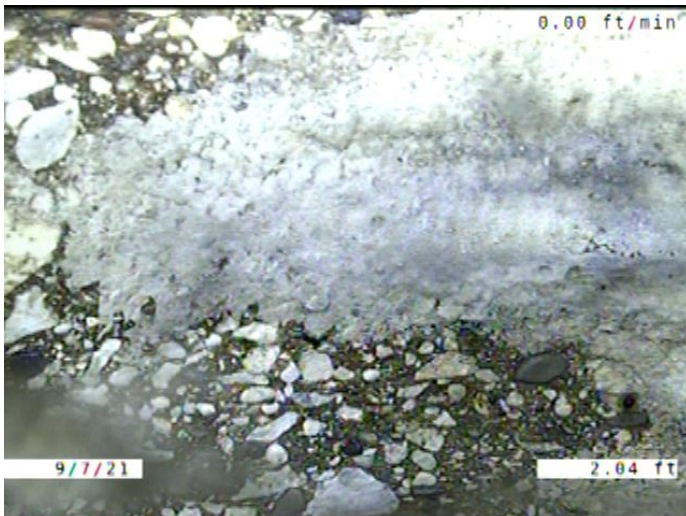
Code: **DAE**
 Description: **Deposits Attached Encrustation**

Distance (ft): **2.0**
 Structural Grade: **0**
 O&M Grade: **2**
 Clock Start/From: **9**
 Clock To: **11**
 1st Value:
 2nd Value:
 Value Percent: **5.000**
 Continuous Index:
 Within 8" of Joint: **YES**
 Remarks:

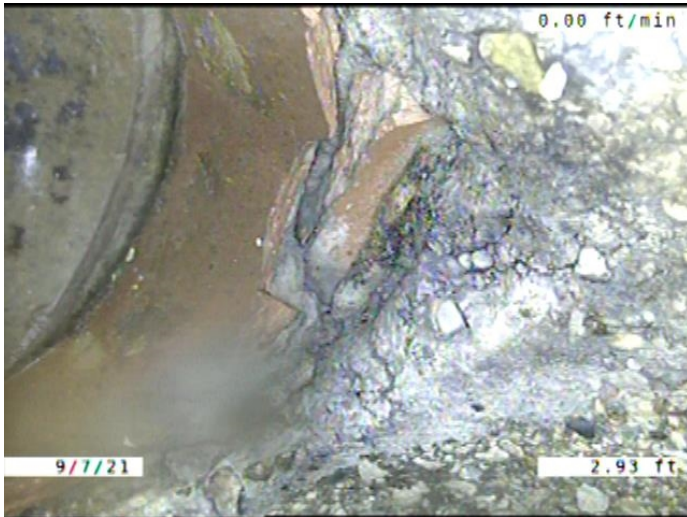
Code: **FM**
 Description: **Fracture Multiple**

Distance (ft): **2.9**
 Structural Grade: **4**
 O&M Grade: **0**
 Clock Start/From: **12**
 Clock To: **12**
 1st Value:
 2nd Value:
 Value Percent:
 Continuous Index:
 Within 8" of Joint: **YES**
 Remarks:

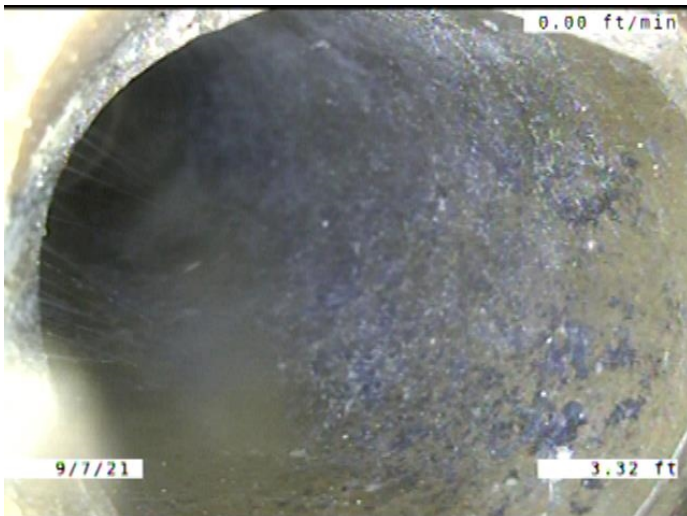
Code: **TB**
 Description: **Tap Break-in/Hammer**

Distance (ft): **3.3**
 Structural Grade: **0**
 O&M Grade: **0**
 Clock Start/From: **11**
 Clock To:
 1st Value: **4.000**
 2nd Value:
 Value Percent:
 Continuous Index:
 Within 8" of Joint: **NO**
 Remarks:

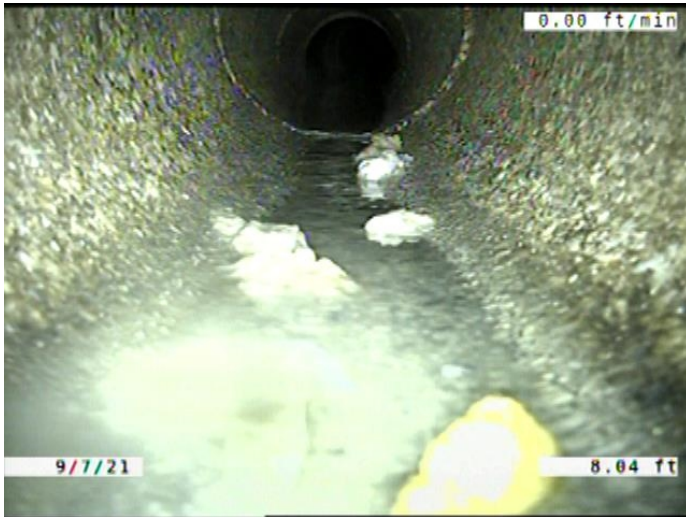
Code: **DSF**
 Description: **Deposits Settled Fine**

Distance (ft): **8.0**
 Structural Grade: **0**
 O&M Grade: **2**
 Clock Start/From: **5**
 Clock To: **7**
 1st Value:
 2nd Value:
 Value Percent: **5.000**
 Continuous Index: **S01**
 Within 8" of Joint: **YES**
 Remarks:

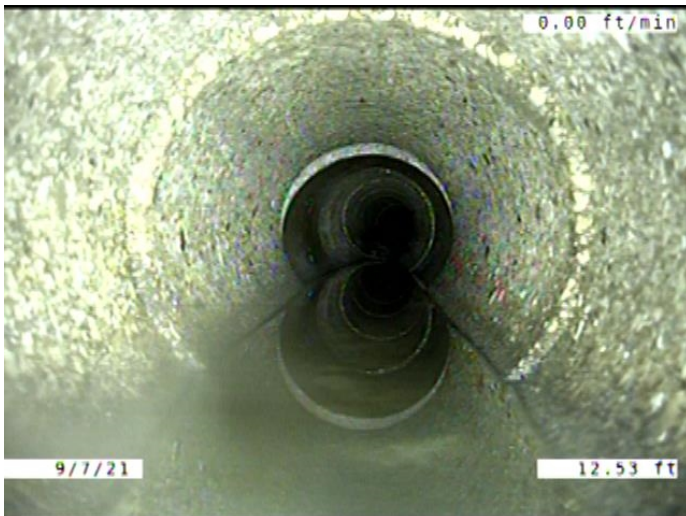
Code: **MWLS**
 Description: **Miscellaneous Water Level Sag**

Distance (ft): **12.5**
 Structural Grade: **2**
 O&M Grade: **0**
 Clock Start/From:
 Clock To:
 1st Value:
 2nd Value:
 Value Percent: **5.000**
 Continuous Index: **S02**
 Within 8" of Joint: **NO**
 Remarks:

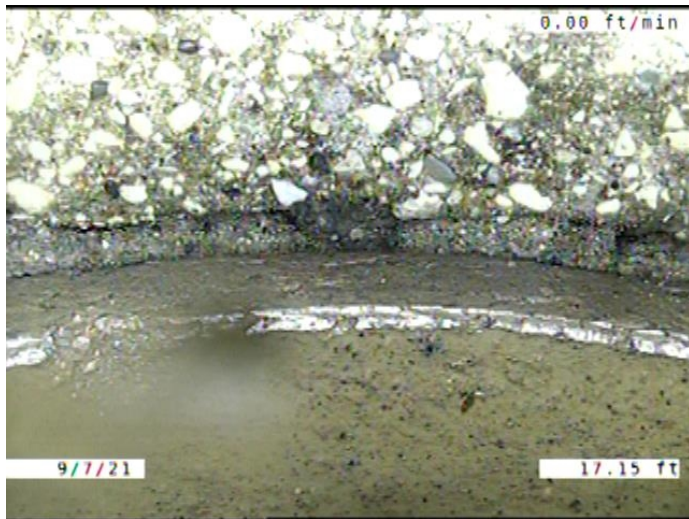
Code: **MMC**
 Description: **Miscellaneous Material Change**

Distance (ft): **17.1**
 Structural Grade: **0**
 O&M Grade: **0**
 Clock Start/From:
 Clock To:
 1st Value:
 2nd Value:
 Value Percent:
 Continuous Index:
 Within 8" of Joint: **NO**
 Remarks: **CONCRETE TO VCP**

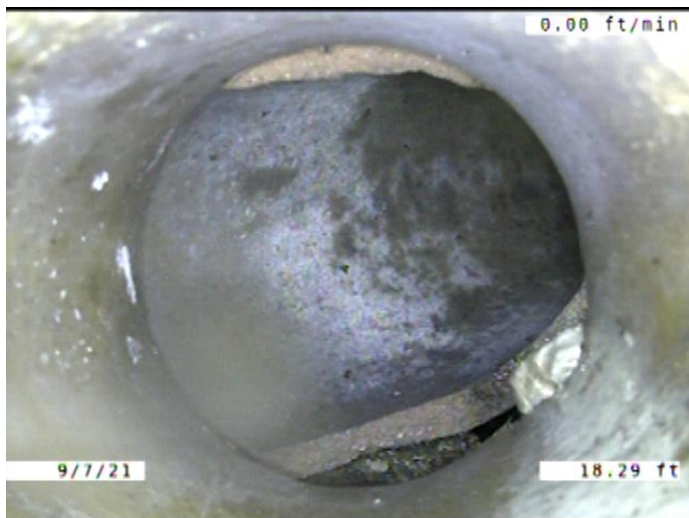
Code: **TFD**
 Description: **Tap Factory Defective**

Distance (ft): **18.3**
 Structural Grade: **0**
 O&M Grade: **3**
 Clock Start/From: **1**
 Clock To:
 1st Value: **4.000**
 2nd Value:
 Value Percent:
 Continuous Index:
 Within 8" of Joint: **YES**
 Remarks: **Defective**

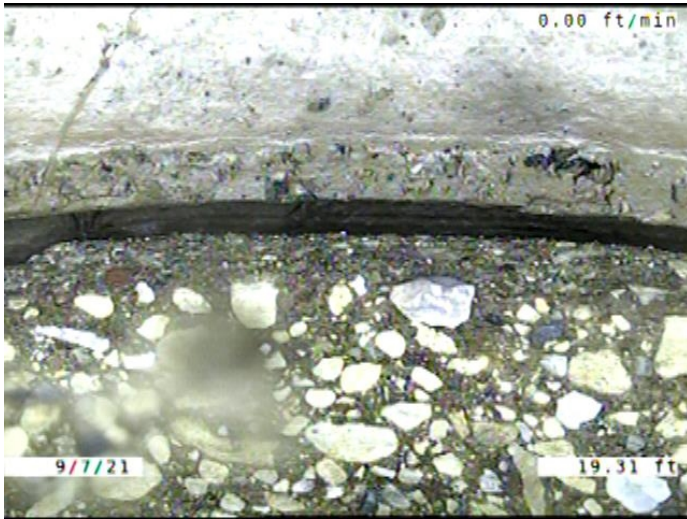
Code: **MMC**
 Description: **Miscellaneous Material Change**

Distance (ft): **19.3**
 Structural Grade: **0**
 O&M Grade: **0**
 Clock Start/From:
 Clock To:
 1st Value:
 2nd Value:
 Value Percent:
 Continuous Index:
 Within 8" of Joint: **NO**
 Remarks: **VCP TO CONCRETE**

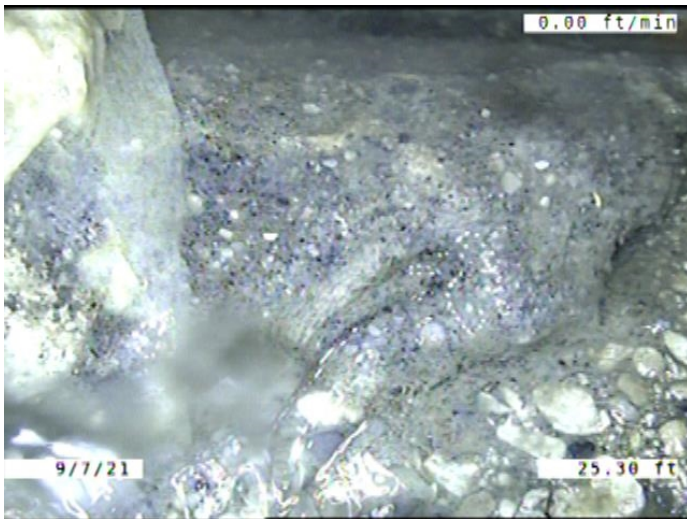
Code: **DAE**
 Description: **Deposits Attached Encrustation**

Distance (ft): **25.3**
 Structural Grade: **0**
 O&M Grade: **2**
 Clock Start/From: **4**
 Clock To: **7**
 1st Value:
 2nd Value:
 Value Percent: **5.000**
 Continuous Index:
 Within 8" of Joint: **YES**
 Remarks:

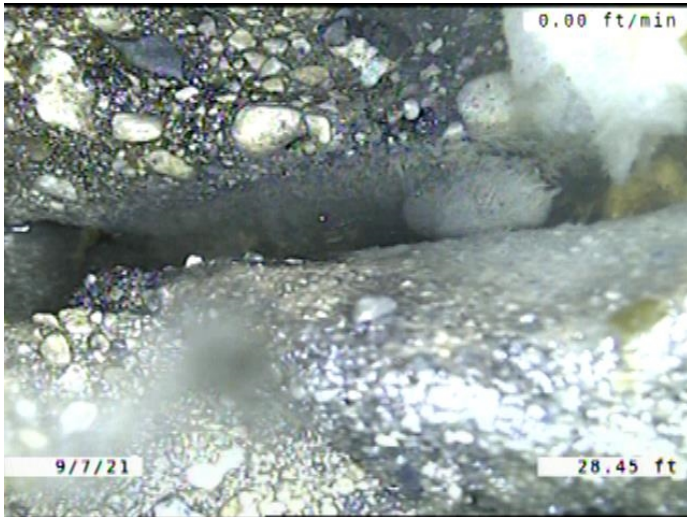
Code: **DAE**
 Description: **Deposits Attached Encrustation**

Distance (ft): **28.4**
 Structural Grade: **0**
 O&M Grade: **2**
 Clock Start/From: **4**
 Clock To: **7**
 1st Value:
 2nd Value:
 Value Percent: **5.000**
 Continuous Index:
 Within 8" of Joint: **YES**
 Remarks:

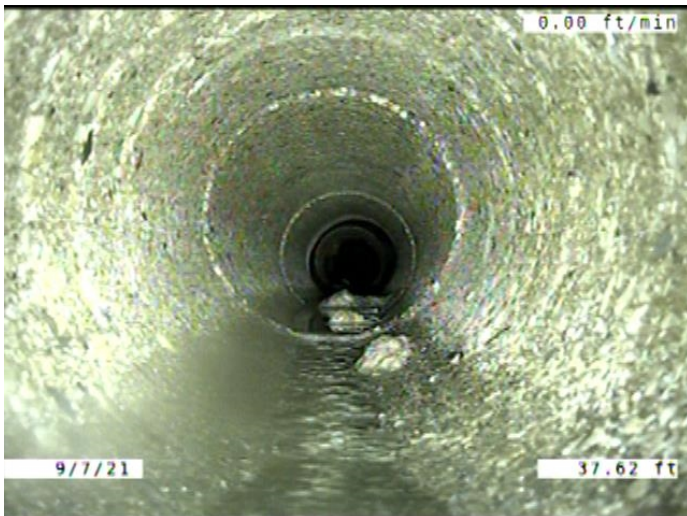
Code: **MWLS**
 Description: **Miscellaneous Water Level Sag**

Distance (ft): **37.6**
 Structural Grade: **2**
 O&M Grade: **0**
 Clock Start/From:
 Clock To:
 1st Value:
 2nd Value:
 Value Percent: **5.000**
 Continuous Index: **F02**
 Within 8" of Joint: **NO**
 Remarks:

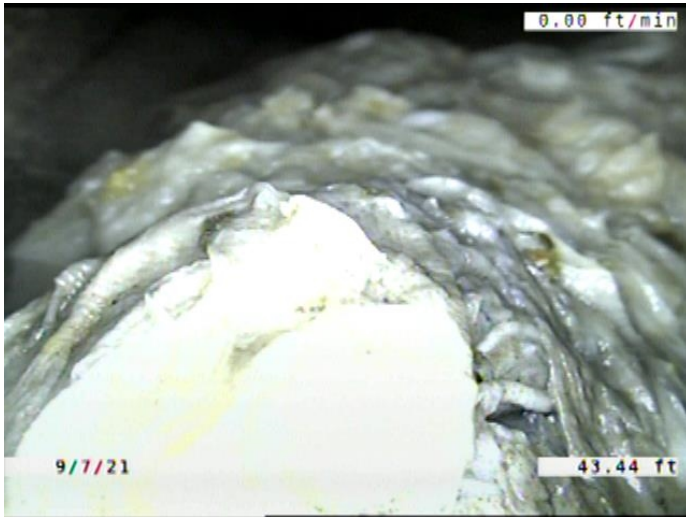
Code: **DAR**
 Description: **Deposits Attached Ragging**

Distance (ft): **43.4**
 Structural Grade: **0**
 O&M Grade: **2**
 Clock Start/From: **5**
 Clock To: **7**
 1st Value:
 2nd Value:
 Value Percent: **5.000**
 Continuous Index:
 Within 8" of Joint: **YES**
 Remarks: **TP AND RAGS**

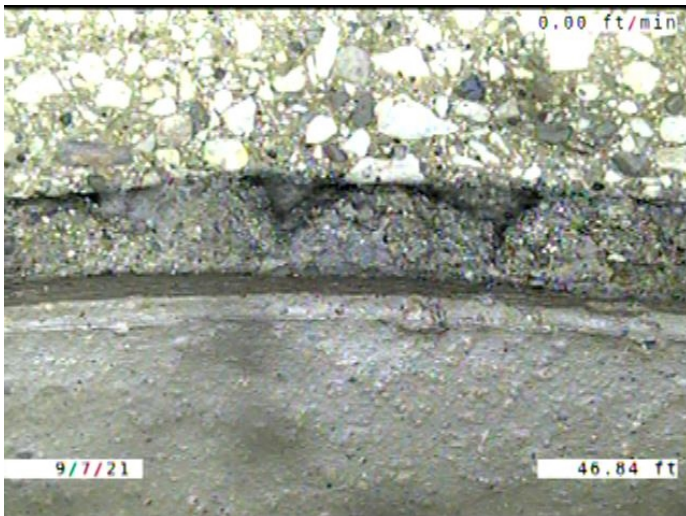
Code: **MMC**
 Description: **Miscellaneous Material Change**

Distance (ft): **46.8**
 Structural Grade: **0**
 O&M Grade: **0**
 Clock Start/From:
 Clock To:
 1st Value:
 2nd Value:
 Value Percent:
 Continuous Index:
 Within 8" of Joint: **NO**
 Remarks: **CONCRETE TO VCP**

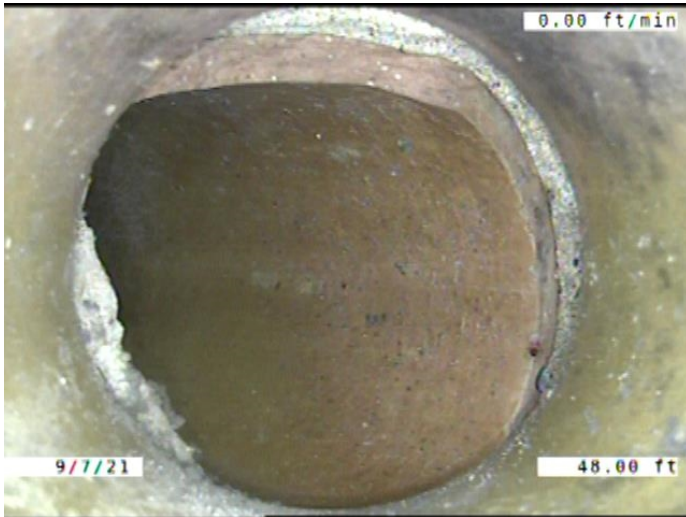
Code: **TF**
 Description: **Tap Factory**

Distance (ft): **48.0**
 Structural Grade: **0**
 O&M Grade: **0**
 Clock Start/From: **11**
 Clock To:
 1st Value: **4.000**
 2nd Value:
 Value Percent:
 Continuous Index:
 Within 8" of Joint: **YES**
 Remarks:

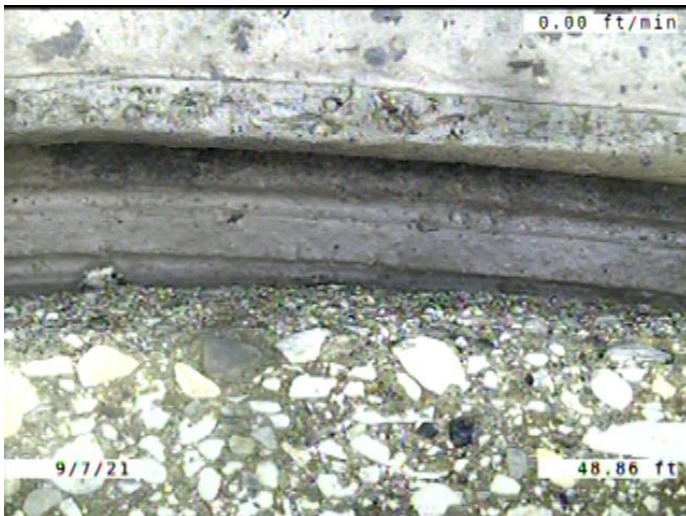
Code: **MMC**
 Description: **Miscellaneous Material Change**

Distance (ft): **48.9**
 Structural Grade: **0**
 O&M Grade: **0**
 Clock Start/From:
 Clock To:
 1st Value:
 2nd Value:
 Value Percent:
 Continuous Index:
 Within 8" of Joint: **NO**
 Remarks: **VCP TO CONCRETE**

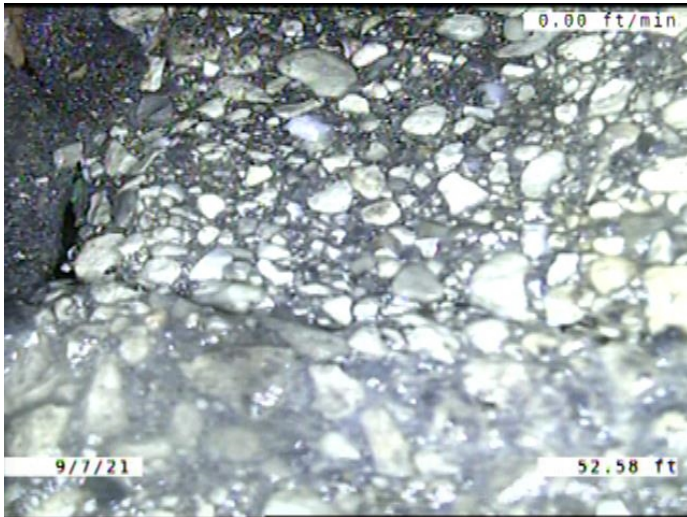
Code: **CM**
 Description: **Crack Multiple**

Distance (ft): **52.6**
 Structural Grade: **3**
 O&M Grade: **0**
 Clock Start/From: **3**
 Clock To: **9**
 1st Value:
 2nd Value:
 Value Percent:
 Continuous Index:
 Within 8" of Joint: **NO**
 Remarks:

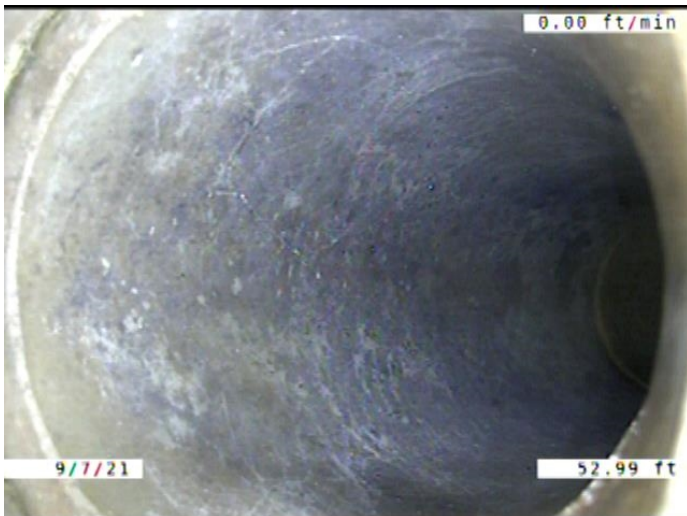
Code: **TBI**
 Description: **Tap Break-in Intruding**

Distance (ft): **53.0**
 Structural Grade: **0**
 O&M Grade: **2**
 Clock Start/From: **10**
 Clock To:
 1st Value: **4.000**
 2nd Value: **2.000**
 Value Percent:
 Continuous Index:
 Within 8" of Joint: **NO**
 Remarks:

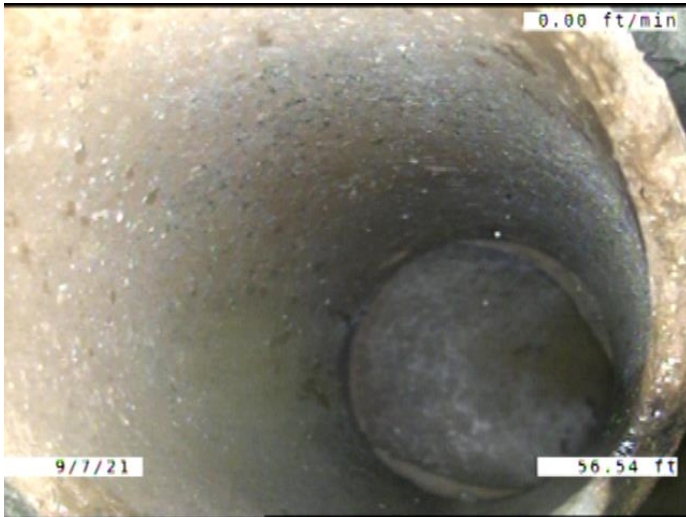
Code: **TBD**
 Description: **Tap Break-in/Hammer Defective**

Distance (ft): **56.5**
 Structural Grade: **0**
 O&M Grade: **3**
 Clock Start/From: **12**
 Clock To:
 1st Value: **4.000**
 2nd Value:
 Value Percent:
 Continuous Index:
 Within 8" of Joint: **YES**
 Remarks: **Defective**

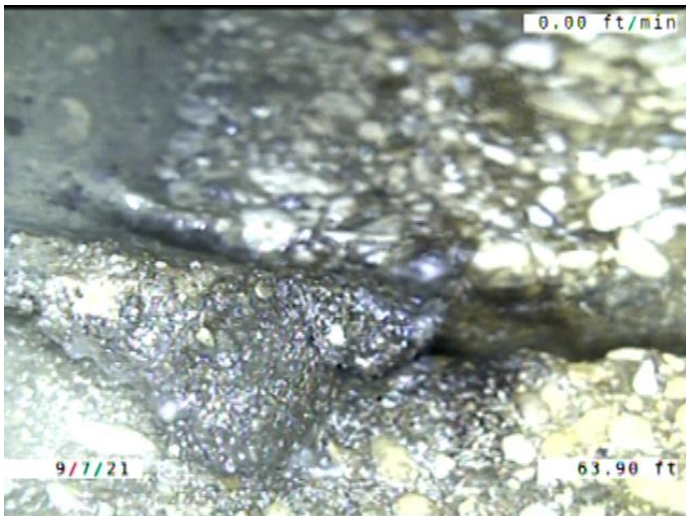
Code: **DAE**
 Description: **Deposits Attached Encrustation**

Distance (ft): **63.9**
 Structural Grade: **0**
 O&M Grade: **2**
 Clock Start/From: **4**
 Clock To: **8**
 1st Value:
 2nd Value:
 Value Percent: **5.000**
 Continuous Index:
 Within 8" of Joint: **YES**
 Remarks:

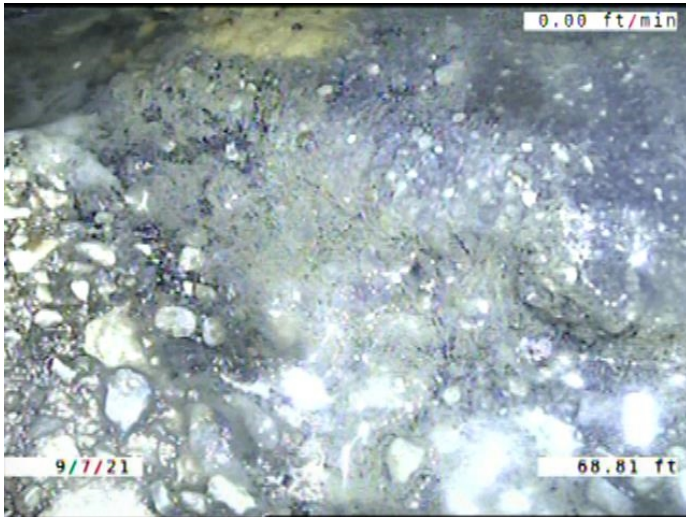
Code: **DAE**
 Description: **Deposits Attached Encrustation**

Distance (ft): **68.8**
 Structural Grade: **0**
 O&M Grade: **2**
 Clock Start/From: **5**
 Clock To: **7**
 1st Value:
 2nd Value:
 Value Percent: **5.000**
 Continuous Index:
 Within 8" of Joint: **YES**
 Remarks:

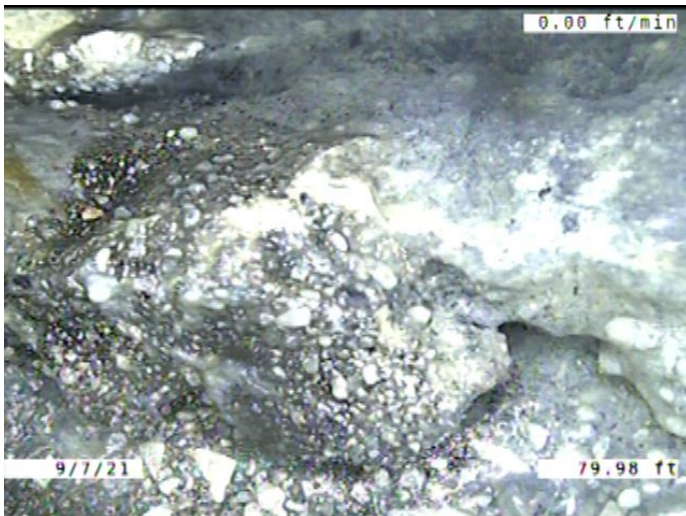
Code: **DAE**
 Description: **Deposits Attached Encrustation**

Distance (ft): **80.0**
 Structural Grade: **0**
 O&M Grade: **2**
 Clock Start/From: **4**
 Clock To: **8**
 1st Value:
 2nd Value:
 Value Percent: **5.000**
 Continuous Index:
 Within 8" of Joint: **YES**
 Remarks:

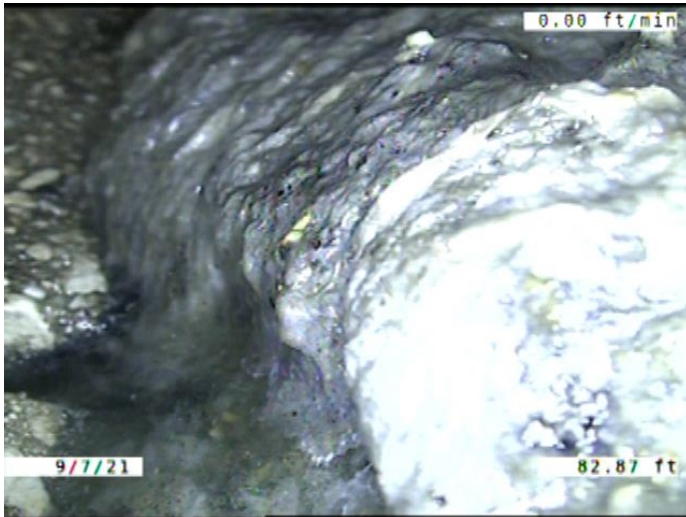
Code: **DAR**
 Description: **Deposits Attached Ragging**

Distance (ft): **82.9**
 Structural Grade: **0**
 O&M Grade: **2**
 Clock Start/From: **6**
 Clock To: **7**
 1st Value:
 2nd Value:
 Value Percent: **5.000**
 Continuous Index:
 Within 8" of Joint: **YES**
 Remarks: **TP AND RAGS**

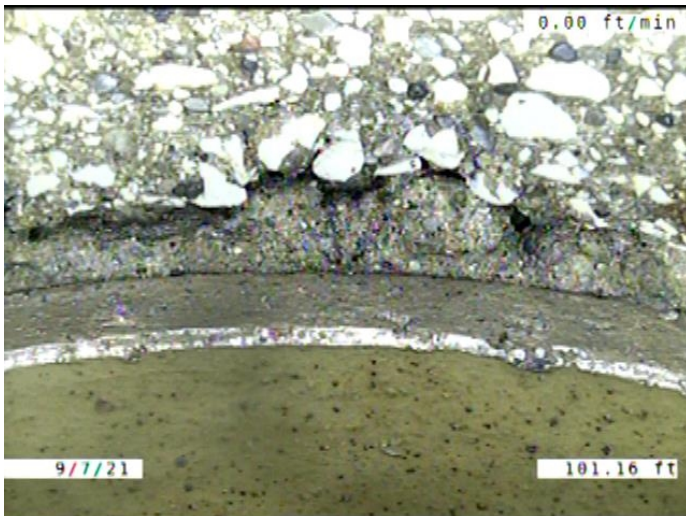
Code: **MMC**
 Description: **Miscellaneous Material Change**

Distance (ft): **101.2**
 Structural Grade: **0**
 O&M Grade: **0**
 Clock Start/From:
 Clock To:
 1st Value:
 2nd Value:
 Value Percent:
 Continuous Index:
 Within 8" of Joint: **NO**
 Remarks: **CONCRETE TO VCP**

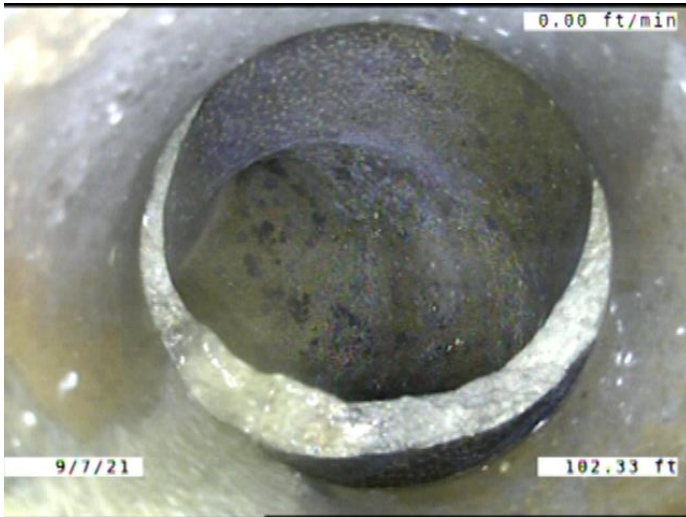
Code: **TF**
Description: **Tap Factory**

Distance (ft): **102.3**
Structural Grade: **0**
O&M Grade: **0**
Clock Start/From: **11**
Clock To:
1st Value: **4.000**
2nd Value:
Value Percent:
Continuous Index:
Within 8" of Joint: **YES**
Remarks:

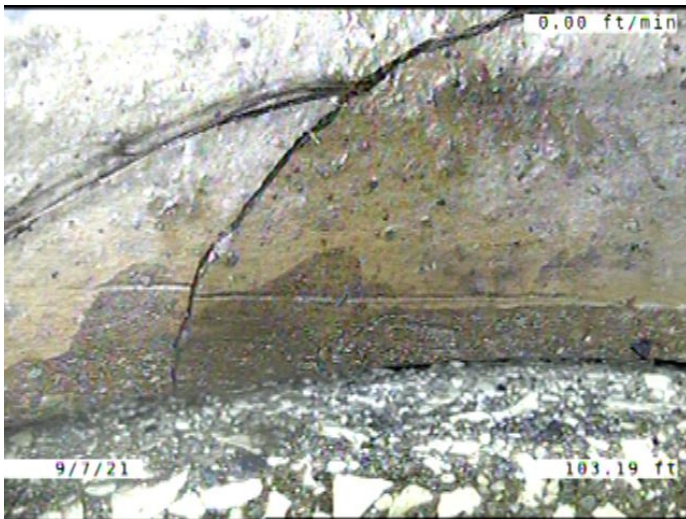
Code: **B**
Description: **Broken**

Distance (ft): **103.2**
Structural Grade: **4**
O&M Grade: **0**
Clock Start/From: **9**
Clock To: **2**
1st Value:
2nd Value:
Value Percent:
Continuous Index:
Within 8" of Joint: **YES**
Remarks:

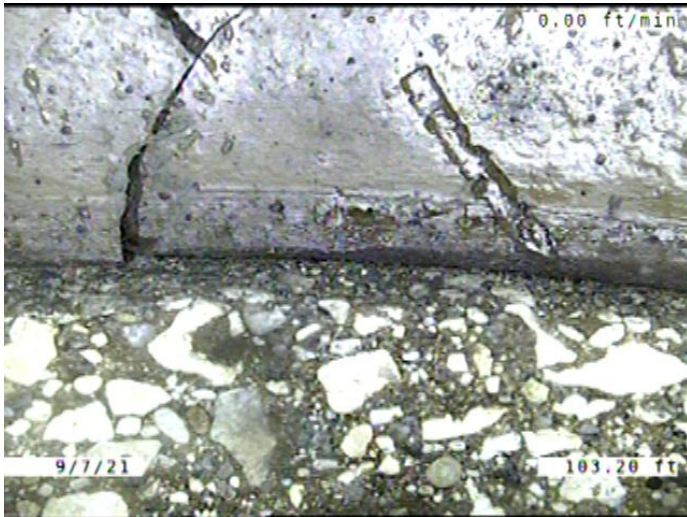
Code: **MMC**
 Description: **Miscellaneous Material Change**

Distance (ft): **103.2**
 Structural Grade: **0**
 O&M Grade: **0**
 Clock Start/From:
 Clock To:
 1st Value:
 2nd Value:
 Value Percent:
 Continuous Index:
 Within 8" of Joint: **NO**
 Remarks: **VCP TO CONCRETE**

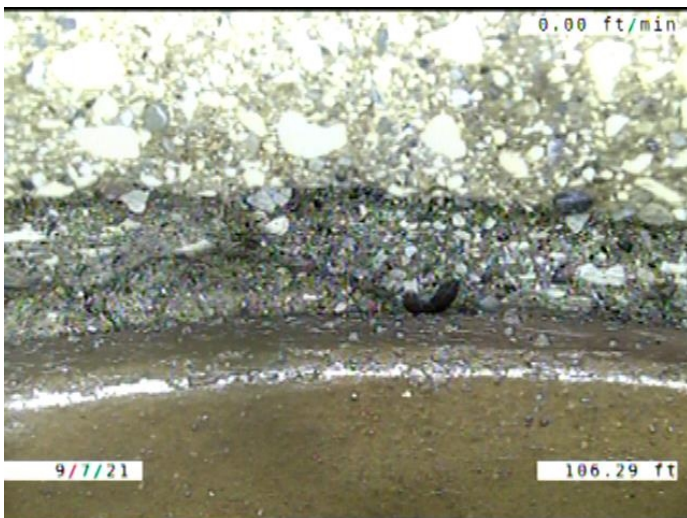
Code: **MMC**
 Description: **Miscellaneous Material Change**

Distance (ft): **106.3**
 Structural Grade: **0**
 O&M Grade: **0**
 Clock Start/From:
 Clock To:
 1st Value:
 2nd Value:
 Value Percent:
 Continuous Index:
 Within 8" of Joint: **NO**
 Remarks: **CONCRETE TO VCP**

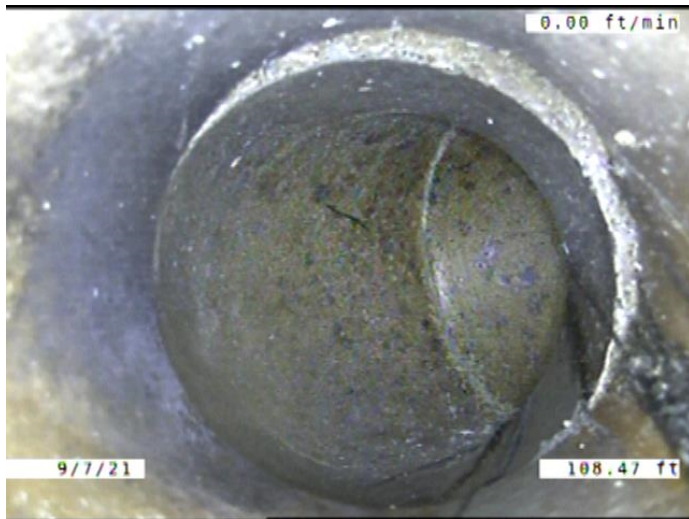
Code: **TF**
 Description: **Tap Factory**

Distance (ft): **108.5**
 Structural Grade: **0**
 O&M Grade: **0**
 Clock Start/From: **12**
 Clock To:
 1st Value: **4.000**
 2nd Value:
 Value Percent:
 Continuous Index:
 Within 8" of Joint: **YES**
 Remarks:

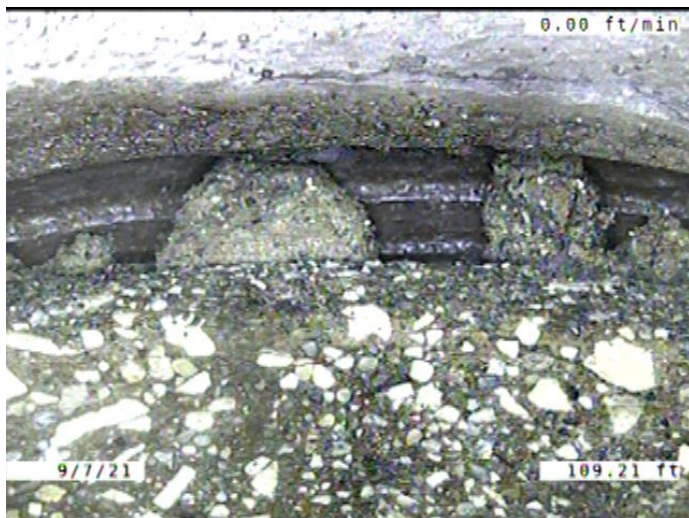
Code: **MMC**
 Description: **Miscellaneous Material Change**

Distance (ft): **109.2**
 Structural Grade: **0**
 O&M Grade: **0**
 Clock Start/From:
 Clock To:
 1st Value:
 2nd Value:
 Value Percent:
 Continuous Index:
 Within 8" of Joint: **NO**
 Remarks: **VCP TO CONCRETE**

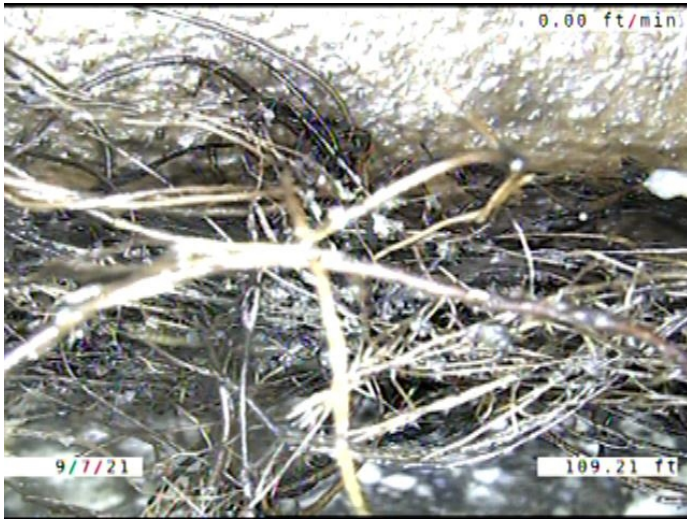
Code: **RMJ**
 Description: **Roots Medium Joint**

Distance (ft): **109.2**
 Structural Grade: **0**
 O&M Grade: **3**
 Clock Start/From: **7**
 Clock To: **4**
 1st Value:
 2nd Value:
 Value Percent: **5.000**
 Continuous Index:
 Within 8" of Joint: **YES**
 Remarks:

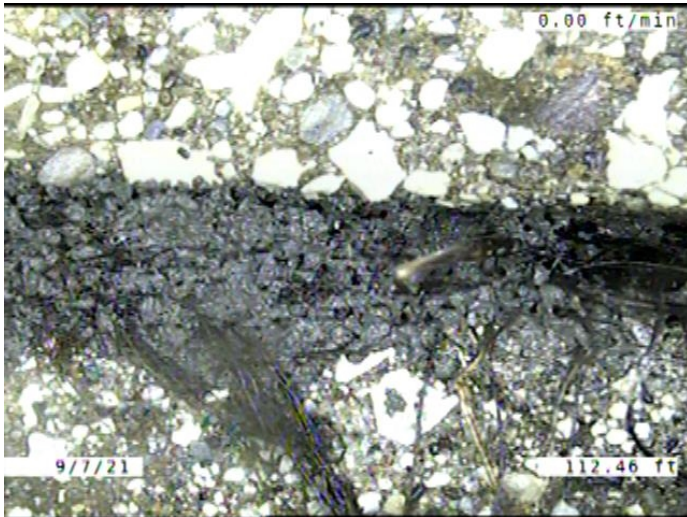
Code: **RFJ**
 Description: **Roots Fine Joint**

Distance (ft): **112.5**
 Structural Grade: **0**
 O&M Grade: **1**
 Clock Start/From: **2**
 Clock To: **9**
 1st Value:
 2nd Value:
 Value Percent:
 Continuous Index: **S03**
 Within 8" of Joint: **YES**
 Remarks:

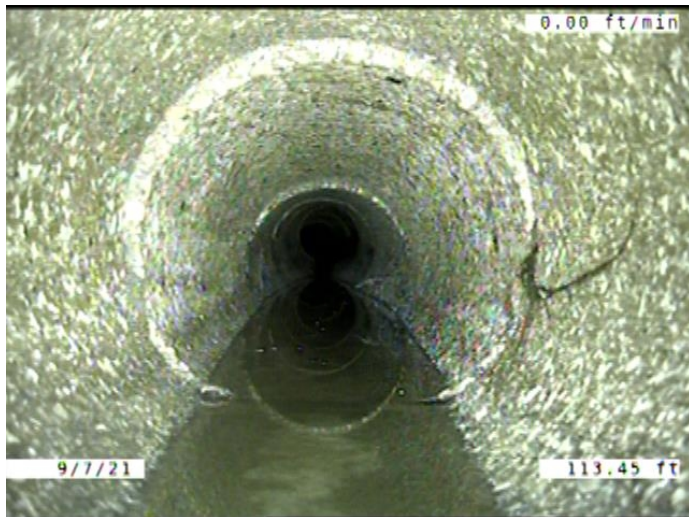
Code: **MWLS**
Description: **Miscellaneous Water Level Sag**

Distance (ft): **113.5**
Structural Grade: **2**
O&M Grade: **0**
Clock Start/From:
Clock To:
1st Value:
2nd Value:
Value Percent: **5.000**
Continuous Index: **S04**
Within 8" of Joint: **NO**
Remarks:

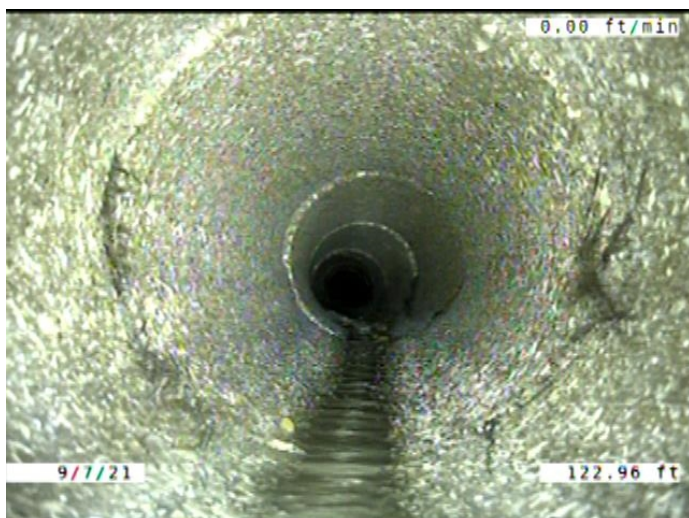
Code: **MWLS**
Description: **Miscellaneous Water Level Sag**

Distance (ft): **123.0**
Structural Grade: **2**
O&M Grade: **0**
Clock Start/From:
Clock To:
1st Value:
2nd Value:
Value Percent: **5.000**
Continuous Index: **F04**
Within 8" of Joint: **NO**
Remarks:

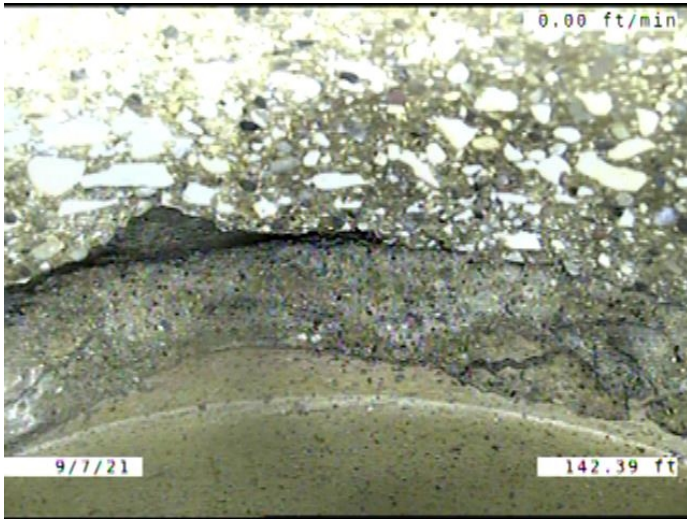
Code: **MMC**
Description: **Miscellaneous Material Change**

Distance (ft): **142.4**
Structural Grade: **0**
O&M Grade: **0**
Clock Start/From:
Clock To:
1st Value:
2nd Value:
Value Percent:
Continuous Index:
Within 8" of Joint: **NO**
Remarks: **CONCRETE TO VCP**

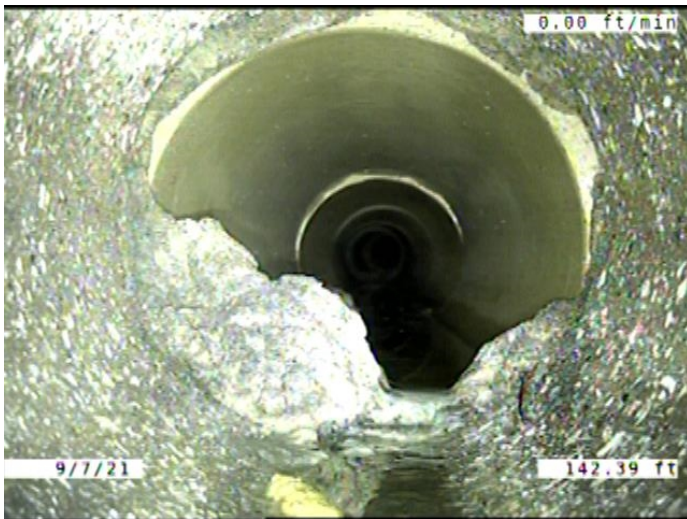
Code: **DAE**
Description: **Deposits Attached Encrustation**

Distance (ft): **142.4**
Structural Grade: **0**
O&M Grade: **4**
Clock Start/From: **4**
Clock To: **9**
1st Value:
2nd Value:
Value Percent: **25.000**
Continuous Index:
Within 8" of Joint: **YES**
Remarks:

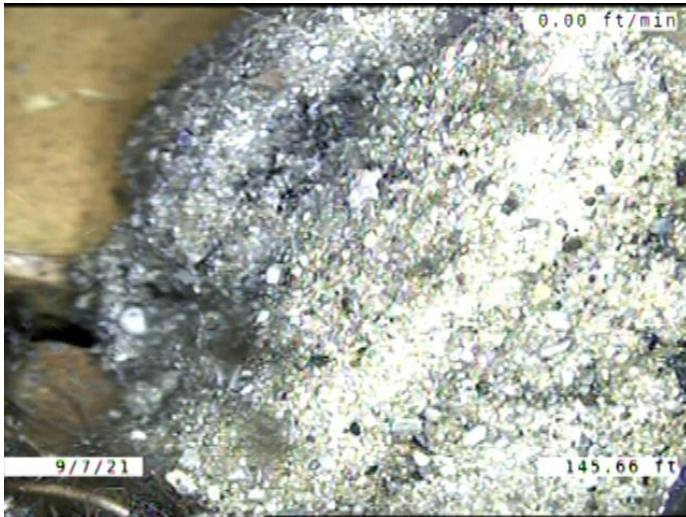
Code: **DAE**
 Description: **Deposits Attached Encrustation**

Distance (ft): **145.7**
 Structural Grade: **0**
 O&M Grade: **2**
 Clock Start/From: **6**
 Clock To: **8**
 1st Value:
 2nd Value:
 Value Percent: **10.000**
 Continuous Index:
 Within 8" of Joint: **YES**
 Remarks:

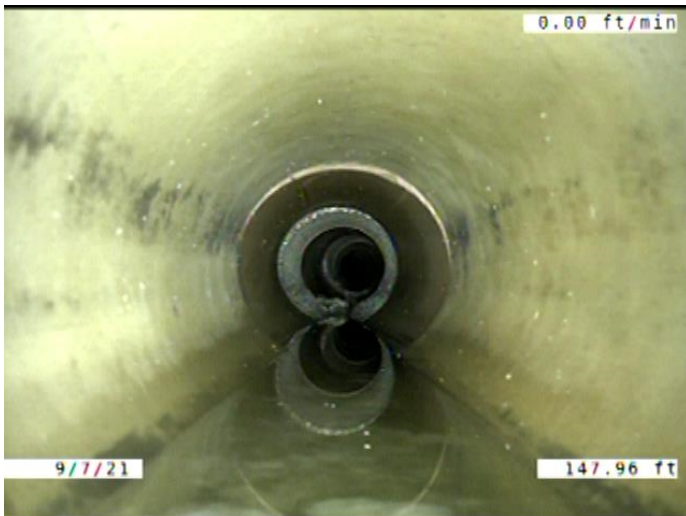
Code: **RFJ**
 Description: **Roots Fine Joint**

Distance (ft): **148.0**
 Structural Grade: **0**
 O&M Grade: **1**
 Clock Start/From: **2**
 Clock To: **9**
 1st Value:
 2nd Value:
 Value Percent:
 Continuous Index: **F03**
 Within 8" of Joint: **YES**
 Remarks:

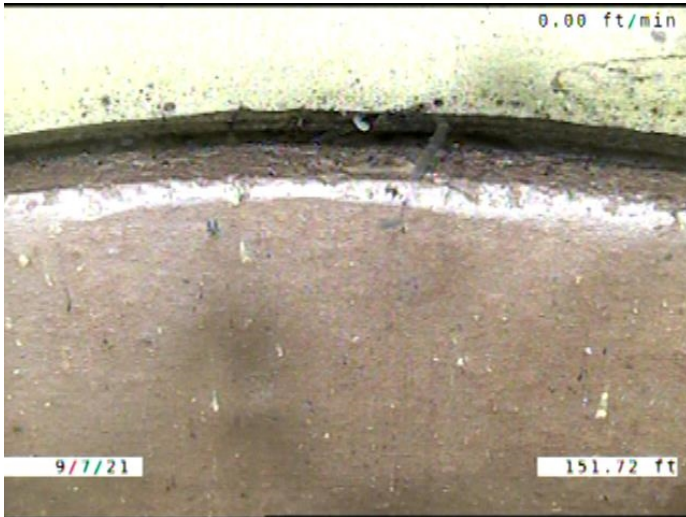
Code: **RFJ**
 Description: **Roots Fine Joint**

Distance (ft): **151.7**
 Structural Grade: **0**
 O&M Grade: **1**
 Clock Start/From: **11**
 Clock To:
 1st Value:
 2nd Value:
 Value Percent:
 Continuous Index:
 Within 8" of Joint: **YES**
 Remarks:

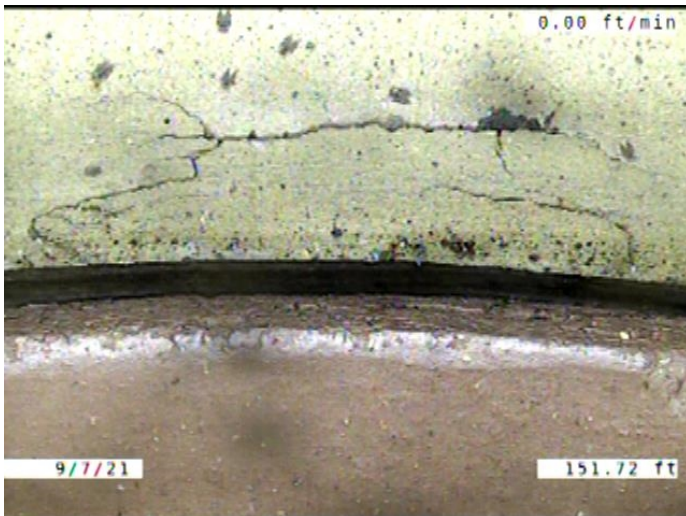
Code: **CM**
 Description: **Crack Multiple**

Distance (ft): **151.7**
 Structural Grade: **3**
 O&M Grade: **0**
 Clock Start/From: **11**
 Clock To: **1**
 1st Value:
 2nd Value:
 Value Percent:
 Continuous Index:
 Within 8" of Joint: **YES**
 Remarks:

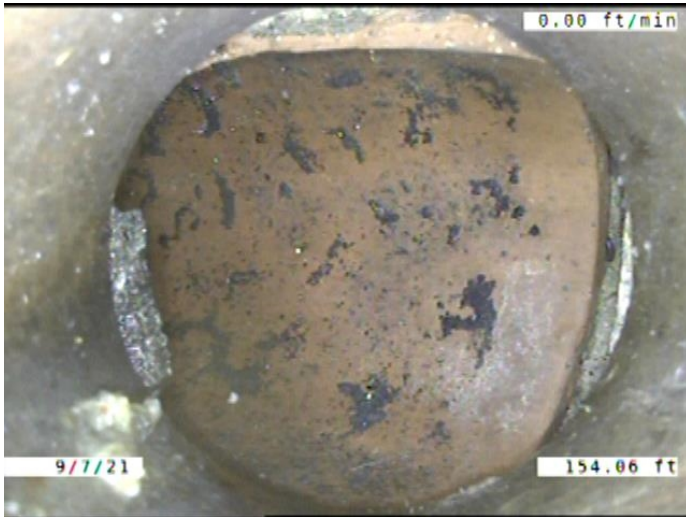
Code: **TF**
 Description: **Tap Factory**

Distance (ft): **154.1**
 Structural Grade: **0**
 O&M Grade: **0**
 Clock Start/From: **11**
 Clock To:
 1st Value: **4.000**
 2nd Value:
 Value Percent:
 Continuous Index:
 Within 8" of Joint: **YES**
 Remarks:

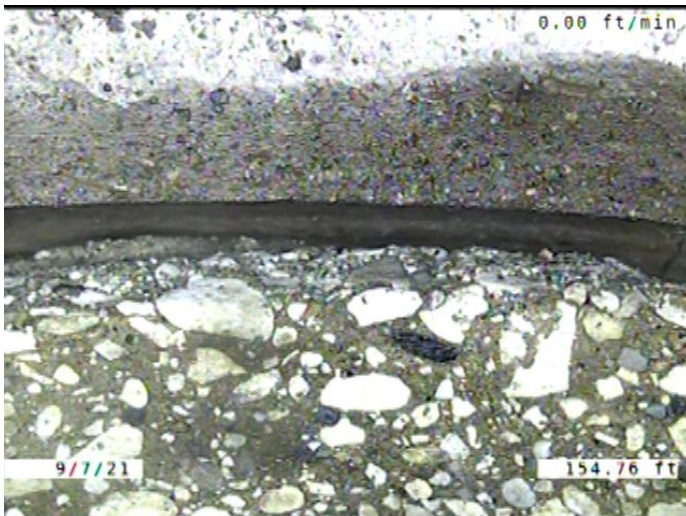
Code: **MMC**
 Description: **Miscellaneous Material Change**

Distance (ft): **154.8**
 Structural Grade: **0**
 O&M Grade: **0**
 Clock Start/From:
 Clock To:
 1st Value:
 2nd Value:
 Value Percent:
 Continuous Index:
 Within 8" of Joint: **NO**
 Remarks: **VCP TO CONCRETE**

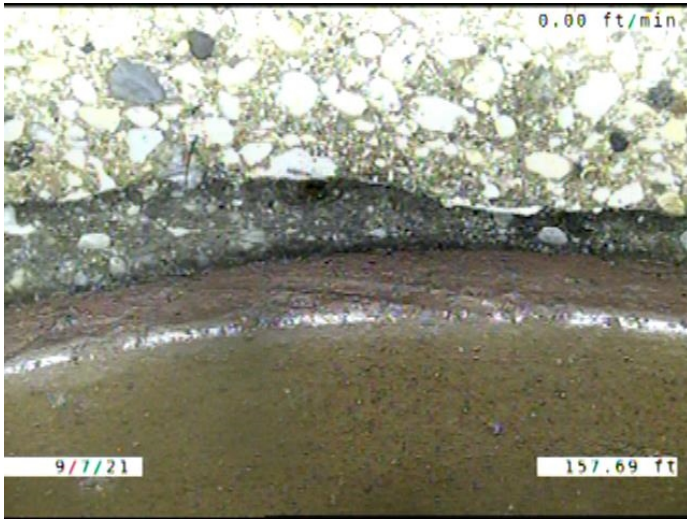
Code: **MMC**
Description: **Miscellaneous Material Change**

Distance (ft): **157.7**
Structural Grade: **0**
O&M Grade: **0**
Clock Start/From:
Clock To:
1st Value:
2nd Value:
Value Percent:
Continuous Index:
Within 8" of Joint: **NO**
Remarks: **CONCRETE TO VCP**

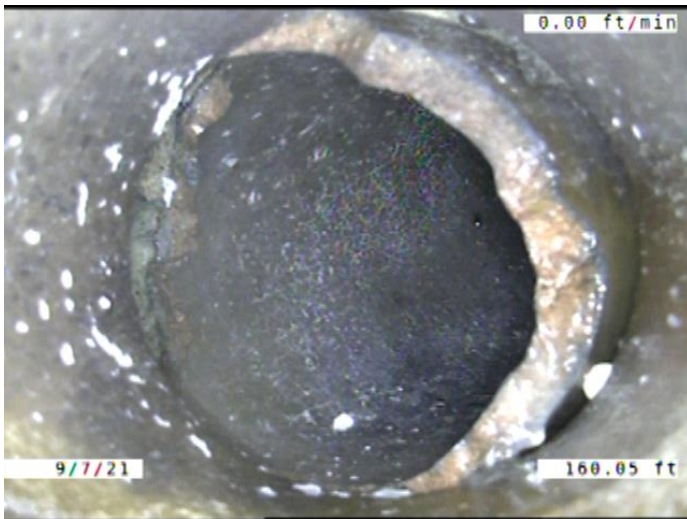
Code: **TFD**
Description: **Tap Factory Defective**

Distance (ft): **160.1**
Structural Grade: **0**
O&M Grade: **3**
Clock Start/From: **1**
Clock To:
1st Value: **4.000**
2nd Value:
Value Percent:
Continuous Index:
Within 8" of Joint: **YES**
Remarks: **Defective**

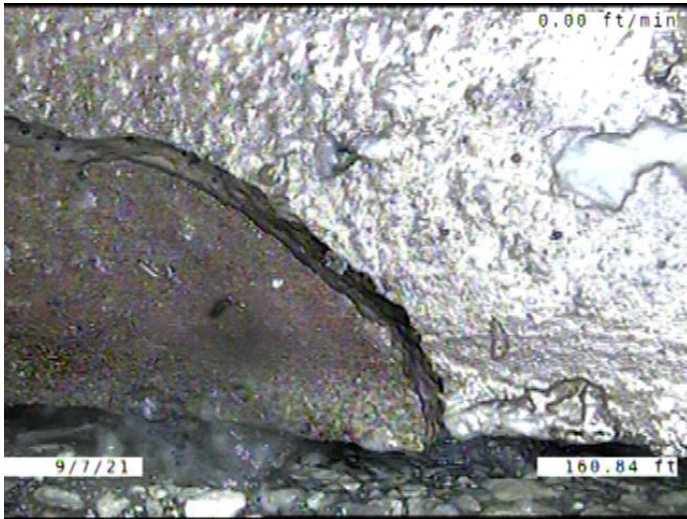
Code: **B**
 Description: **Broken**

Distance (ft): **160.8**
 Structural Grade: **4**
 O&M Grade: **0**
 Clock Start/From: **2**
 Clock To: **4**
 1st Value:
 2nd Value:
 Value Percent:
 Continuous Index:
 Within 8" of Joint: **YES**
 Remarks:

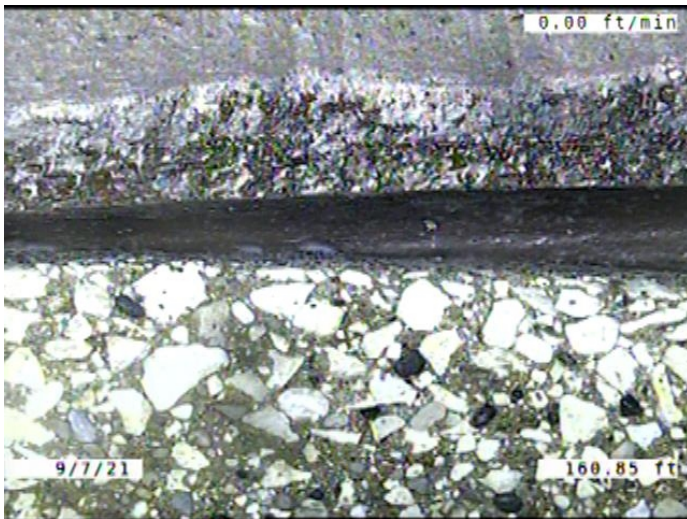
Code: **MMC**
 Description: **Miscellaneous Material Change**

Distance (ft): **160.9**
 Structural Grade: **0**
 O&M Grade: **0**
 Clock Start/From:
 Clock To:
 1st Value:
 2nd Value:
 Value Percent:
 Continuous Index:
 Within 8" of Joint: **NO**
 Remarks: **VCP TO CONCRETE**

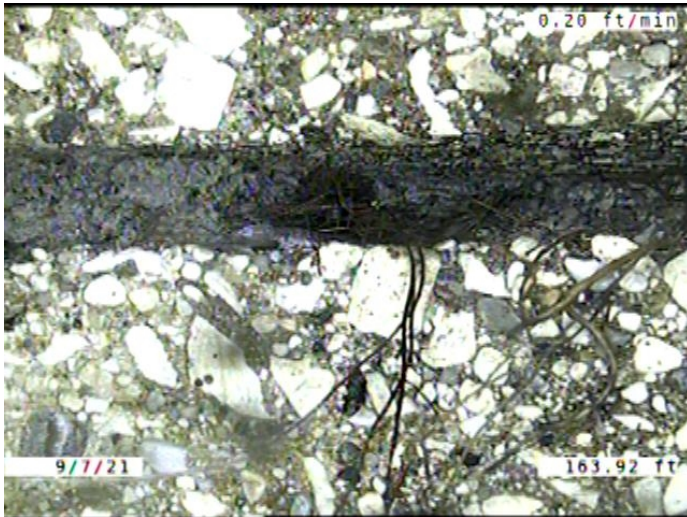
Code: **RFJ**
Description: **Roots Fine Joint**

Distance (ft): **163.9**
Structural Grade: **0**
O&M Grade: **1**
Clock Start/From: **3**
Clock To: **9**
1st Value:
2nd Value:
Value Percent:
Continuous Index: **S05**
Within 8" of Joint: **YES**
Remarks:

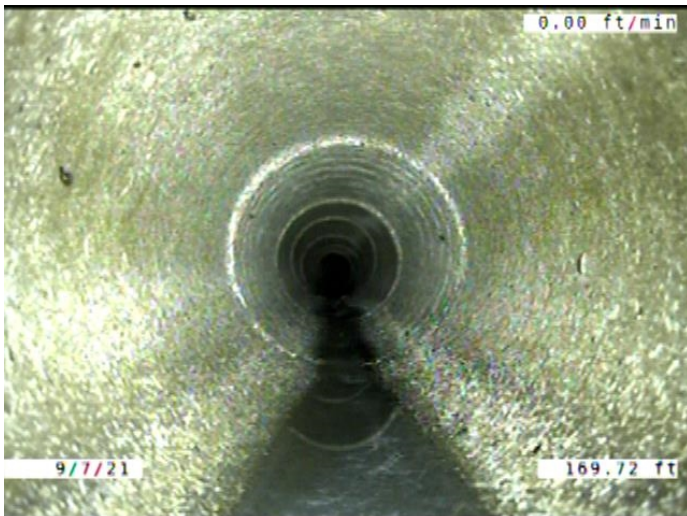
Code: **RFJ**
Description: **Roots Fine Joint**

Distance (ft): **169.7**
Structural Grade: **0**
O&M Grade: **1**
Clock Start/From: **3**
Clock To: **9**
1st Value:
2nd Value:
Value Percent:
Continuous Index: **F05**
Within 8" of Joint: **YES**
Remarks:

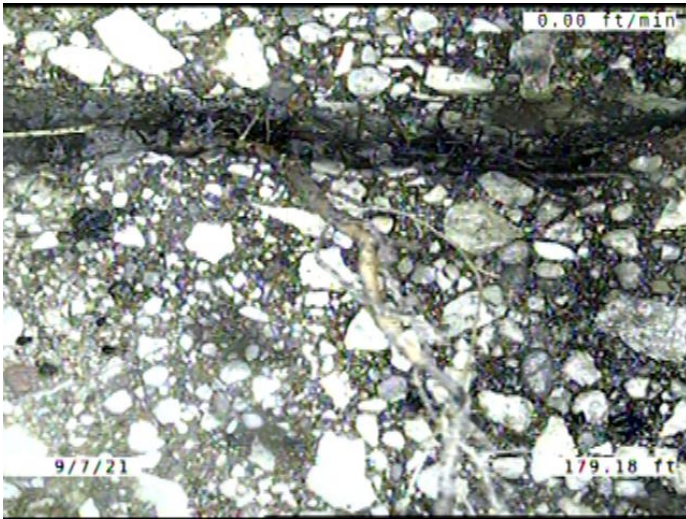
Code: **RFJ**
 Description: **Roots Fine Joint**

Distance (ft): **179.2**
 Structural Grade: **0**
 O&M Grade: **1**
 Clock Start/From: **8**
 Clock To:
 1st Value:
 2nd Value:
 Value Percent:
 Continuous Index:
 Within 8" of Joint: **YES**
 Remarks:

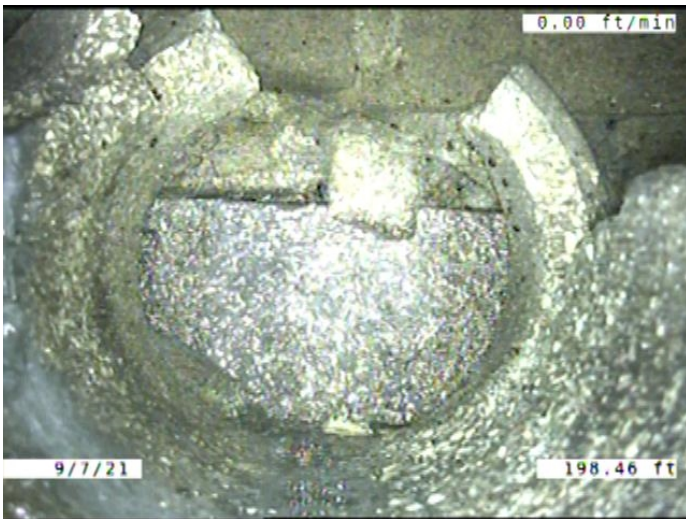
Code: **DSF**
 Description: **Deposits Settled Fine**

Distance (ft): **198.5**
 Structural Grade: **0**
 O&M Grade: **2**
 Clock Start/From: **5**
 Clock To: **7**
 1st Value:
 2nd Value:
 Value Percent: **5.000**
 Continuous Index: **F01**
 Within 8" of Joint: **YES**
 Remarks:

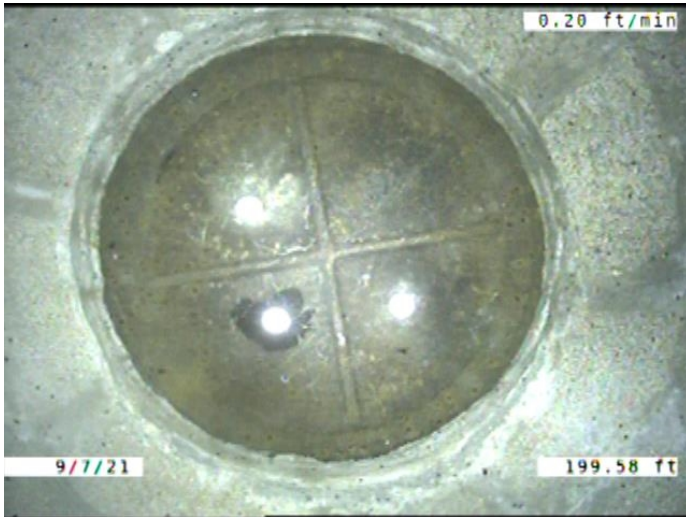
Code:	AMH
Description:	Manhole
Distance (ft):	199.6
Structural Grade:	0
O&M Grade:	0
Clock Start/From:	
Clock To:	
1st Value:	
2nd Value:	
Value Percent:	
Continuous Index:	
Within 8" of Joint:	NO
Remarks:	M-504-110
