Profile/Photo Observation Report

Date:	04/17/2018	Weather:		Coding:	PACP 6.0
Pipe Length (ft):	208.8	Owner:	NA	Pre Clean:	Not Known
P.O.#:		Surveyor:	Jen Costello	PSR:	P-504-118-117
Customer:		Clean Date:	01/01/1900	Shape:	C

Street:	W 42ND AVE	Flow Control:	Not Controlled
City:	Hobart, IN	Year Renewed:	
Location:	Light Highway	Tape/Media #:	
Purpose:	Not Known	Dia/Height:	12"
Use:	Sanitary	Material:	VCP
Drain Area:	NA	Lining:	
Category:	NA		
Comment:

Location Details:		Direction of Survey:	Downstream
US MH:	M-504-117	DS MH:	M-504-118
		Total Length Surveyed (ft):	24.0

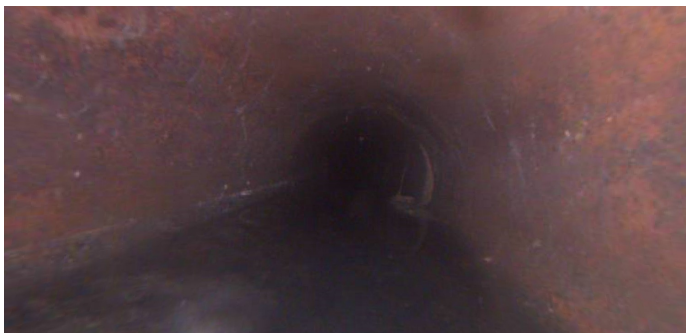
Code: **AMH**
Description: **Manhole**

Distance (ft): **.0**
Structural Grade: **0**
O&M Grade: **0**
Clock Start/From:
Clock To:
1st Value:
2nd Value:
Value Percent:
Continuous Index:
Within 8" of Joint: **NO**
Remarks: **M-504-117**

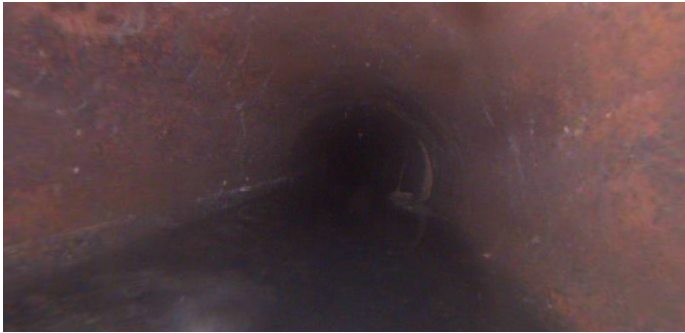
Code:	MWL
Description:	Water Level

Distance (ft):	.0
Structural Grade:	0
O&M Grade:	0
Clock Start/From:	
Clock To:	
1st Value:	
2nd Value:	
Value Percent:	30.000
Continuous Index:	
Within 8" of Joint:	NO
Remarks:

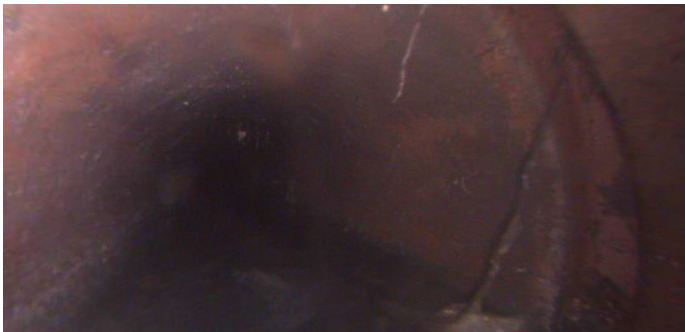
Code:	RFJ
Description:	Roots Fine Joint

Distance (ft):	2.9
Structural Grade:	0
O&M Grade:	1
Clock Start/From:	12
Clock To:	1
1st Value:	
2nd Value:	
Value Percent:	
Continuous Index:	
Within 8" of Joint:	YES
Remarks:

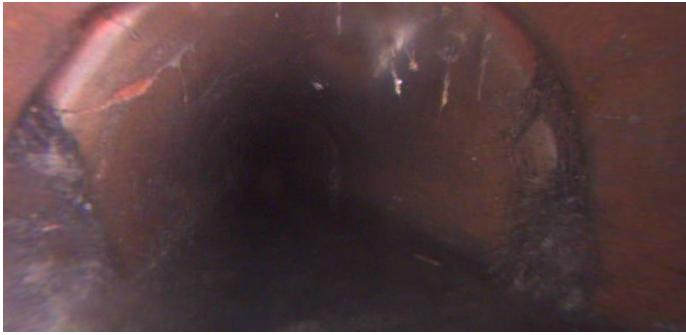
Code: **RMJ**
Description: **Roots Medium Joint**

Distance (ft): **4.8**
Structural Grade: **0**
O&M Grade: **3**
Clock Start/From: **8**
Clock To: **4**
1st Value:
2nd Value:
Value Percent: **5.000**
Continuous Index:
Within 8" of Joint: **YES**
Remarks:

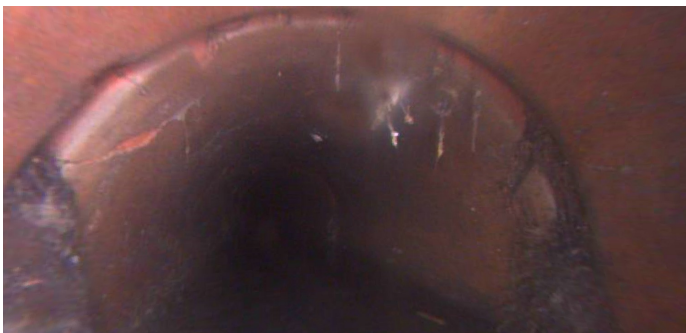
Code: **FM**
Description: **Fracture Multiple**

Distance (ft): **4.8**
Structural Grade: **4**
O&M Grade: **0**
Clock Start/From: **10**
Clock To: **12**
1st Value:
2nd Value:
Value Percent:
Continuous Index:
Within 8" of Joint: **YES**
Remarks:

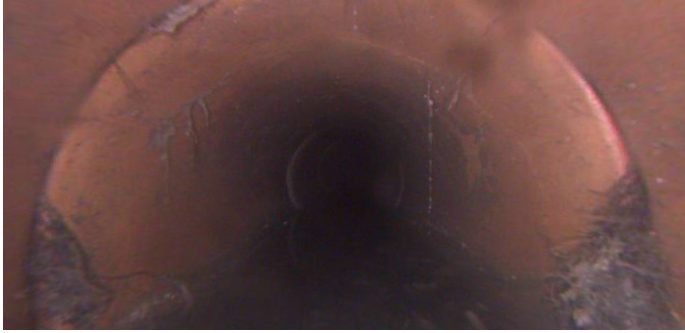
Code: **RMJ**
Description: **Roots Medium Joint**

Distance (ft): **6.9**
Structural Grade: **0**
O&M Grade: **3**
Clock Start/From: **8**
Clock To: **4**
1st Value:
2nd Value:
Value Percent: **5.000**
Continuous Index:
Within 8" of Joint: **YES**
Remarks:

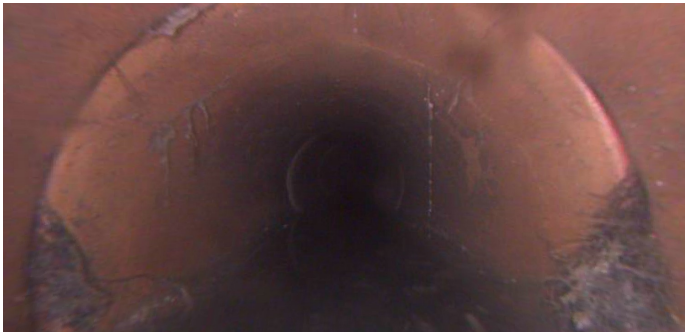
Code: **FM**
Description: **Fracture Multiple**

Distance (ft): **6.9**
Structural Grade: **4**
O&M Grade: **0**
Clock Start/From: **10**
Clock To: **2**
1st Value:
2nd Value:
Value Percent:
Continuous Index:
Within 8" of Joint: **YES**
Remarks:

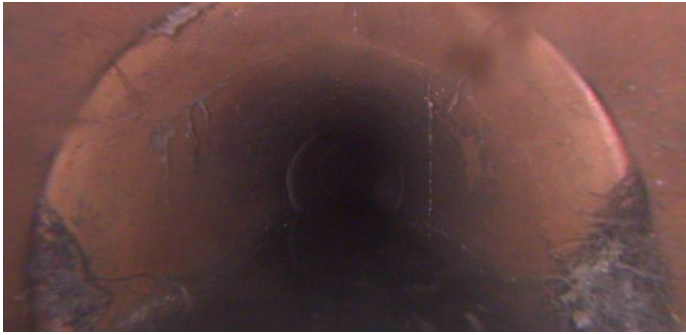
Code: **RFB**
Description: **Roots Fine Barrel**

Distance (ft): **6.9**
Structural Grade: **0**
O&M Grade: **2**
Clock Start/From: **10**
Clock To: **12**
1st Value:
2nd Value:
Value Percent:
Continuous Index:
Within 8" of Joint: **NO**
Remarks:

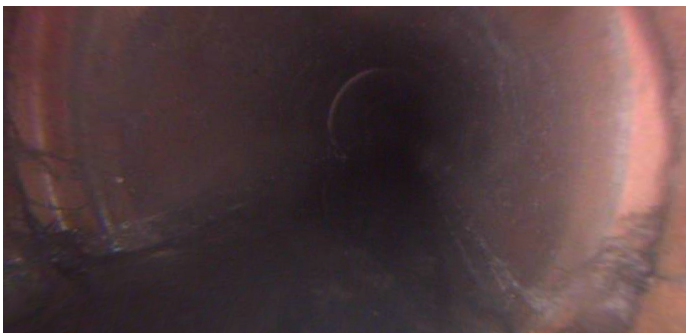
Code: **RFJ**
Description: **Roots Fine Joint**

Distance (ft): **9.0**
Structural Grade: **0**
O&M Grade: **1**
Clock Start/From: **8**
Clock To: **4**
1st Value:
2nd Value:
Value Percent:
Continuous Index: **S01**
Within 8" of Joint: **YES**
Remarks:

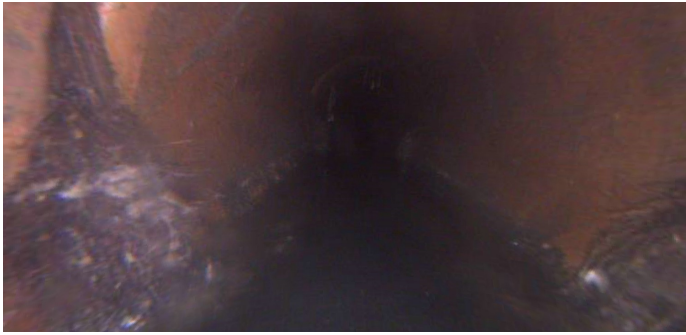
Code: **RMJ**
Description: **Roots Medium Joint**

Distance (ft): **13.3**
Structural Grade: **0**
O&M Grade: **3**
Clock Start/From: **8**
Clock To: **4**
1st Value:
2nd Value:
Value Percent: **10.000**
Continuous Index: **S02**
Within 8" of Joint: **YES**
Remarks:

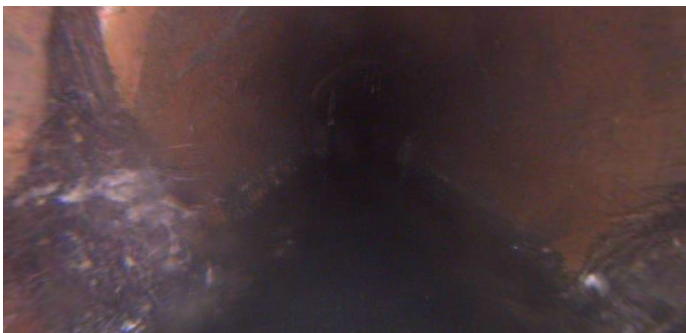
Code: **RFJ**
Description: **Roots Fine Joint**

Distance (ft): **13.3**
Structural Grade: **0**
O&M Grade: **1**
Clock Start/From: **8**
Clock To: **4**
1st Value:
2nd Value:
Value Percent:
Continuous Index: **F01**
Within 8" of Joint: **YES**
Remarks:

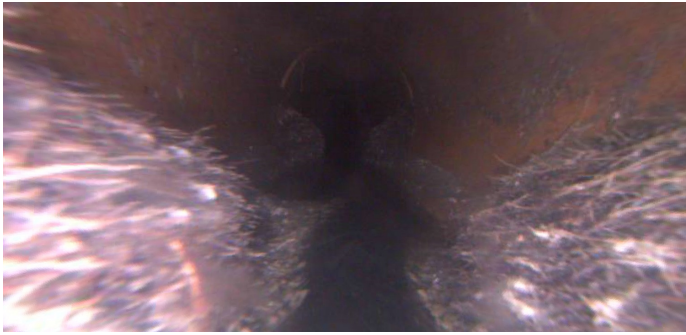
Code: **RMJ**
Description: **Roots Medium Joint**

Distance (ft): **24.0**
Structural Grade: **0**
O&M Grade: **3**
Clock Start/From: **8**
Clock To: **4**
1st Value:
2nd Value:
Value Percent: **20.000**
Continuous Index:
Within 8" of Joint: **YES**
Remarks:

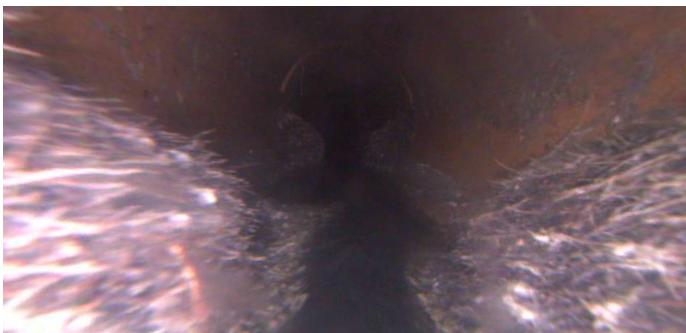
Code: **RMJ**
Description: **Roots Medium Joint**

Distance (ft): **24.0**
Structural Grade: **0**
O&M Grade: **3**
Clock Start/From: **8**
Clock To: **4**
1st Value:
2nd Value:
Value Percent: **10.000**
Continuous Index: **F02**
Within 8" of Joint: **YES**
Remarks:

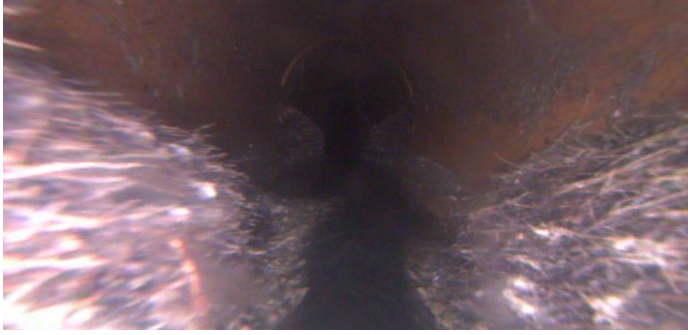
Code:	MSA
Description:	Abandoned Survey
Distance (ft):	24.0
Structural Grade:	0
O&M Grade:	0
Clock Start/From:	
Clock To:	
1st Value:	
2nd Value:	
Value Percent:	
Continuous Index:	
Within 8" of Joint:	NO
Remarks:	ROOTS
