## Profile/Photo Observation Report

Street:	<b>ALLEY BETWEEN N COLORADO ST &amp;</b>	Flow Control:	<b>Not Controlled</b>
City:	<b>Hobart, IN</b>	Year Renewed:	
Location:	<b>Light Highway</b>	Tape/Media #:	
Purpose:	<b>Not Known</b>	Dia/Height:	<b>12"</b>
Use:	<b>Sanitary</b>	Material:	<b>VCP</b>
Drain Area:	<b>NA</b>	Lining:	
Category:	<b>NA</b>		
Comment:

Location Details:		Direction of Survey:	<b>Upstream</b>
US MH:	<b>M-504-118</b>	DS MH:	<b>M-504-119</b>
		Total Length Surveyed (ft):	<b>19.9</b>

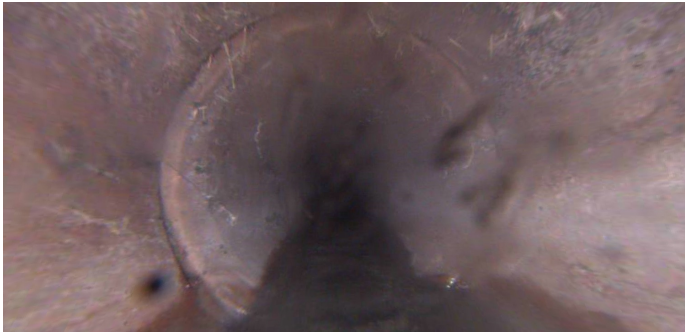
Code:	<b>MWL</b>
Description:	<b>Water Level</b>

Distance (ft):	<b>.0</b>
Structural Grade:	<b>0</b>
O&M Grade:	<b>0</b>
Clock Start/From:	
Clock To:	
1st Value:	
2nd Value:	
Value Percent:	<b>5.000</b>
Continuous Index:	
Within 8" of Joint:	<b>NO</b>
Remarks:

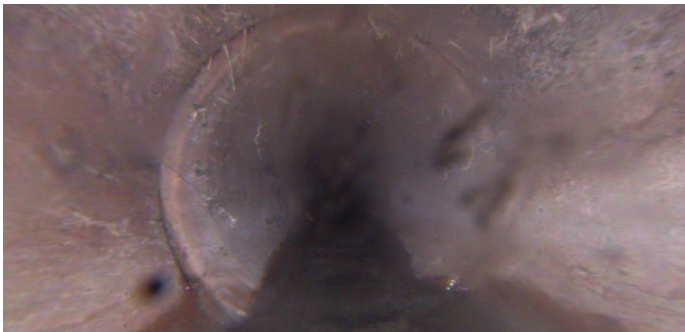
Code:	<b>RFJ</b>
Description:	<b>Roots Fine Joint</b>

Distance (ft):	<b>.0</b>
Structural Grade:	<b>0</b>
O&M Grade:	<b>1</b>
Clock Start/From:	<b>8</b>
Clock To:	<b>4</b>
1st Value:	
2nd Value:	
Value Percent:	
Continuous Index:	<b>S01</b>
Within 8" of Joint:	<b>YES</b>
Remarks:

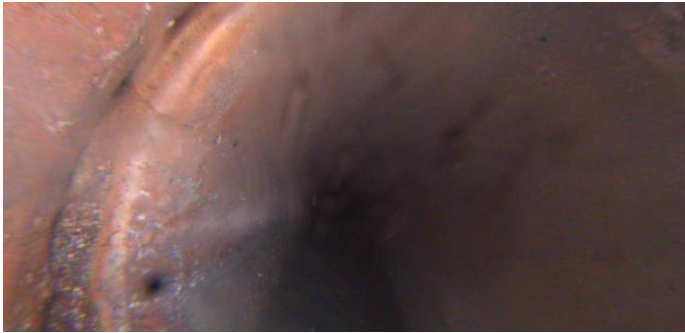
Code: **CM**  
Description: **Crack Multiple**

Distance (ft): **19.9**  
Structural Grade: **3**  
O&M Grade: **0**  
Clock Start/From: **9**  
Clock To: **10**  
1st Value:  
2nd Value:  
Value Percent:  
Continuous Index:  
Within 8" of Joint: **YES**  
Remarks:

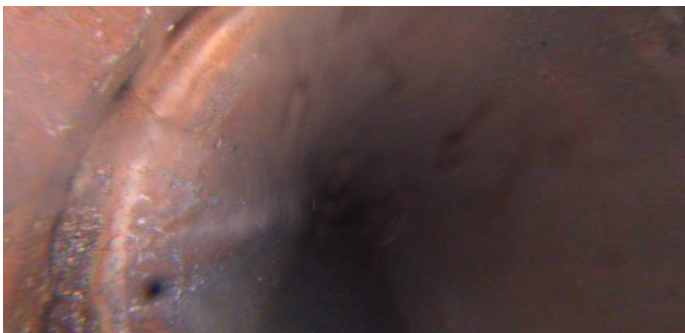
Code: **MSA**  
Description: **Abandoned Survey**

Distance (ft): **19.9**  
Structural Grade: **0**  
O&M Grade: **0**  
Clock Start/From:  
Clock To:  
1st Value:  
2nd Value:  
Value Percent:  
Continuous Index:  
Within 8" of Joint: **NO**  
Remarks: **unknown**

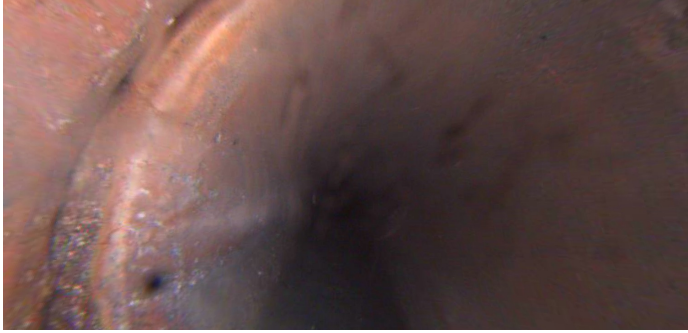
Code:	RFJ
Description:	Roots Fine Joint
Distance (ft):	19.9
Structural Grade:	0
O&M Grade:	1
Clock Start/From:	8
Clock To:	4
1st Value:	
2nd Value:	
Value Percent:	
Continuous Index:	F01
Within 8" of Joint:	YES
Remarks:
