Profile/Photo Observation Report

Date:	04/17/2018	Weather:		Coding:	PACP 6.0
Pipe Length (ft):	142.5	Owner:	NA	Pre Clean:	Not Known
P.O.#:		Surveyor:	Justin Gonzales	PSR:	P-504-121-079
Customer:		Clean Date:	01/01/1900	Shape:	C

Street:	W 42ND AVE	Flow Control:	Not Controlled
City:	Hobart, IN	Year Renewed:	
Location:	Light Highway	Tape/Media #:	
Purpose:	Not Known	Dia/Height:	12"
Use:	Sanitary	Material:	VCP
Drain Area:	NA	Lining:	
Category:	NA		
Comment:

Location Details:		Direction of Survey:	Downstream
US MH:	M-504-121	DS MH:	M-504-079
		Total Length Surveyed (ft):	137.3

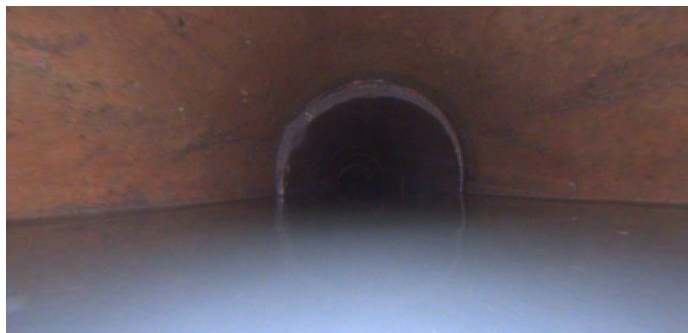
Code: **AMH**
 Description: **Manhole**
 Distance (ft): **.0**
 Structural Grade: **0**
 O&M Grade: **0**
 Clock Start/From:
 Clock To:
 1st Value:
 2nd Value:
 Value Percent:
 Continuous Index:
 Within 8" of Joint: **NO**
 Remarks: **M-504-121**

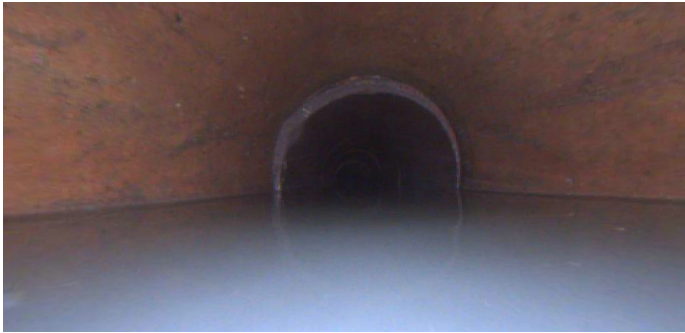
Code:	MWL
Description:	Water Level

Distance (ft):	.0
Structural Grade:	0
O&M Grade:	0
Clock Start/From:	
Clock To:	
1st Value:	
2nd Value:	
Value Percent:	15.000
Continuous Index:	
Within 8" of Joint:	NO
Remarks:

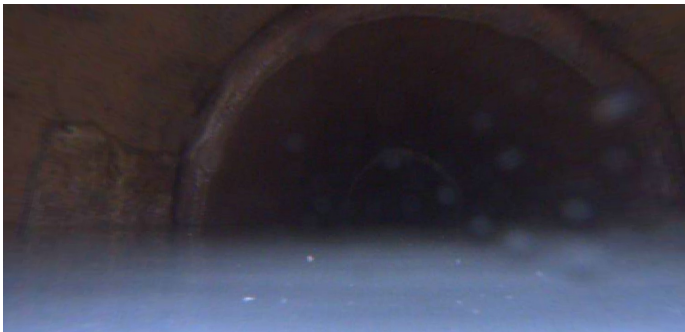
Code:	CM
Description:	Crack Multiple

Distance (ft):	5.2
Structural Grade:	3
O&M Grade:	0
Clock Start/From:	7
Clock To:	9
1st Value:	
2nd Value:	
Value Percent:	
Continuous Index:	
Within 8" of Joint:	YES
Remarks:

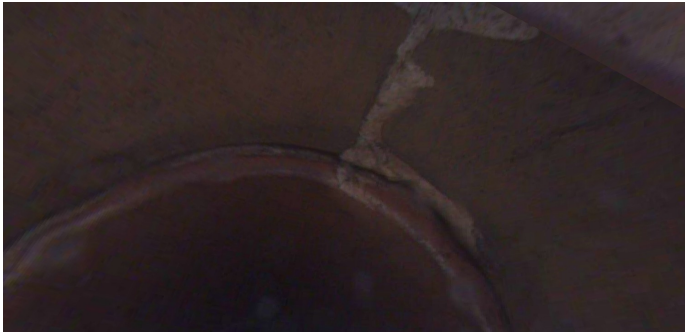
Code: **CL**
Description: **Crack Longitudinal**

Distance (ft): **9.4**
Structural Grade: **2**
O&M Grade: **0**
Clock Start/From: **1**
Clock To:
1st Value:
2nd Value:
Value Percent:
Continuous Index:
Within 8" of Joint: **YES**
Remarks:

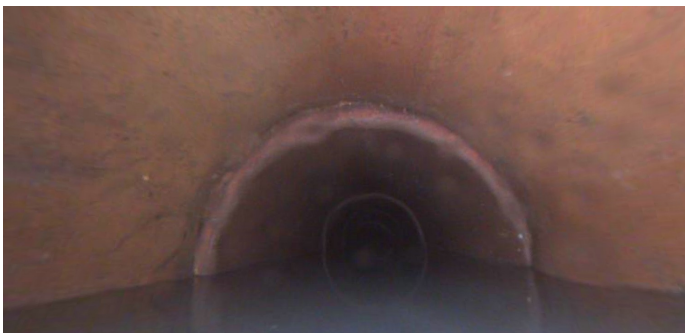
Code: **RFJ**
Description: **Roots Fine Joint**

Distance (ft): **19.6**
Structural Grade: **0**
O&M Grade: **1**
Clock Start/From: **8**
Clock To: **9**
1st Value:
2nd Value:
Value Percent:
Continuous Index:
Within 8" of Joint: **YES**
Remarks:

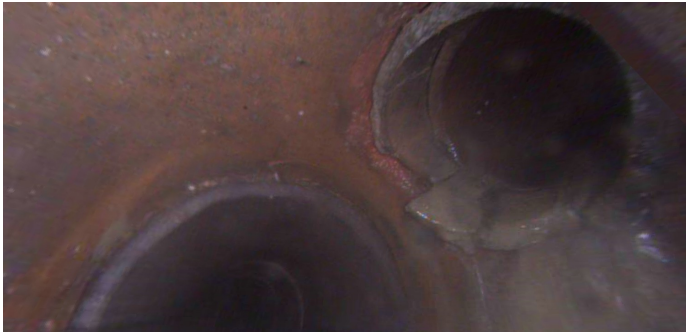
Code: **TBA**
Description: **Tap Break-in Active**

Distance (ft): **46.5**
Structural Grade: **0**
O&M Grade: **0**
Clock Start/From: **2**
Clock To:
1st Value: **4.000**
2nd Value:
Value Percent:
Continuous Index:
Within 8" of Joint:
Remarks:

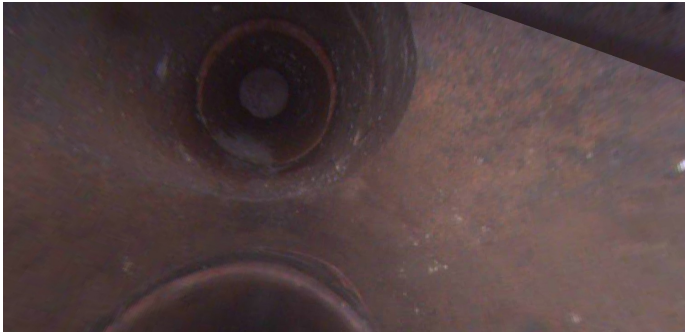
Code: **TF**
Description: **Tap Factory**

Distance (ft): **50.6**
Structural Grade: **0**
O&M Grade: **0**
Clock Start/From: **12**
Clock To:
1st Value: **4.000**
2nd Value:
Value Percent:
Continuous Index:
Within 8" of Joint:
Remarks:

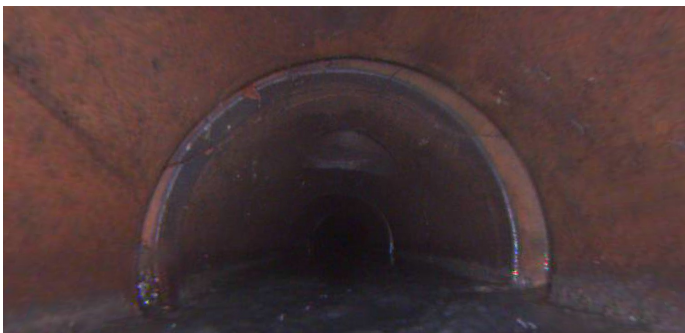
Code: **FM**
Description: **Fracture Multiple**

Distance (ft): **52.7**
Structural Grade: **4**
O&M Grade: **0**
Clock Start/From: **10**
Clock To: **2**
1st Value:
2nd Value:
Value Percent:
Continuous Index:
Within 8" of Joint: **YES**
Remarks:

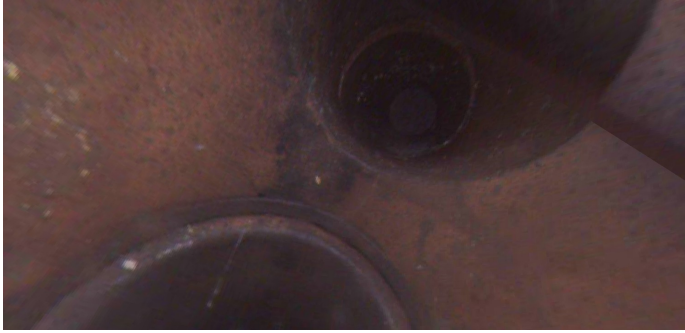
Code: **TF**
Description: **Tap Factory**

Distance (ft): **53.0**
Structural Grade: **0**
O&M Grade: **0**
Clock Start/From: **1**
Clock To:
1st Value: **4.000**
2nd Value:
Value Percent:
Continuous Index:
Within 8" of Joint:
Remarks:

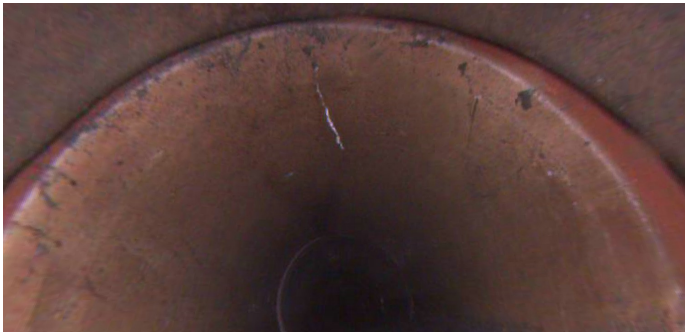
Code: **RFJ**
Description: **Roots Fine Joint**

Distance (ft): **60.7**
Structural Grade: **0**
O&M Grade: **1**
Clock Start/From: **10**
Clock To: **2**
1st Value:
2nd Value:
Value Percent:
Continuous Index:
Within 8" of Joint: **YES**
Remarks:

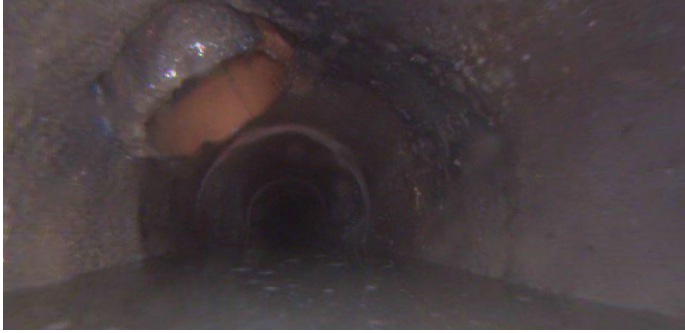
Code: **TBI**
Description: **Tap Break-in Intruding**

Distance (ft): **66.9**
Structural Grade: **0**
O&M Grade: **2**
Clock Start/From: **10**
Clock To:
1st Value: **4.000**
2nd Value: **0.500**
Value Percent:
Continuous Index:
Within 8" of Joint:
Remarks:

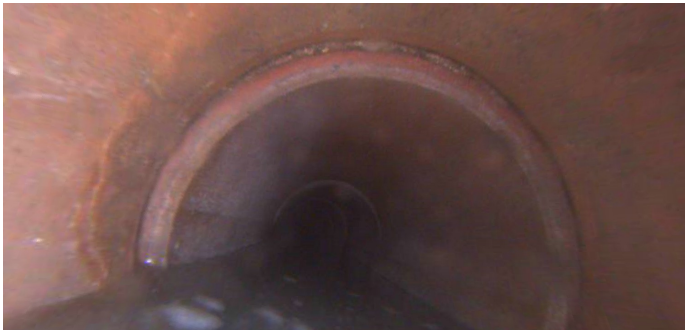
Code: **CC**
Description: **Crack Circumferential**

Distance (ft): **80.7**
Structural Grade: **1**
O&M Grade: **0**
Clock Start/From: **9**
Clock To: **11**
1st Value:
2nd Value:
Value Percent:
Continuous Index:
Within 8" of Joint: **YES**
Remarks:

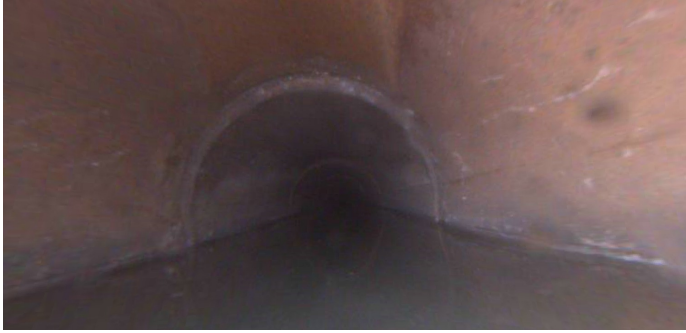
Code: **CM**
Description: **Crack Multiple**

Distance (ft): **94.9**
Structural Grade: **3**
O&M Grade: **0**
Clock Start/From: **8**
Clock To: **4**
1st Value:
2nd Value:
Value Percent:
Continuous Index: **S01**
Within 8" of Joint: **YES**
Remarks:

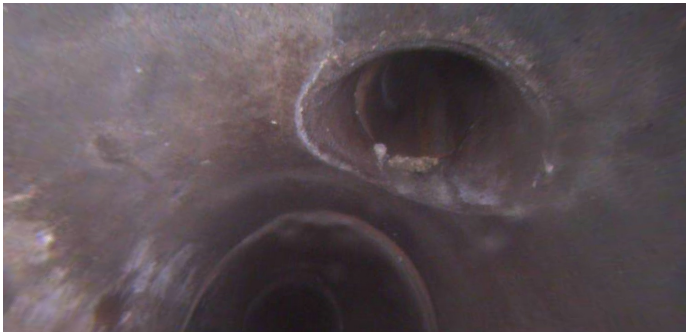
Code: **TF**
Description: **Tap Factory**

Distance (ft): **103.3**
Structural Grade: **0**
O&M Grade: **0**
Clock Start/From: **1**
Clock To:
1st Value: **4.000**
2nd Value:
Value Percent:
Continuous Index:
Within 8" of Joint:
Remarks:

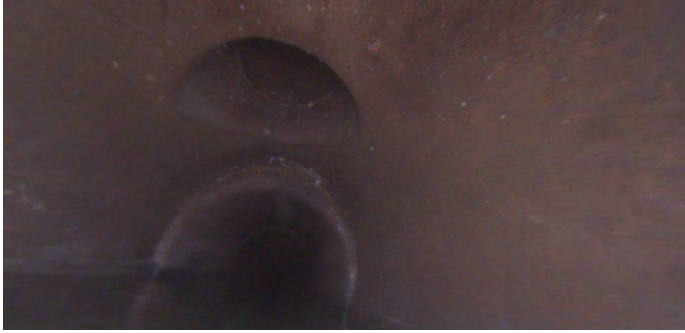
Code: **TF**
Description: **Tap Factory**

Distance (ft): **104.9**
Structural Grade: **0**
O&M Grade: **0**
Clock Start/From: **12**
Clock To:
1st Value: **4.000**
2nd Value:
Value Percent:
Continuous Index:
Within 8" of Joint:
Remarks:

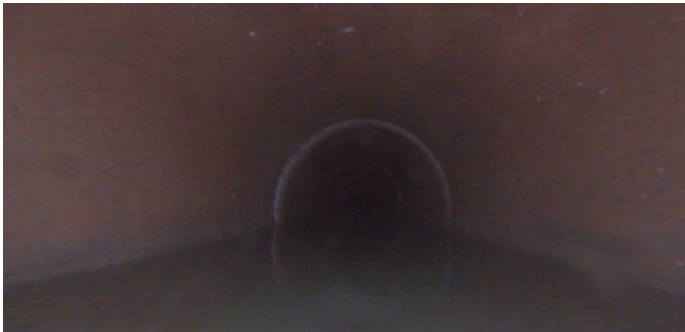
Code: **CM**
Description: **Crack Multiple**

Distance (ft): **113.4**
Structural Grade: **3**
O&M Grade: **0**
Clock Start/From: **8**
Clock To: **4**
1st Value:
2nd Value:
Value Percent:
Continuous Index: **F01**
Within 8" of Joint: **YES**
Remarks:

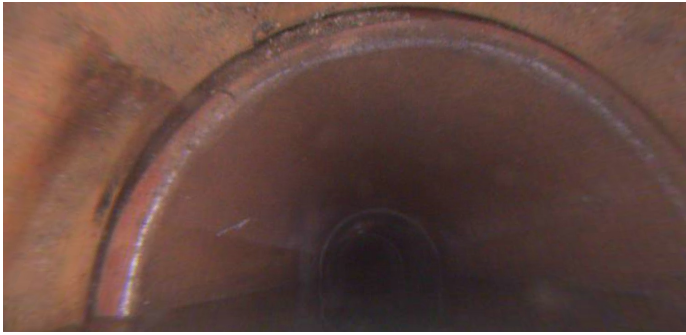
Code: **FL**
Description: **Fracture Longitudinal**

Distance (ft): **127.3**
Structural Grade: **3**
O&M Grade: **0**
Clock Start/From: **10**
Clock To:
1st Value:
2nd Value:
Value Percent:
Continuous Index:
Within 8" of Joint: **YES**
Remarks:

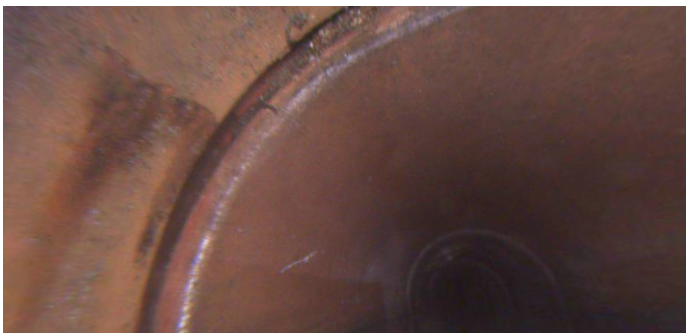
Code: **IS**
Description: **Infil Stain**

Distance (ft): **127.4**
Structural Grade: **0**
O&M Grade: **0**
Clock Start/From: **10**
Clock To:
1st Value:
2nd Value:
Value Percent:
Continuous Index:
Within 8" of Joint: **YES**
Remarks:

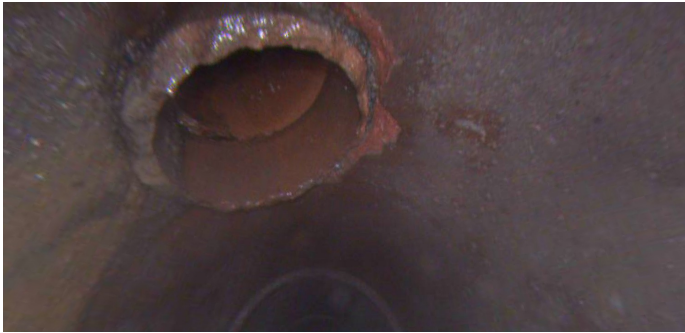
Code: **TBI**
Description: **Tap Break-in Intruding**

Distance (ft): **130.1**
Structural Grade: **0**
O&M Grade: **2**
Clock Start/From: **12**
Clock To:
1st Value: **4.000**
2nd Value: **1.000**
Value Percent:
Continuous Index:
Within 8" of Joint:
Remarks:
