## Profile/Photo Observation Report

Date:	<b>04/17/2018</b>	Weather:		Coding:	<b>PACP 6.0</b>
Pipe Length (ft):	<b>142.5</b>	Owner:	<b>NA</b>	Pre Clean:	<b>Not Known</b>
P.O.#:		Surveyor:	<b>Justin Gonzales</b>	PSR:	<b>P-504-121-079</b>
Customer:		Clean Date:	<b>01/01/1900</b>	Shape:	<b>C</b>

Street:	<b>Summerlin</b>	Flow Control:	<b>Not Controlled</b>
City:	<b>Hobart, IN</b>	Year Renewed:	
Location:	<b>Light Highway</b>	Tape/Media #:	
Purpose:	<b>Not Known</b>	Dia/Height:	<b>12"</b>
Use:	<b>Sanitary</b>	Material:	<b>VCP</b>
Drain Area:	<b>NA</b>	Lining:	
Category:	<b>NA</b>		
Comment:

Location Details:		Direction of Survey:	<b>Downstream</b>
US MH:	<b>M-504-121</b>	DS MH:	<b>M-504-079</b>
		Total Length Surveyed (ft):	<b>137.3</b>

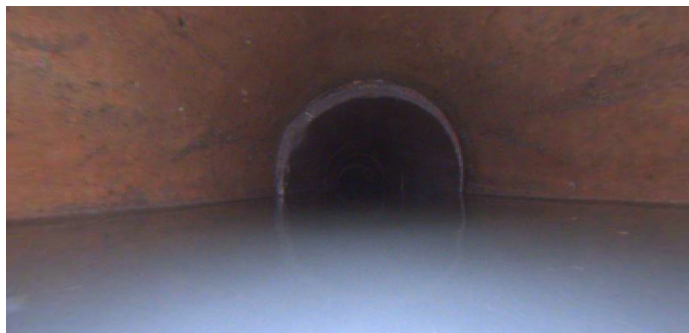
Code: **AMH**  
 Description: **Manhole**  
 Distance (ft): **.0**  
 Structural Grade: **0**  
 O&M Grade: **0**  
 Clock Start/From:  
 Clock To:  
 1st Value:  
 2nd Value:  
 Value Percent:  
 Continuous Index:  
 Within 8" of Joint: **NO**  
 Remarks: **M-504-121**

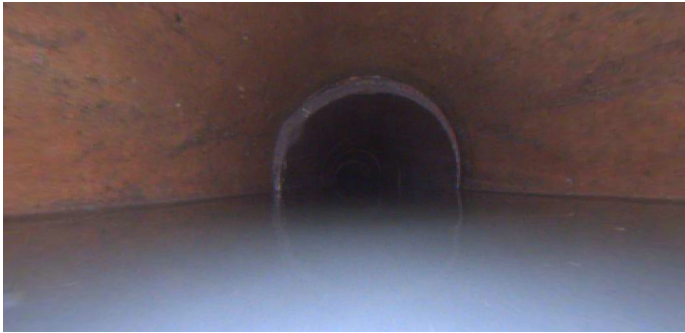
Code:	<b>MWL</b>
Description:	<b>Water Level</b>

Distance (ft):	<b>.0</b>
Structural Grade:	<b>0</b>
O&M Grade:	<b>0</b>
Clock Start/From:	
Clock To:	
1st Value:	
2nd Value:	
Value Percent:	<b>15.000</b>
Continuous Index:	
Within 8" of Joint:	<b>NO</b>
Remarks:

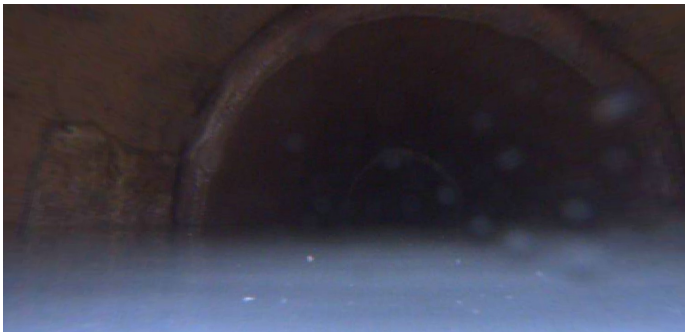
Code:	<b>CM</b>
Description:	<b>Crack Multiple</b>

Distance (ft):	<b>5.2</b>
Structural Grade:	<b>3</b>
O&M Grade:	<b>0</b>
Clock Start/From:	<b>7</b>
Clock To:	<b>9</b>
1st Value:	
2nd Value:	
Value Percent:	
Continuous Index:	
Within 8" of Joint:	<b>YES</b>
Remarks:

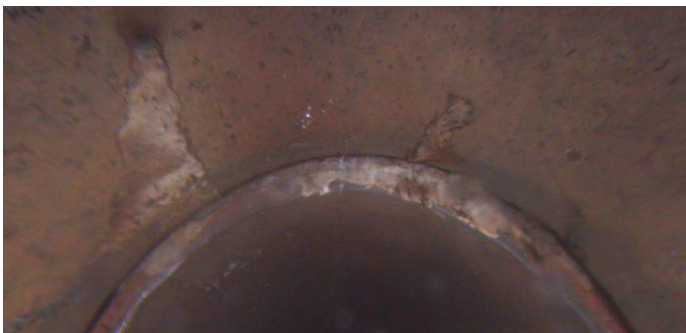
Code: **CM**  
Description: **Crack Multiple**

Distance (ft): **7.3**  
Structural Grade: **3**  
O&M Grade: **0**  
Clock Start/From: **10**  
Clock To: **1**  
1st Value:  
2nd Value:  
Value Percent:  
Continuous Index:  
Within 8" of Joint: **YES**  
Remarks:

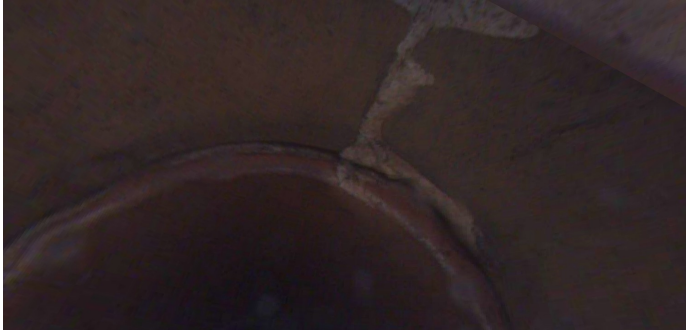
Code: **CL**  
Description: **Crack Longitudinal**

Distance (ft): **9.4**  
Structural Grade: **2**  
O&M Grade: **0**  
Clock Start/From: **1**  
Clock To:  
1st Value:  
2nd Value:  
Value Percent:  
Continuous Index:  
Within 8" of Joint: **YES**  
Remarks:

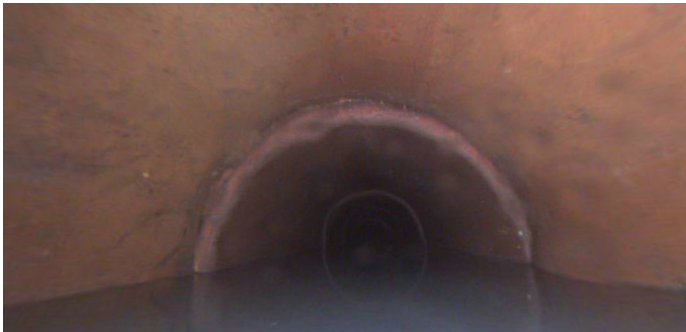
Code: **RFJ**  
Description: **Roots Fine Joint**

Distance (ft): **19.6**  
Structural Grade: **0**  
O&M Grade: **1**  
Clock Start/From: **8**  
Clock To: **9**  
1st Value:  
2nd Value:  
Value Percent:  
Continuous Index:  
Within 8" of Joint: **YES**  
Remarks:

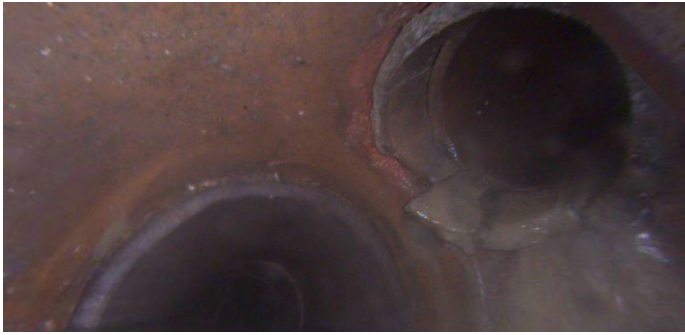
Code: **TBA**  
Description: **Tap Break-in Active**

Distance (ft): **46.5**  
Structural Grade: **0**  
O&M Grade: **0**  
Clock Start/From: **2**  
Clock To:  
1st Value: **4.000**  
2nd Value:  
Value Percent:  
Continuous Index:  
Within 8" of Joint:  
Remarks:

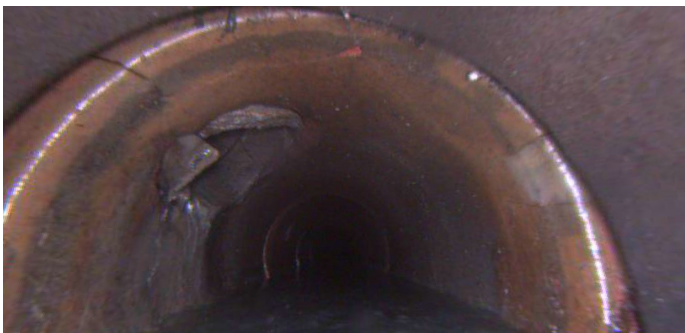
Code: **FM**  
Description: **Fracture Multiple**

Distance (ft): **48.1**  
Structural Grade: **4**  
O&M Grade: **0**  
Clock Start/From: **10**  
Clock To: **2**  
1st Value:  
2nd Value:  
Value Percent:  
Continuous Index:  
Within 8" of Joint: **YES**  
Remarks:

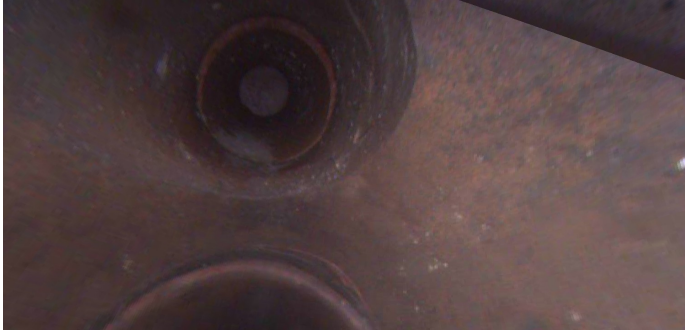
Code: **TF**  
Description: **Tap Factory**

Distance (ft): **50.6**  
Structural Grade: **0**  
O&M Grade: **0**  
Clock Start/From: **12**  
Clock To:  
1st Value: **4.000**  
2nd Value:  
Value Percent:  
Continuous Index:  
Within 8" of Joint:  
Remarks:

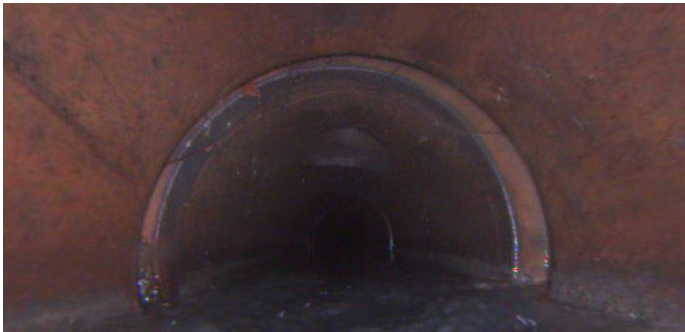
Code: **FM**  
Description: **Fracture Multiple**

Distance (ft): **52.7**  
Structural Grade: **4**  
O&M Grade: **0**  
Clock Start/From: **10**  
Clock To: **2**  
1st Value:  
2nd Value:  
Value Percent:  
Continuous Index:  
Within 8" of Joint: **YES**  
Remarks:

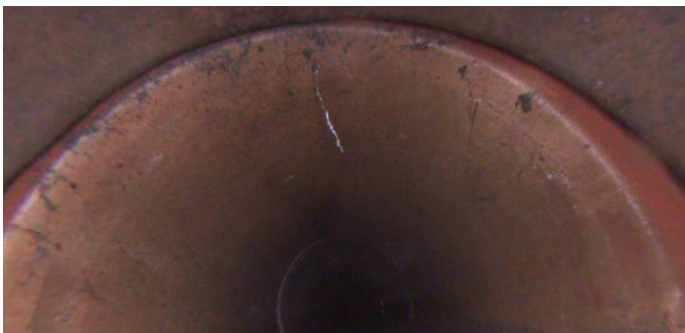
Code: **RFJ**  
Description: **Roots Fine Joint**

Distance (ft): **60.7**  
Structural Grade: **0**  
O&M Grade: **1**  
Clock Start/From: **10**  
Clock To: **2**  
1st Value:  
2nd Value:  
Value Percent:  
Continuous Index:  
Within 8" of Joint: **YES**  
Remarks:

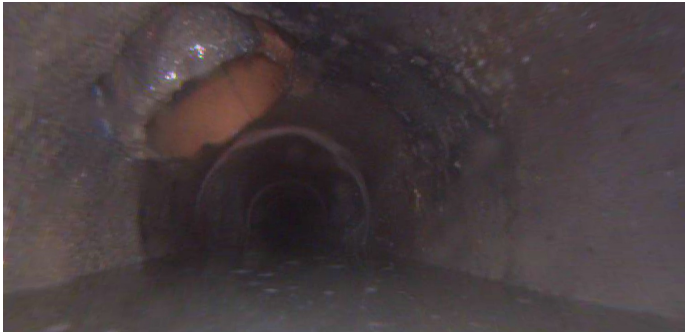
Code: **TBI**  
Description: **Tap Break-in Intruding**

Distance (ft): **66.9**  
Structural Grade: **0**  
O&M Grade: **2**  
Clock Start/From: **10**  
Clock To:  
1st Value: **4.000**  
2nd Value: **0.500**  
Value Percent:  
Continuous Index:  
Within 8" of Joint:  
Remarks:

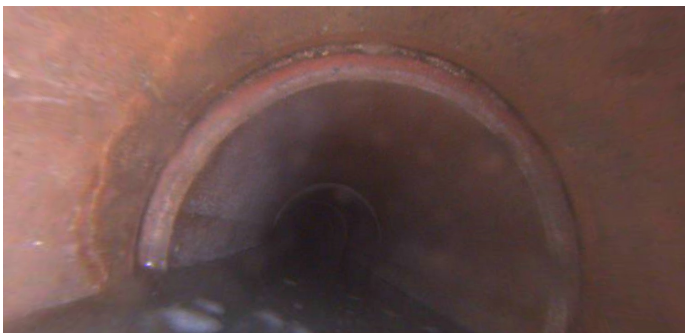
Code: **CC**  
Description: **Crack Circumferential**

Distance (ft): **80.7**  
Structural Grade: **1**  
O&M Grade: **0**  
Clock Start/From: **9**  
Clock To: **11**  
1st Value:  
2nd Value:  
Value Percent:  
Continuous Index:  
Within 8" of Joint: **YES**  
Remarks:

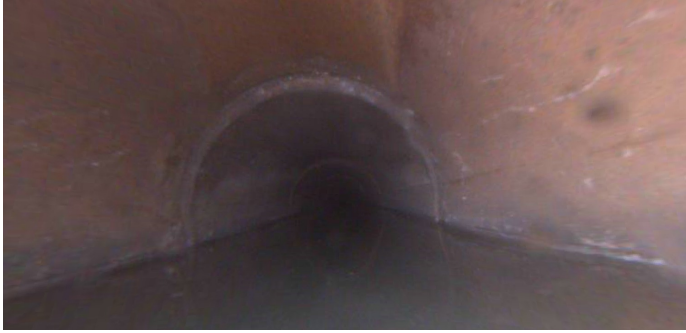
Code: **CM**  
Description: **Crack Multiple**

Distance (ft): **94.9**  
Structural Grade: **3**  
O&M Grade: **0**  
Clock Start/From: **8**  
Clock To: **4**  
1st Value:  
2nd Value:  
Value Percent:  
Continuous Index: **S01**  
Within 8" of Joint: **YES**  
Remarks:

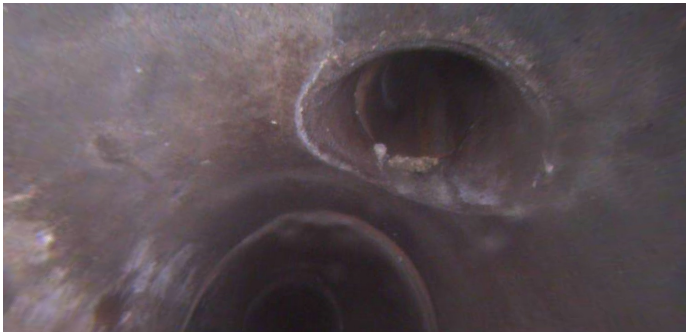
Code: **TF**  
Description: **Tap Factory**

Distance (ft): **103.3**  
Structural Grade: **0**  
O&M Grade: **0**  
Clock Start/From: **1**  
Clock To:  
1st Value: **4.000**  
2nd Value:  
Value Percent:  
Continuous Index:  
Within 8" of Joint:  
Remarks:

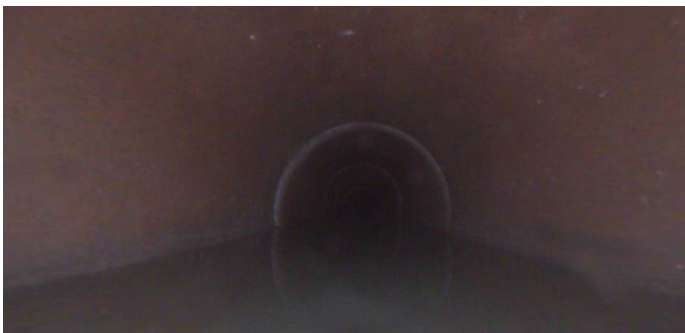
Code: **CM**  
Description: **Crack Multiple**

Distance (ft): **113.4**  
Structural Grade: **3**  
O&M Grade: **0**  
Clock Start/From: **8**  
Clock To: **4**  
1st Value:  
2nd Value:  
Value Percent:  
Continuous Index: **F01**  
Within 8" of Joint: **YES**  
Remarks:

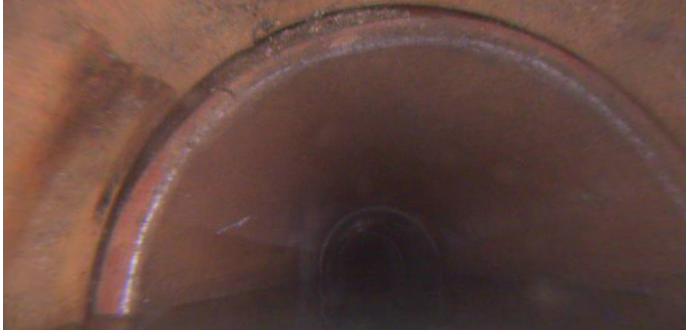
Code: **FL**  
Description: **Fracture Longitudinal**

Distance (ft): **127.3**  
Structural Grade: **3**  
O&M Grade: **0**  
Clock Start/From: **10**  
Clock To:  
1st Value:  
2nd Value:  
Value Percent:  
Continuous Index:  
Within 8" of Joint: **YES**  
Remarks:

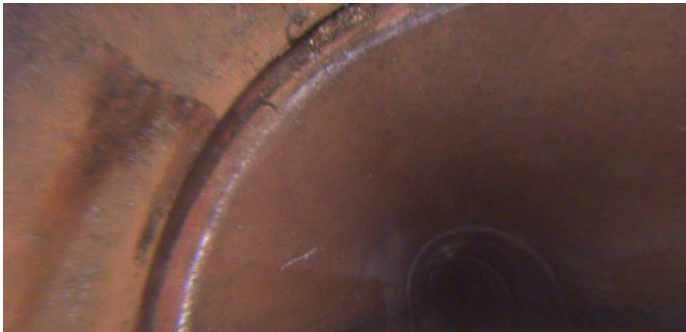
Code: **IS**  
Description: **Infil Stain**

Distance (ft): **127.4**  
Structural Grade: **0**  
O&M Grade: **0**  
Clock Start/From: **10**  
Clock To:  
1st Value:  
2nd Value:  
Value Percent:  
Continuous Index:  
Within 8" of Joint: **YES**  
Remarks:

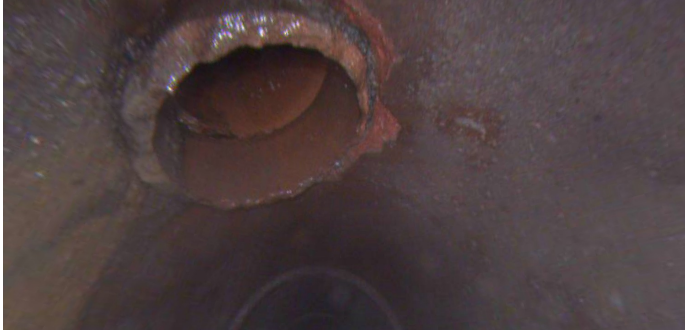
Code: **TBI**  
Description: **Tap Break-in Intruding**

Distance (ft): **130.1**  
Structural Grade: **0**  
O&M Grade: **2**  
Clock Start/From: **12**  
Clock To:  
1st Value: **4.000**  
2nd Value: **1.000**  
Value Percent:  
Continuous Index:  
Within 8" of Joint:  
Remarks:
