Profile/Photo Observation Report

Street:	41st Avenue	Flow Control:	Not Controlled
City:	Hobart, IN	Year Renewed:	
Location:	Alley	Tape/Media #:	
Purpose:	Routine Assessment	Dia/Height:	12"
Use:	Sanitary Sewage Pipe	Material:	CP
Drain Area:		Lining:

US MH: **M-504-124** DS MH: **M-504-123** Total Length Surveyed (ft): **247.4**

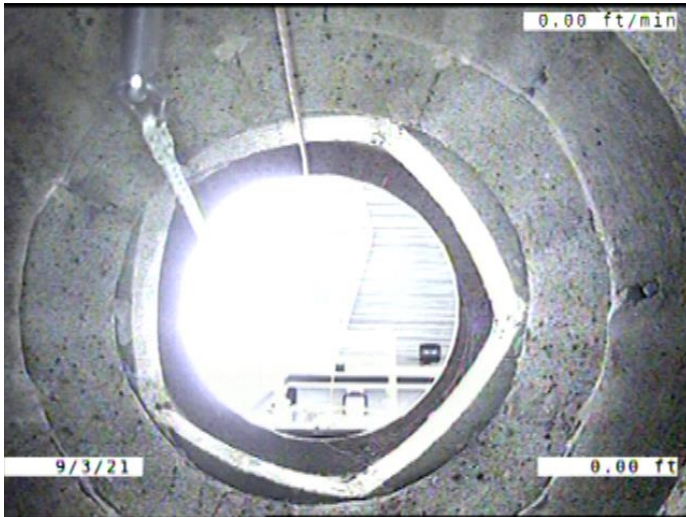
Code: **AMH**
Description: **Manhole**

Distance (ft): **.0**
Structural Grade: **0**
O&M Grade: **0**
Clock Start/From:
Clock To:
1st Value:
2nd Value:
Value Percent:
Continuous Index:
Within 8" of Joint: **NO**
Remarks: **M-504-124**

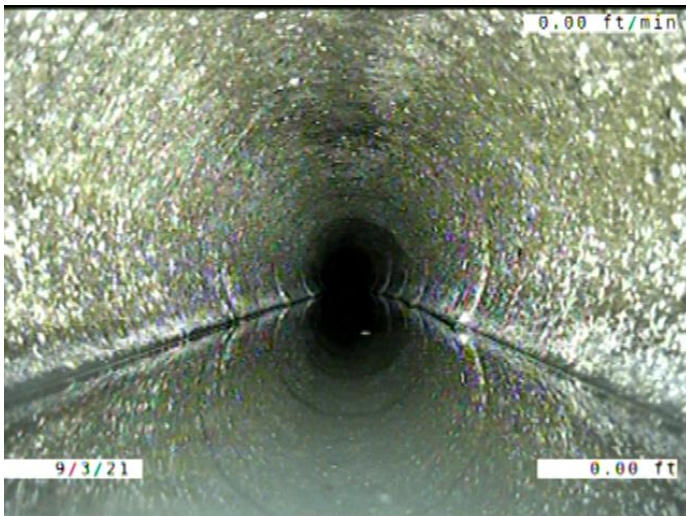
Code: **MWL**
Description: **Miscellaneous Water Level**

Distance (ft): **.0**
Structural Grade: **0**
O&M Grade: **0**
Clock Start/From:
Clock To:
1st Value:
2nd Value:
Value Percent: **10.000**
Continuous Index:
Within 8" of Joint: **NO**
Remarks:

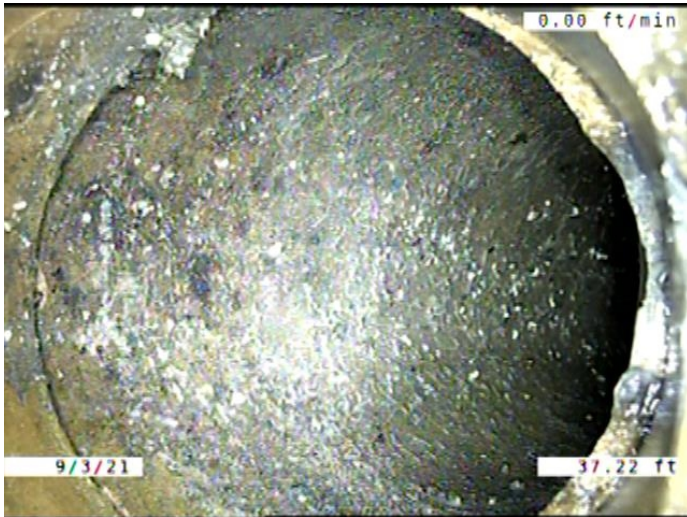
Code: **TBI**
 Description: **Tap Break-in Intruding**

Distance (ft): **37.2**
 Structural Grade: **0**
 O&M Grade: **2**
 Clock Start/From: **2**
 Clock To:
 1st Value: **6.000**
 2nd Value: **2.000**
 Value Percent:
 Continuous Index:
 Within 8" of Joint: **YES**
 Remarks:

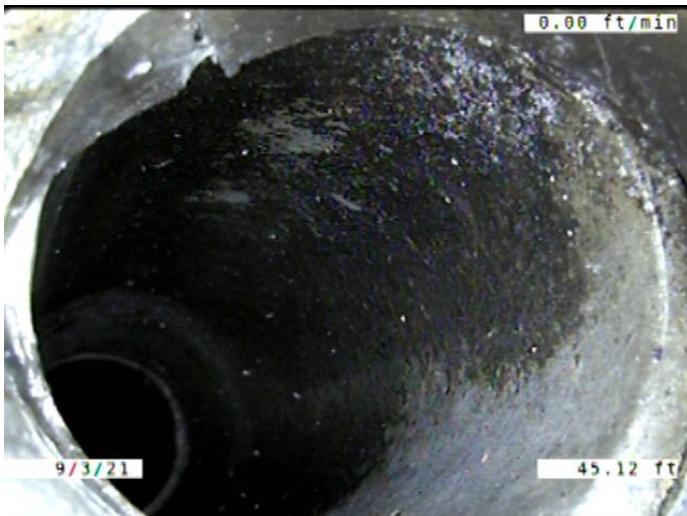
Code: **TBI**
 Description: **Tap Break-in Intruding**

Distance (ft): **45.1**
 Structural Grade: **0**
 O&M Grade: **2**
 Clock Start/From: **10**
 Clock To:
 1st Value: **6.000**
 2nd Value: **1.000**
 Value Percent:
 Continuous Index:
 Within 8" of Joint: **NO**
 Remarks:

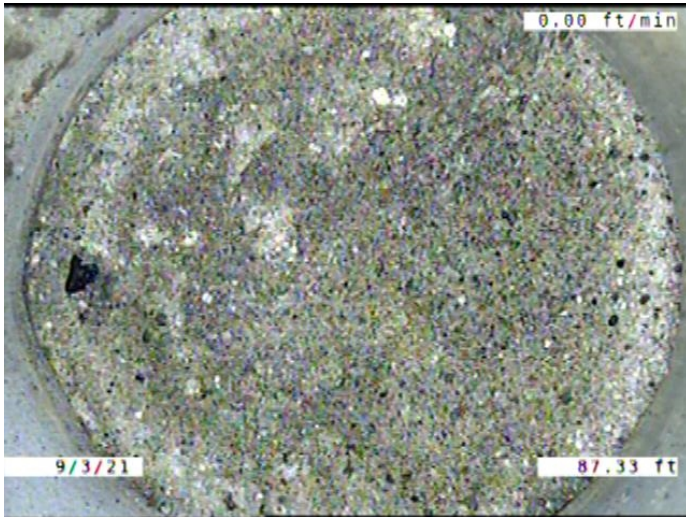
Code: **TBI**
 Description: **Tap Break-in Intruding**

Distance (ft): **87.3**
 Structural Grade: **0**
 O&M Grade: **2**
 Clock Start/From: **2**
 Clock To:
 1st Value: **6.000**
 2nd Value: **1.000**
 Value Percent:
 Continuous Index:
 Within 8" of Joint: **NO**
 Remarks: **CAPPED**

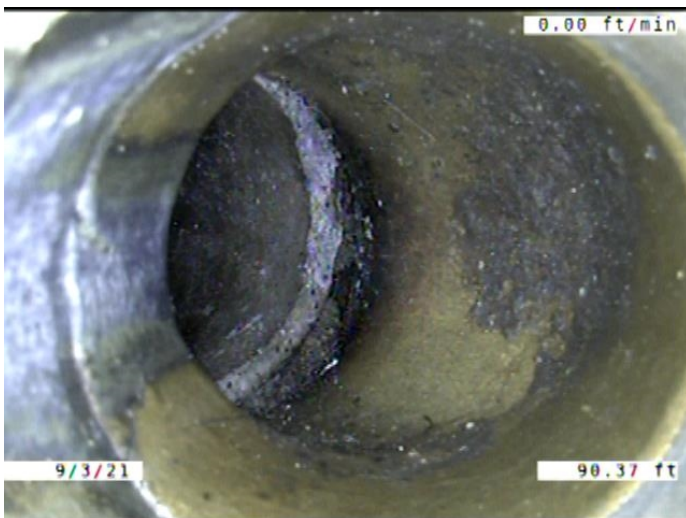
Code: **TBI**
 Description: **Tap Break-in Intruding**

Distance (ft): **90.4**
 Structural Grade: **0**
 O&M Grade: **2**
 Clock Start/From: **11**
 Clock To:
 1st Value: **6.000**
 2nd Value: **1.000**
 Value Percent:
 Continuous Index:
 Within 8" of Joint: **YES**
 Remarks:

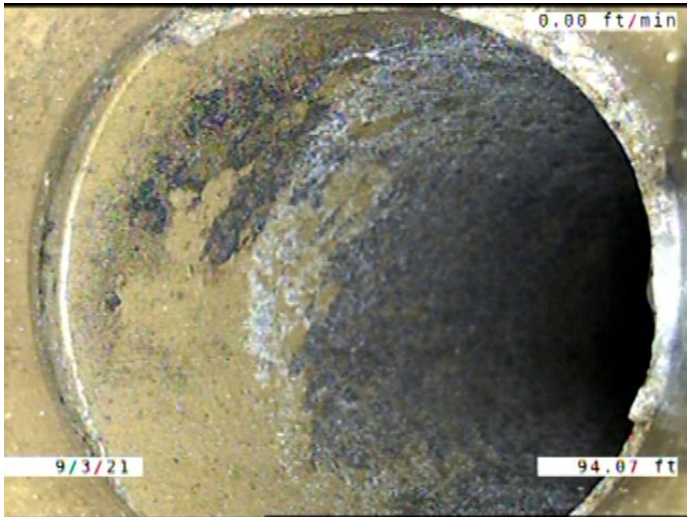
Code: **TBI**
 Description: **Tap Break-in Intruding**

Distance (ft): **94.1**
 Structural Grade: **0**
 O&M Grade: **2**
 Clock Start/From: **2**
 Clock To:
 1st Value: **6.000**
 2nd Value: **2.000**
 Value Percent:
 Continuous Index:
 Within 8" of Joint: **NO**
 Remarks:

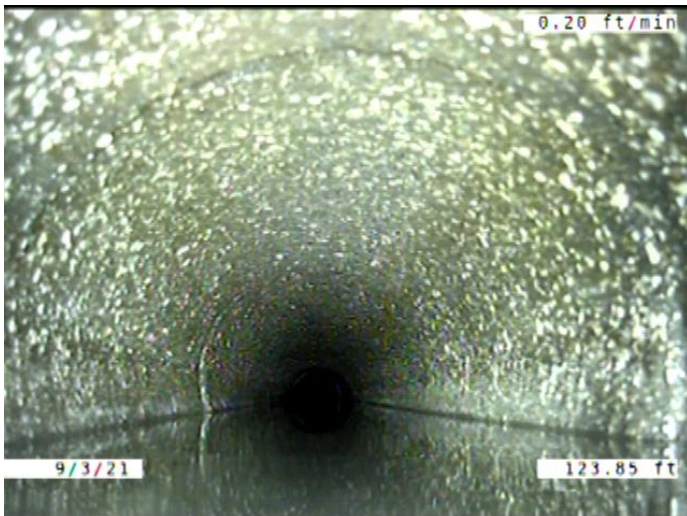
Code: **MWL**
 Description: **Miscellaneous Water Level**

Distance (ft): **123.8**
 Structural Grade: **0**
 O&M Grade: **0**
 Clock Start/From:
 Clock To:
 1st Value:
 2nd Value:
 Value Percent: **15.000**
 Continuous Index:
 Within 8" of Joint: **NO**
 Remarks:

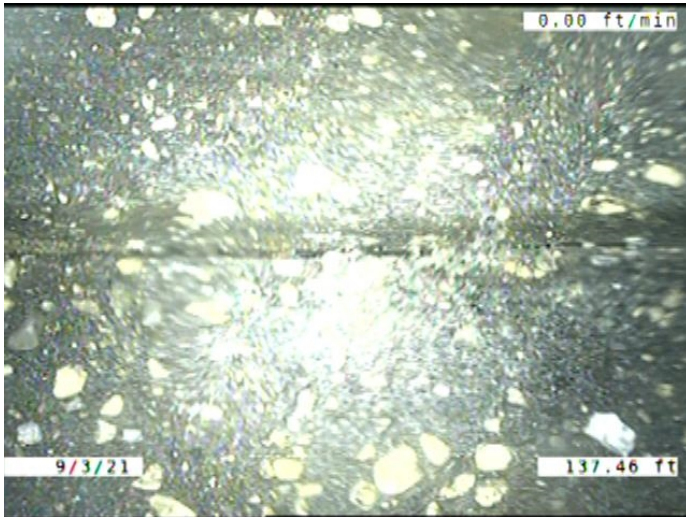
Code:	MCU
Description:	Miscellaneous Camera Underwater
Distance (ft):	137.5
Structural Grade:	0
O&M Grade:	4
Clock Start/From:	
Clock To:	
1st Value:	
2nd Value:	
Value Percent:	
Continuous Index:	
Within 8" of Joint:	NO
Remarks:	Out at 138.1

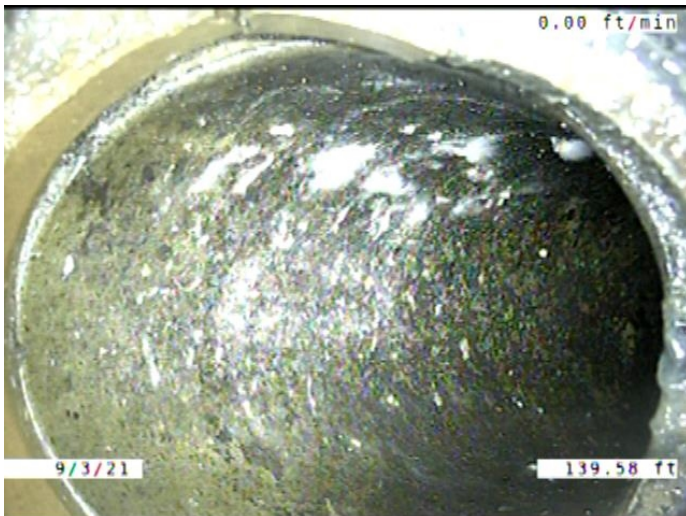
Code:	TB
Description:	Tap Break-in/Hammer
Distance (ft):	139.6
Structural Grade:	0
O&M Grade:	0
Clock Start/From:	1
Clock To:	
1st Value:	6.000
2nd Value:	
Value Percent:	
Continuous Index:	
Within 8" of Joint:	NO
Remarks:

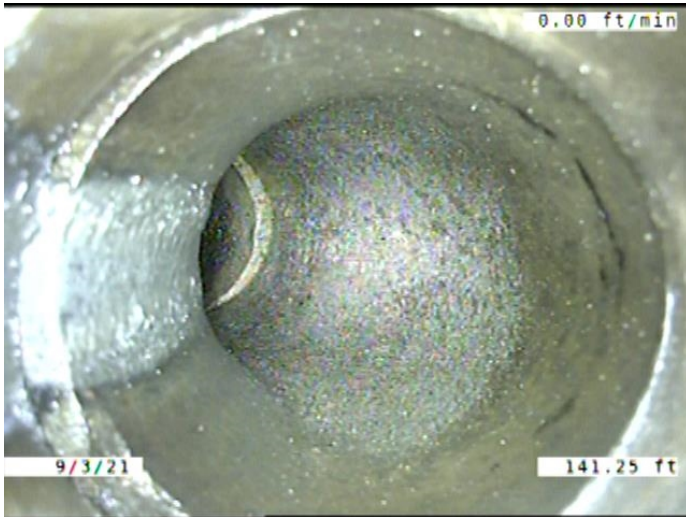
Code: **TB**
Description: **Tap Break-in/Hammer**

Distance (ft): **141.2**
Structural Grade: **0**
O&M Grade: **0**
Clock Start/From: **11**
Clock To:
1st Value: **6.000**
2nd Value:
Value Percent:
Continuous Index:
Within 8" of Joint: **NO**
Remarks:

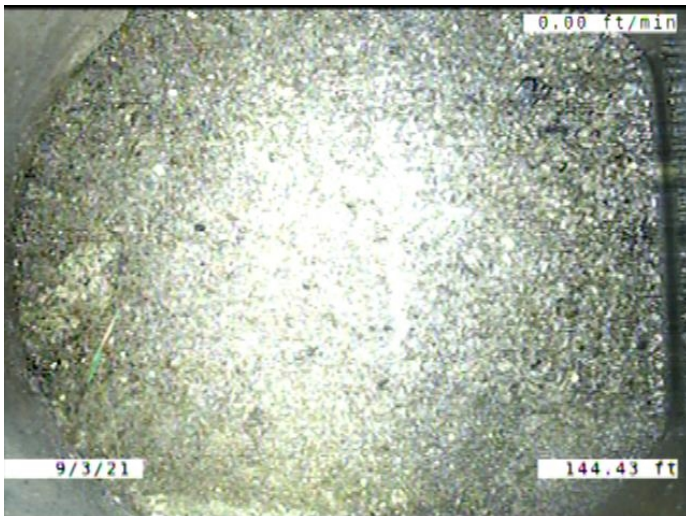
Code: **TBC**
Description: **Tap Break-in Capped**

Distance (ft): **144.4**
Structural Grade: **0**
O&M Grade: **0**
Clock Start/From: **2**
Clock To:
1st Value: **6.000**
2nd Value:
Value Percent:
Continuous Index:
Within 8" of Joint: **YES**
Remarks:

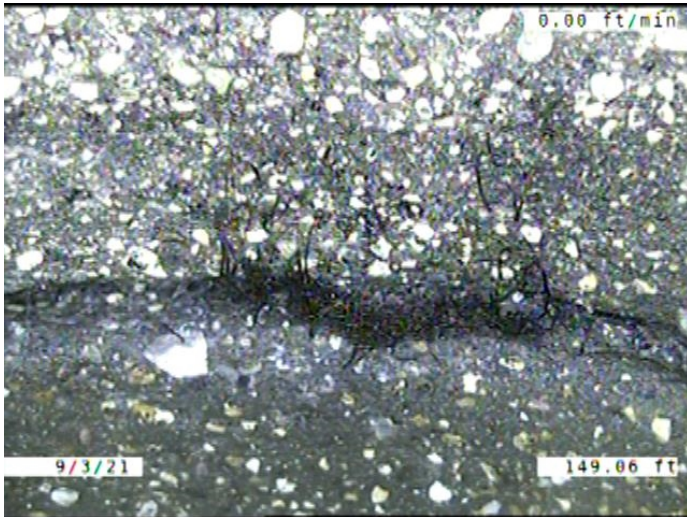
Code: **RFJ**
 Description: **Roots Fine Joint**

Distance (ft): **149.1**
 Structural Grade: **0**
 O&M Grade: **1**
 Clock Start/From: **10**
 Clock To: **2**
 1st Value:
 2nd Value:
 Value Percent:
 Continuous Index:
 Within 8" of Joint: **YES**
 Remarks:

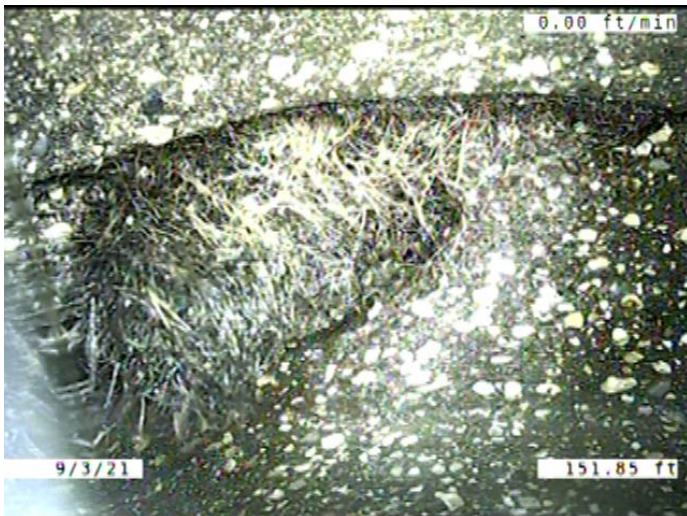
Code: **RMJ**
 Description: **Roots Medium Joint**

Distance (ft): **151.9**
 Structural Grade: **0**
 O&M Grade: **3**
 Clock Start/From: **9**
 Clock To: **10**
 1st Value:
 2nd Value:
 Value Percent: **5.000**
 Continuous Index:
 Within 8" of Joint: **YES**
 Remarks:

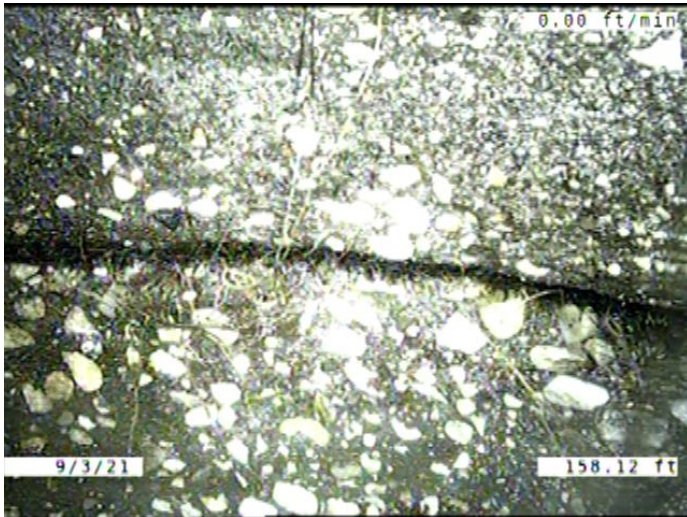
Code: **RFJ**
 Description: **Roots Fine Joint**

Distance (ft): **158.1**
 Structural Grade: **0**
 O&M Grade: **1**
 Clock Start/From: **12**
 Clock To: **3**
 1st Value:
 2nd Value:
 Value Percent:
 Continuous Index:
 Within 8" of Joint: **YES**
 Remarks:

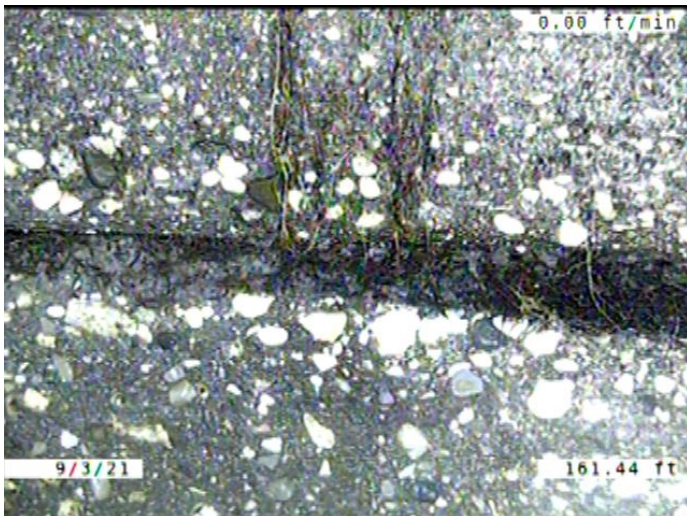
Code: **RFJ**
 Description: **Roots Fine Joint**

Distance (ft): **161.4**
 Structural Grade: **0**
 O&M Grade: **1**
 Clock Start/From: **10**
 Clock To: **3**
 1st Value:
 2nd Value:
 Value Percent:
 Continuous Index:
 Within 8" of Joint: **YES**
 Remarks:

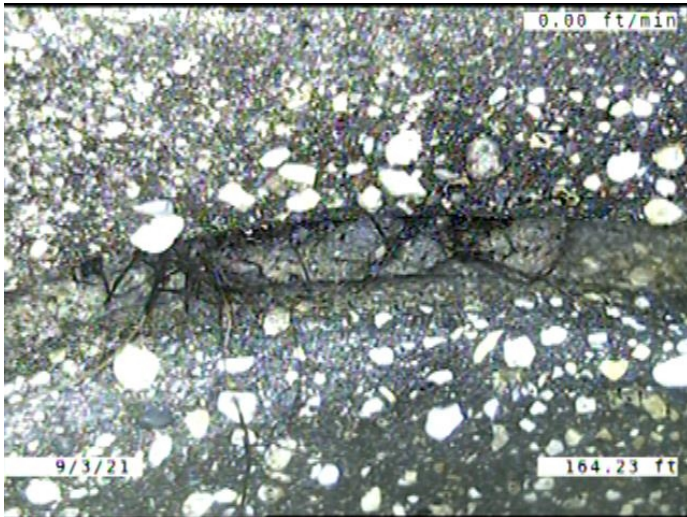
Code: **RFJ**
 Description: **Roots Fine Joint**

Distance (ft): **164.2**
 Structural Grade: **0**
 O&M Grade: **1**
 Clock Start/From: **9**
 Clock To: **3**
 1st Value:
 2nd Value:
 Value Percent:
 Continuous Index:
 Within 8" of Joint: **YES**
 Remarks:

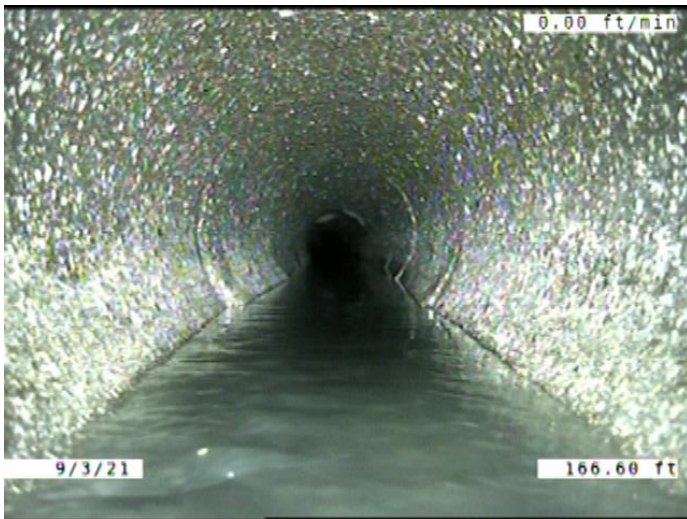
Code: **MWL**
 Description: **Miscellaneous Water Level**

Distance (ft): **166.6**
 Structural Grade: **0**
 O&M Grade: **0**
 Clock Start/From:
 Clock To:
 1st Value:
 2nd Value:
 Value Percent: **5.000**
 Continuous Index:
 Within 8" of Joint: **NO**
 Remarks:

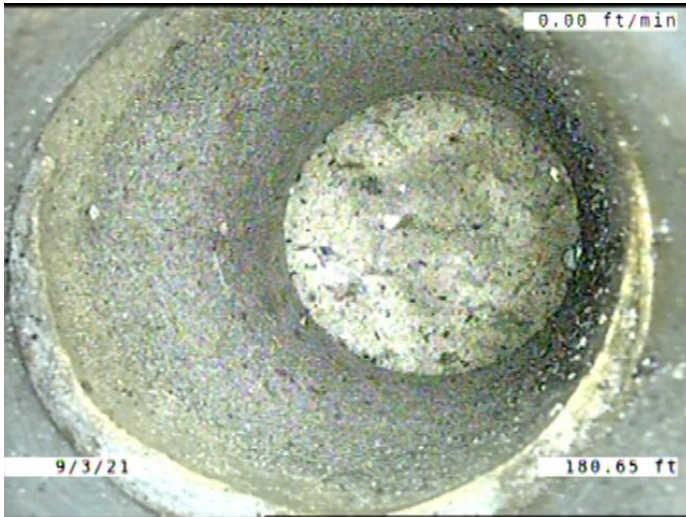
Code: **TBI**
 Description: **Tap Break-in Intruding**

Distance (ft): **180.6**
 Structural Grade: **0**
 O&M Grade: **2**
 Clock Start/From: **1**
 Clock To:
 1st Value: **6.000**
 2nd Value: **1.000**
 Value Percent:
 Continuous Index:
 Within 8" of Joint: **NO**
 Remarks: **CAPPED**

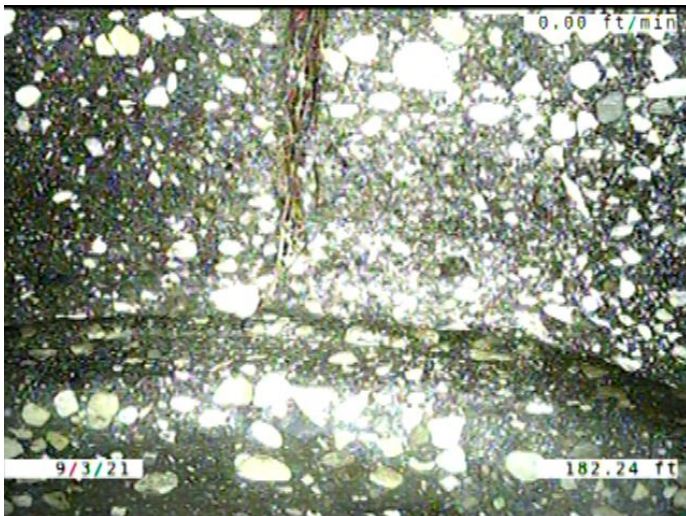
Code: **RFJ**
 Description: **Roots Fine Joint**

Distance (ft): **182.2**
 Structural Grade: **0**
 O&M Grade: **1**
 Clock Start/From: **2**
 Clock To:
 1st Value:
 2nd Value:
 Value Percent:
 Continuous Index:
 Within 8" of Joint: **YES**
 Remarks:

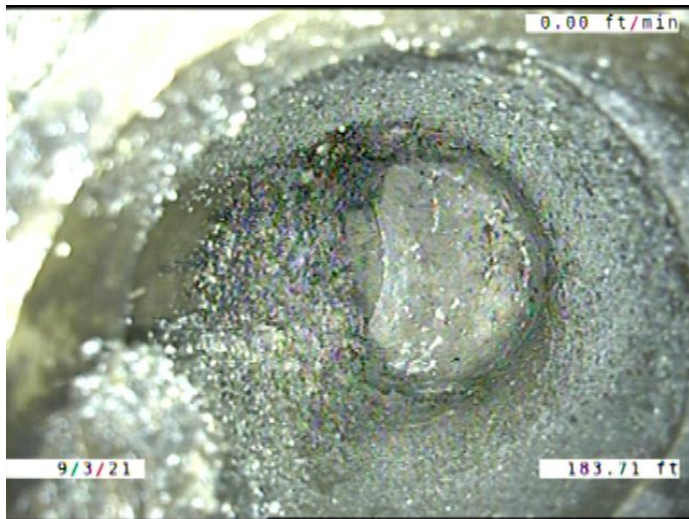
Code: **TBI**
 Description: **Tap Break-in Intruding**

Distance (ft): **183.7**
 Structural Grade: **0**
 O&M Grade: **2**
 Clock Start/From: **11**
 Clock To:
 1st Value: **6.000**
 2nd Value: **2.000**
 Value Percent:
 Continuous Index:
 Within 8" of Joint: **NO**
 Remarks: **ROOTS GROWING IN THE TAP**

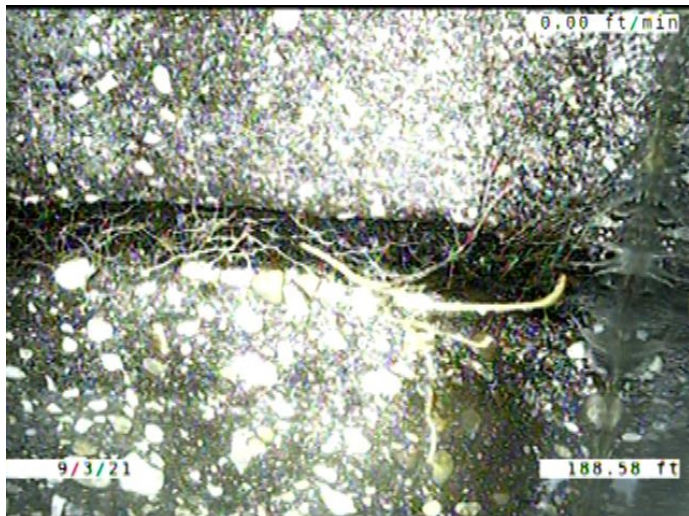
Code: **RFJ**
 Description: **Roots Fine Joint**

Distance (ft): **188.6**
 Structural Grade: **0**
 O&M Grade: **1**
 Clock Start/From: **9**
 Clock To: **3**
 1st Value:
 2nd Value:
 Value Percent:
 Continuous Index:
 Within 8" of Joint: **YES**
 Remarks:

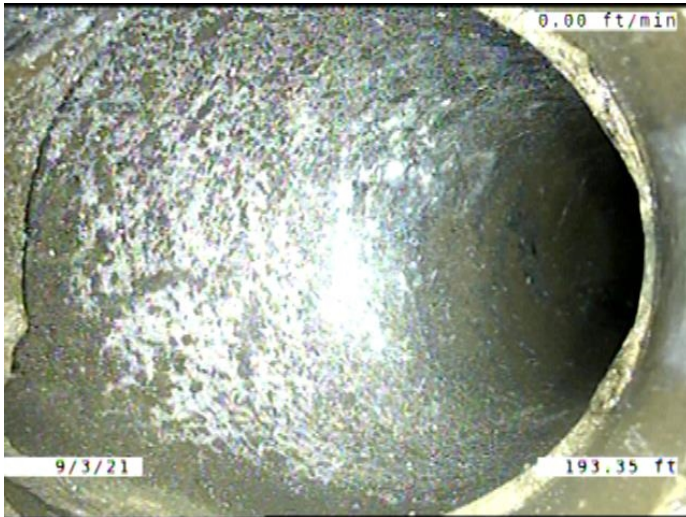
Code: **TBI**
 Description: **Tap Break-in Intruding**

Distance (ft): **193.3**
 Structural Grade: **0**
 O&M Grade: **2**
 Clock Start/From: **1**
 Clock To:
 1st Value: **6.000**
 2nd Value: **1.000**
 Value Percent:
 Continuous Index:
 Within 8" of Joint: **NO**
 Remarks:

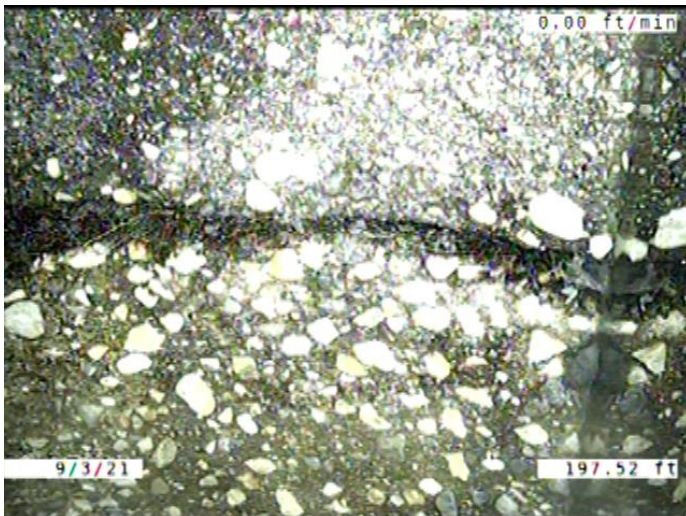
Code: **RFJ**
 Description: **Roots Fine Joint**

Distance (ft): **197.5**
 Structural Grade: **0**
 O&M Grade: **1**
 Clock Start/From: **9**
 Clock To: **3**
 1st Value:
 2nd Value:
 Value Percent:
 Continuous Index:
 Within 8" of Joint: **YES**
 Remarks:

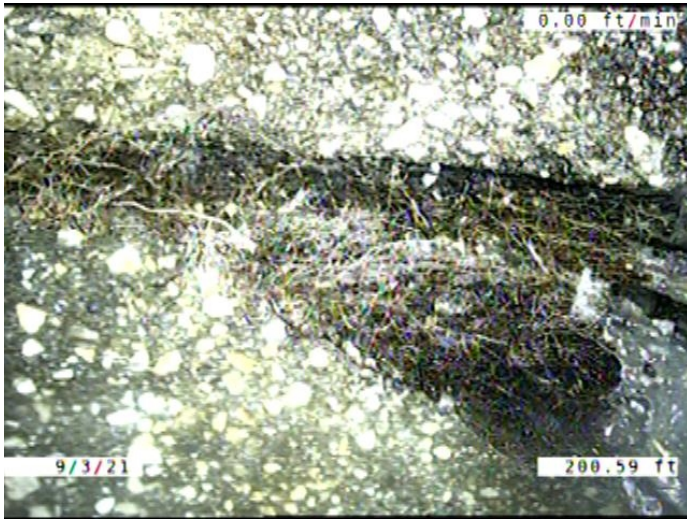
Code: **RMJ**
 Description: **Roots Medium Joint**

Distance (ft): **200.6**
 Structural Grade: **0**
 O&M Grade: **3**
 Clock Start/From: **1**
 Clock To: **3**
 1st Value:
 2nd Value:
 Value Percent: **5.000**
 Continuous Index:
 Within 8" of Joint: **YES**
 Remarks:

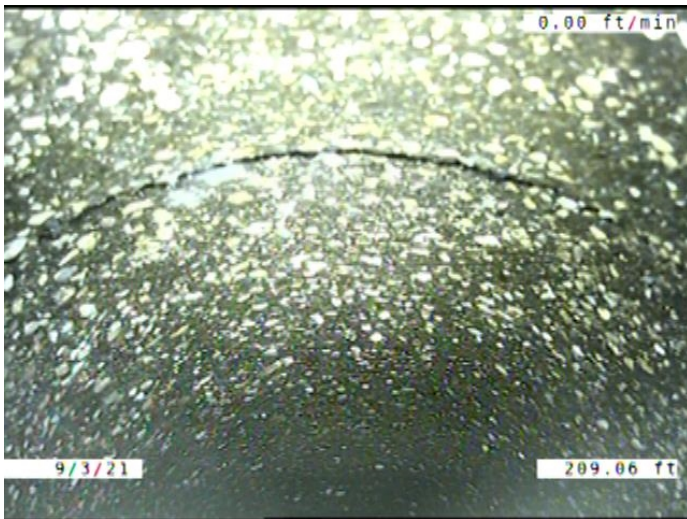
Code: **MWL**
 Description: **Miscellaneous Water Level**

Distance (ft): **209.1**
 Structural Grade: **0**
 O&M Grade: **0**
 Clock Start/From:
 Clock To:
 1st Value:
 2nd Value:
 Value Percent: **15.000**
 Continuous Index:
 Within 8" of Joint: **NO**
 Remarks:

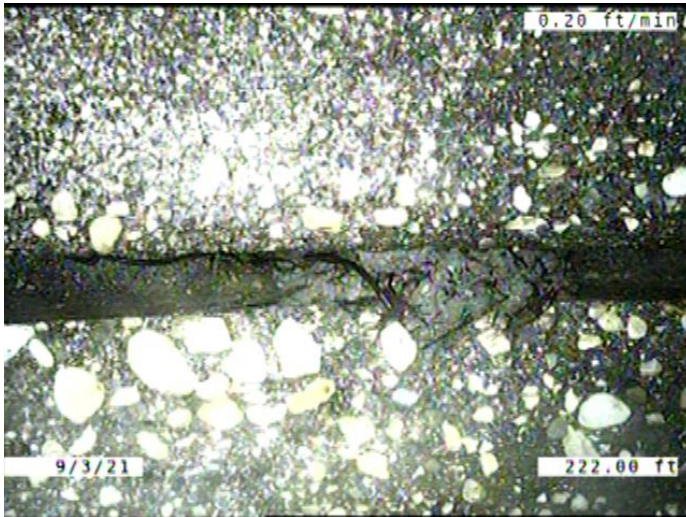
Code: **RFJ**
Description: **Roots Fine Joint**

Distance (ft): **222.0**
Structural Grade: **0**
O&M Grade: **1**
Clock Start/From: **9**
Clock To: **3**
1st Value:
2nd Value:
Value Percent:
Continuous Index:
Within 8" of Joint: **YES**
Remarks:

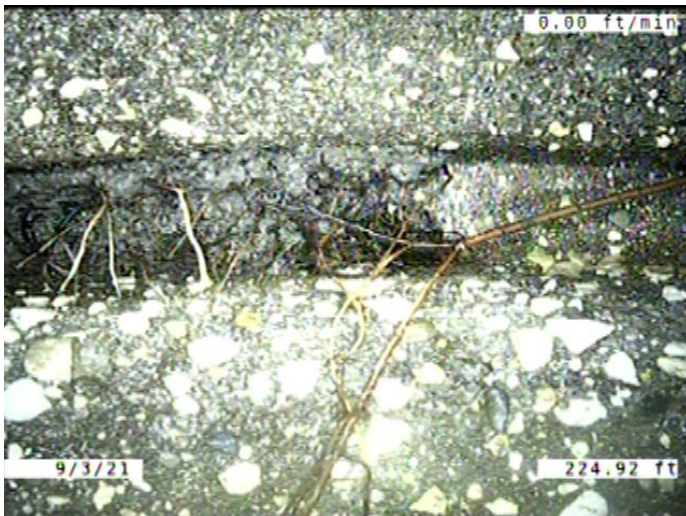
Code: **RFJ**
Description: **Roots Fine Joint**

Distance (ft): **224.9**
Structural Grade: **0**
O&M Grade: **1**
Clock Start/From: **9**
Clock To: **4**
1st Value:
2nd Value:
Value Percent:
Continuous Index:
Within 8" of Joint: **YES**
Remarks:

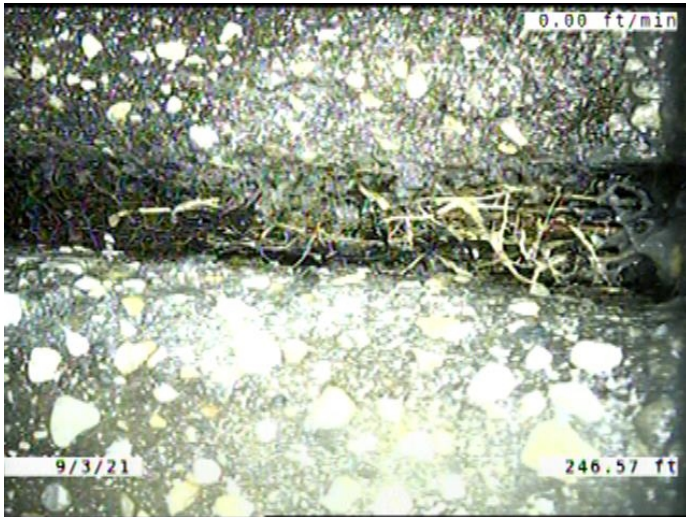
Code: **RFJ**
 Description: **Roots Fine Joint**

Distance (ft): **246.6**
 Structural Grade: **0**
 O&M Grade: **1**
 Clock Start/From: **9**
 Clock To: **3**
 1st Value:
 2nd Value:
 Value Percent:
 Continuous Index:
 Within 8" of Joint: **YES**
 Remarks:

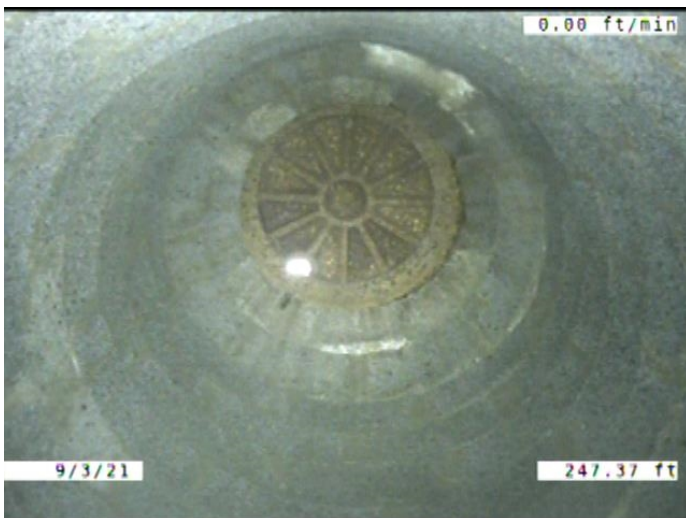
Code: **AMH**
 Description: **Manhole**

Distance (ft): **247.4**
 Structural Grade: **0**
 O&M Grade: **0**
 Clock Start/From:
 Clock To:
 1st Value:
 2nd Value:
 Value Percent:
 Continuous Index:
 Within 8" of Joint: **NO**
 Remarks: **M-504-123**
