## Profile/Photo Observation Report

Street:	<b>W 41ST AVE</b>	Flow Control:	<b>Not Controlled</b>
City:	<b>Hobart, IN</b>	Year Renewed:	
Location:	<b>Other</b>	Tape/Media #:	
Purpose:	<b>Not Known</b>	Dia/Height:	<b>10"</b>
Use:	<b>Sanitary</b>	Material:	<b>CP</b>
Drain Area:	<b>NA</b>	Lining:	
Category:	<b>NA</b>		
Comment:

Location Details:		Direction of Survey:	<b>Downstream</b>
US MH:	<b>M-504-125</b>	DS MH:	<b>M-504-124</b>
		Total Length Surveyed (ft):	<b>9.1</b>

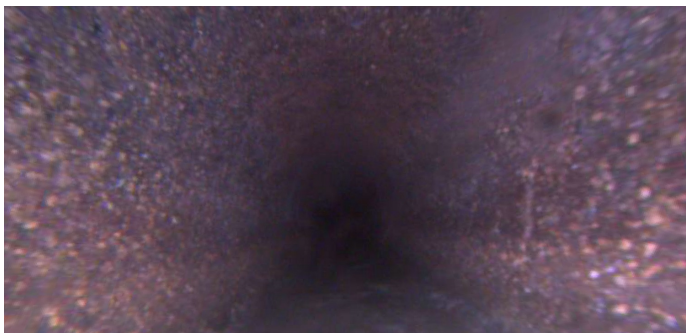
Code: **AMH**  
Description: **Manhole**

Distance (ft): **.0**  
Structural Grade: **0**  
O&M Grade: **0**  
Clock Start/From:  
Clock To:  
1st Value:  
2nd Value:  
Value Percent:  
Continuous Index:  
Within 8" of Joint: **NO**  
Remarks: **M-504-125**

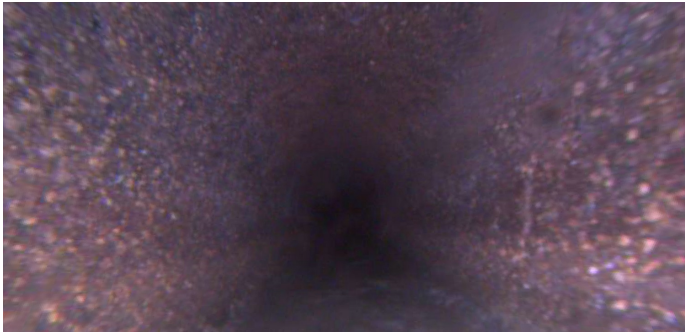
Code:	<b>MWL</b>
Description:	<b>Water Level</b>

Distance (ft):	<b>.0</b>
Structural Grade:	<b>0</b>
O&M Grade:	<b>0</b>
Clock Start/From:	
Clock To:	
1st Value:	
2nd Value:	
Value Percent:	<b>5.000</b>
Continuous Index:	
Within 8" of Joint:	<b>NO</b>
Remarks:

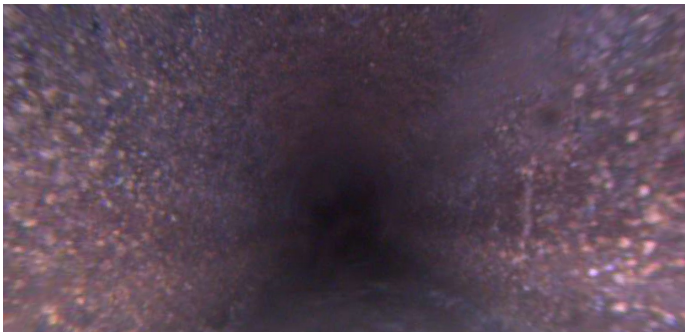
Code:	<b>SAP</b>
Description:	<b>Surface Aggregate Projecting</b>

Distance (ft):	<b>.0</b>
Structural Grade:	<b>3</b>
O&M Grade:	<b>0</b>
Clock Start/From:	<b>8</b>
Clock To:	<b>4</b>
1st Value:	
2nd Value:	
Value Percent:	
Continuous Index:	<b>S01</b>
Within 8" of Joint:	
Remarks:

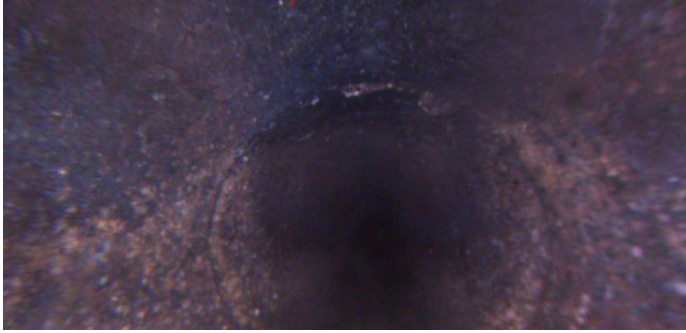
Code: **SAP**  
Description: **Surface Aggregate Projecting**

Distance (ft): **9.1**  
Structural Grade: **3**  
O&M Grade: **0**  
Clock Start/From: **8**  
Clock To: **4**  
1st Value:  
2nd Value:  
Value Percent:  
Continuous Index: **F01**  
Within 8" of Joint:  
Remarks:

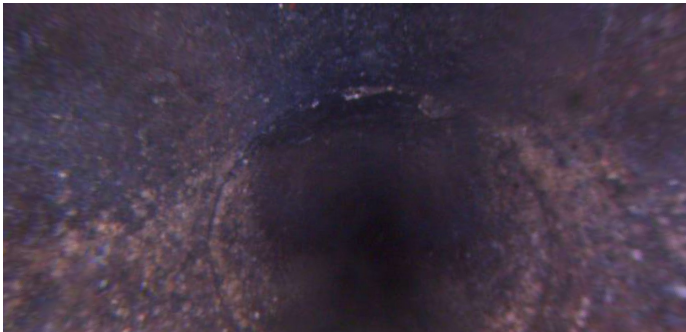
Code: **MSA**  
Description: **Abandoned Survey**

Distance (ft): **9.1**  
Structural Grade: **0**  
O&M Grade: **0**  
Clock Start/From:  
Clock To:  
1st Value:  
2nd Value:  
Value Percent:  
Continuous Index:  
Within 8" of Joint: **NO**  
Remarks: **unknown**
