Profile/Photo Observation Report

Street:	W 40th ave	Flow Control:	Not Controlled
City:	Hobart, IN	Year Renewed:	
Location:	Other	Tape/Media #:	
Purpose:	Not Known	Dia/Height:	10"
Use:	Sanitary	Material:	CP
Drain Area:	NA	Lining:	
Category:	NA		
Comment:

Location Details:		Direction of Survey:	Downstream
US MH:	M-504-125	DS MH:	M-504-124
		Total Length Surveyed (ft):	9.1

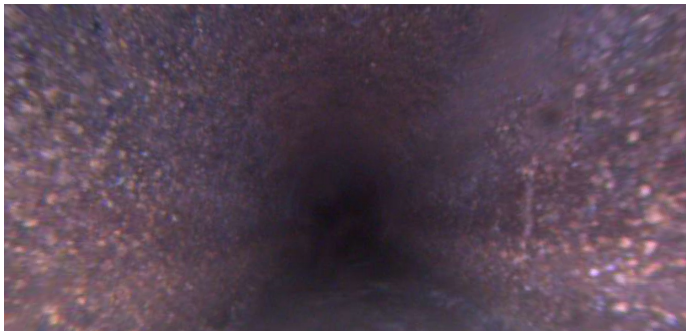
Code: **AMH**
Description: **Manhole**

Distance (ft): **.0**
Structural Grade: **0**
O&M Grade: **0**
Clock Start/From:
Clock To:
1st Value:
2nd Value:
Value Percent:
Continuous Index:
Within 8" of Joint: **NO**
Remarks: **M-504-125**

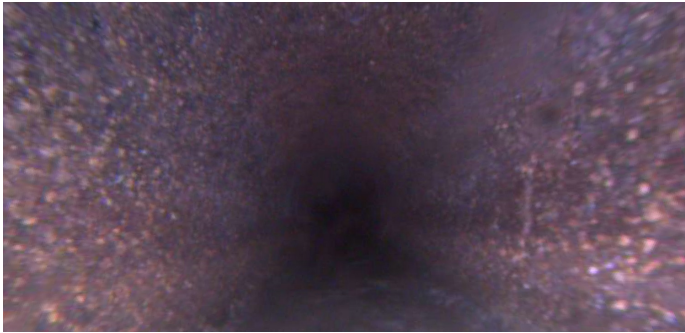
Code:	MWL
Description:	Water Level

Distance (ft):	.0
Structural Grade:	0
O&M Grade:	0
Clock Start/From:	
Clock To:	
1st Value:	
2nd Value:	
Value Percent:	5.000
Continuous Index:	
Within 8" of Joint:	NO
Remarks:

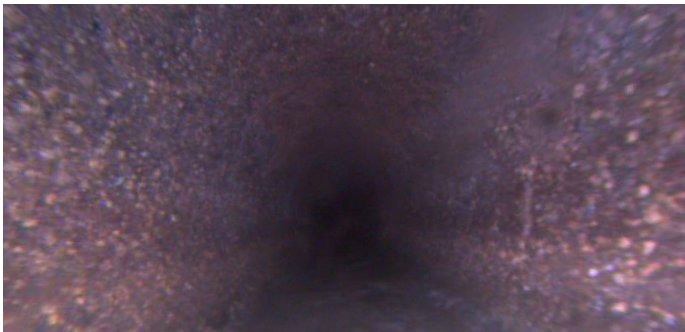
Code:	SAP
Description:	Surface Aggregate Projecting

Distance (ft):	.0
Structural Grade:	3
O&M Grade:	0
Clock Start/From:	8
Clock To:	4
1st Value:	
2nd Value:	
Value Percent:	
Continuous Index:	S01
Within 8" of Joint:	
Remarks:

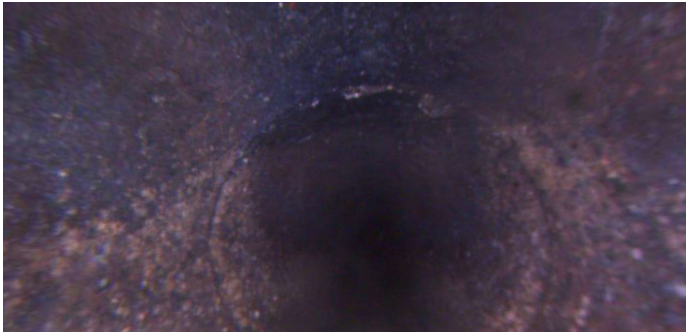
Code: **SAP**
Description: **Surface Aggregate Projecting**

Distance (ft): **9.1**
Structural Grade: **3**
O&M Grade: **0**
Clock Start/From: **8**
Clock To: **4**
1st Value:
2nd Value:
Value Percent:
Continuous Index: **F01**
Within 8" of Joint:
Remarks:

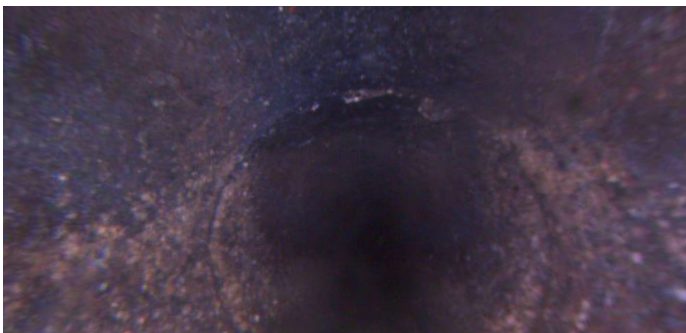
Code: **MSA**
Description: **Abandoned Survey**

Distance (ft): **9.1**
Structural Grade: **0**
O&M Grade: **0**
Clock Start/From:
Clock To:
1st Value:
2nd Value:
Value Percent:
Continuous Index:
Within 8" of Joint: **NO**
Remarks: **unknown**
