Profile/Photo Observation Report

Street:	W 42ND AVE	Flow Control:	Not Controlled
City:	Hobart, IN	Year Renewed:	
Location:	Light Highway	Tape/Media #:	
Purpose:	Not Known	Dia/Height:	12"
Use:	Sanitary	Material:	VCP
Drain Area:	NA	Lining:	
Category:	NA		
Comment:

Location Details:		Direction of Survey:	Downstream
US MH:	M-504-130	DS MH:	M-504-088
		Total Length Surveyed (ft):	5.4

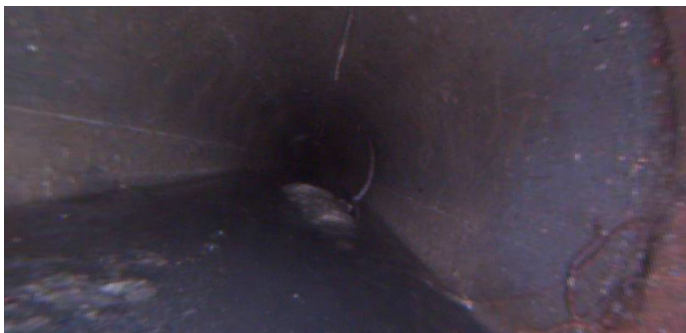
Code: **AMH**
Description: **Manhole**

Distance (ft): **.0**
Structural Grade: **0**
O&M Grade: **0**
Clock Start/From:
Clock To:
1st Value:
2nd Value:
Value Percent:
Continuous Index:
Within 8" of Joint: **NO**
Remarks: **M-504-130**

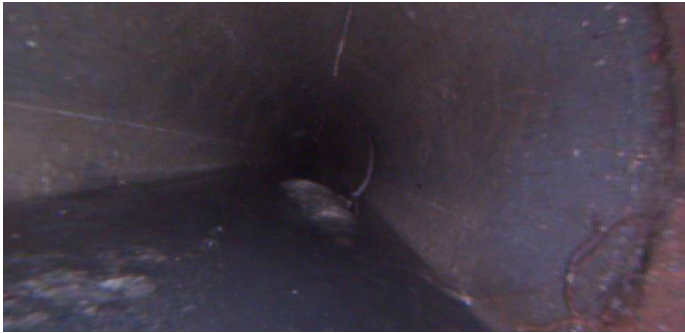
Code:	MWL
Description:	Water Level

Distance (ft):	.0
Structural Grade:	0
O&M Grade:	0
Clock Start/From:	
Clock To:	
1st Value:	
2nd Value:	
Value Percent:	5.000
Continuous Index:	
Within 8" of Joint:	NO
Remarks:

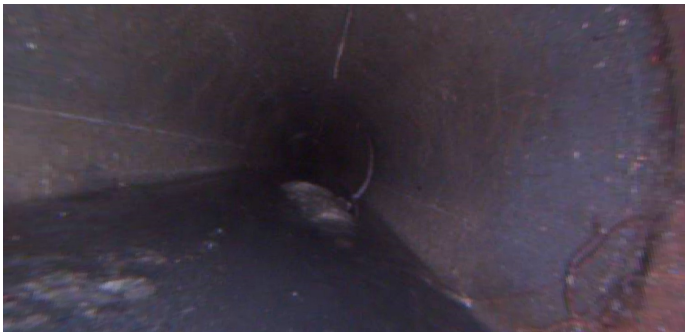
Code:	DSZ
Description:	Deposits Settled Other

Distance (ft):	.0
Structural Grade:	0
O&M Grade:	2
Clock Start/From:	6
Clock To:	
1st Value:	
2nd Value:	
Value Percent:	5.000
Continuous Index:	S01
Within 8" of Joint:	NO
Remarks:	tissue

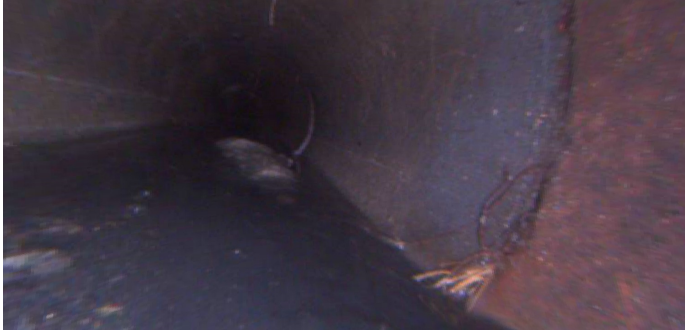
Code: **RFJ**
Description: **Roots Fine Joint**

Distance (ft): **.0**
Structural Grade: **0**
O&M Grade: **1**
Clock Start/From: **4**
Clock To: **5**
1st Value:
2nd Value:
Value Percent:
Continuous Index:
Within 8" of Joint: **YES**
Remarks:

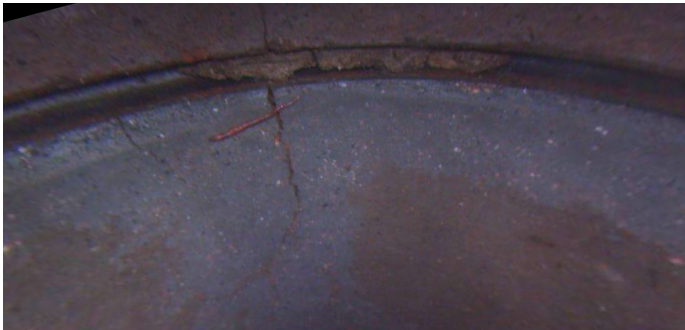
Code: **FL**
Description: **Fracture Longitudinal**

Distance (ft): **5.4**
Structural Grade: **3**
O&M Grade: **0**
Clock Start/From: **12**
Clock To:
1st Value:
2nd Value:
Value Percent:
Continuous Index:
Within 8" of Joint: **YES**
Remarks:

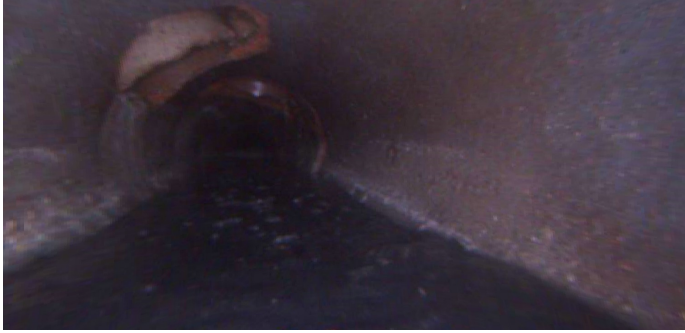
Code: **MSA**
Description: **Abandoned Survey**

Distance (ft): **5.4**
Structural Grade: **0**
O&M Grade: **0**
Clock Start/From:
Clock To:
1st Value:
2nd Value:
Value Percent:
Continuous Index:
Within 8" of Joint: **NO**
Remarks: **no blockage**

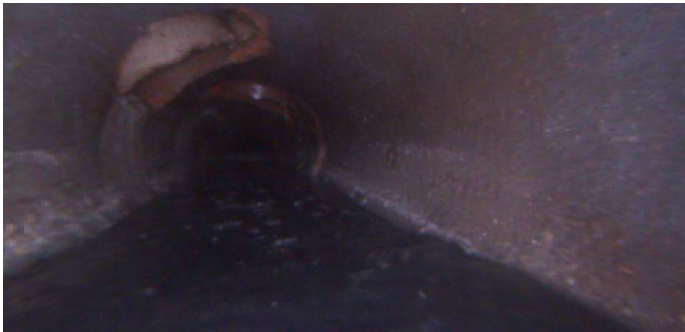
Code: **DSZ**
Description: **Deposits Settled Other**

Distance (ft): **5.4**
Structural Grade: **0**
O&M Grade: **2**
Clock Start/From: **6**
Clock To:
1st Value:
2nd Value:
Value Percent: **5.000**
Continuous Index: **F01**
Within 8" of Joint: **NO**
Remarks: **tissue**
