Profile/Photo Observation Report

Date:	04/18/2018	Weather:		Coding:	PACP 6.0
Pipe Length (ft):	179.9	Owner:	NA	Pre Clean:	Not Known
P.O.#:		Surveyor:	Byrd Fitzgerald	PSR:	P-504-088-130
Customer:		Clean Date:	01/01/1900	Shape:	C

Location Details:		Direction of Survey:	Downstream
US MH:	M-504-130	DS MH:	M-504-088
		Total Length Surveyed (ft):	5.4

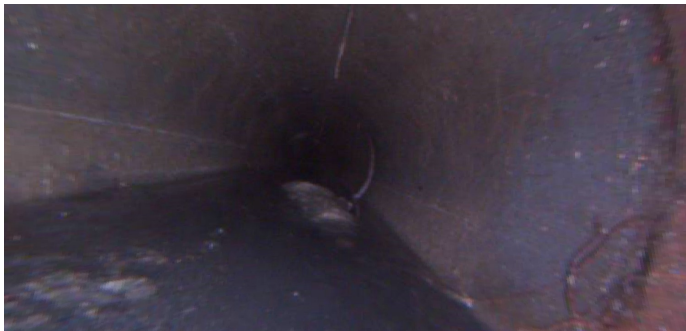
Code: **AMH**
Description: **Manhole**

Distance (ft): **.0**
Structural Grade: **0**
O&M Grade: **0**
Clock Start/From:
Clock To:
1st Value:
2nd Value:
Value Percent:
Continuous Index:
Within 8" of Joint: **NO**
Remarks: **M-504-130**

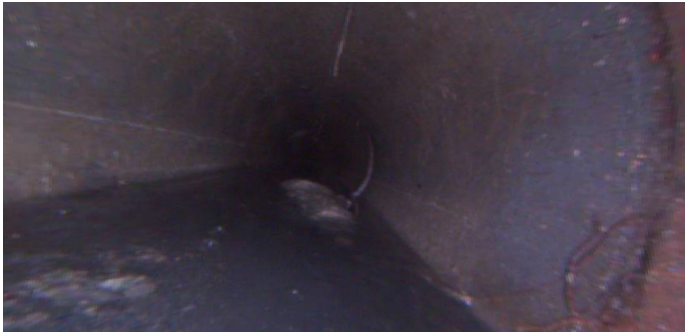
Code:	MWL
Description:	Water Level

Distance (ft):	.0
Structural Grade:	0
O&M Grade:	0
Clock Start/From:	
Clock To:	
1st Value:	
2nd Value:	
Value Percent:	5.000
Continuous Index:	
Within 8" of Joint:	NO
Remarks:

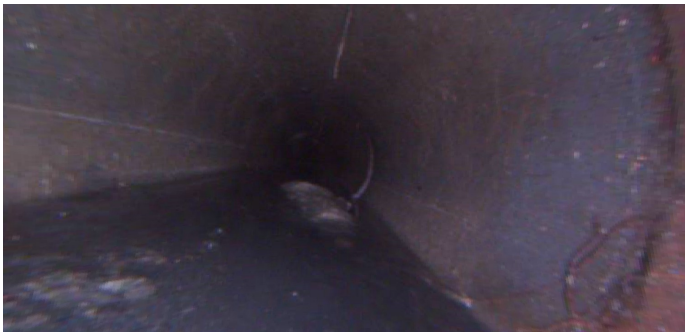
Code:	DSZ
Description:	Deposits Settled Other

Distance (ft):	.0
Structural Grade:	0
O&M Grade:	2
Clock Start/From:	6
Clock To:	
1st Value:	
2nd Value:	
Value Percent:	5.000
Continuous Index:	S01
Within 8" of Joint:	NO
Remarks:	tissue

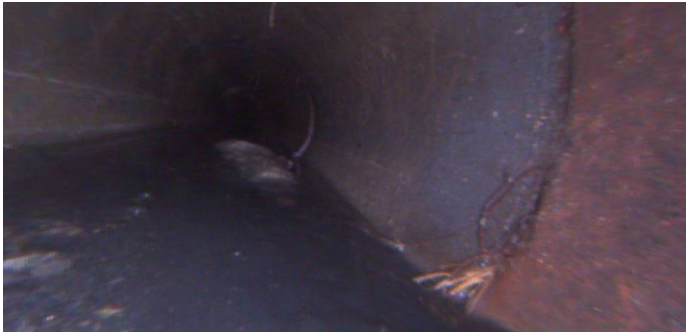
Code: **RFJ**
Description: **Roots Fine Joint**

Distance (ft): **.0**
Structural Grade: **0**
O&M Grade: **1**
Clock Start/From: **4**
Clock To: **5**
1st Value:
2nd Value:
Value Percent:
Continuous Index:
Within 8" of Joint: **YES**
Remarks:

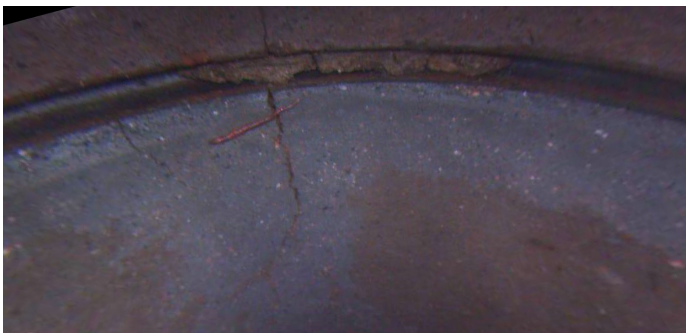
Code: **FL**
Description: **Fracture Longitudinal**

Distance (ft): **5.4**
Structural Grade: **3**
O&M Grade: **0**
Clock Start/From: **12**
Clock To:
1st Value:
2nd Value:
Value Percent:
Continuous Index:
Within 8" of Joint: **YES**
Remarks:

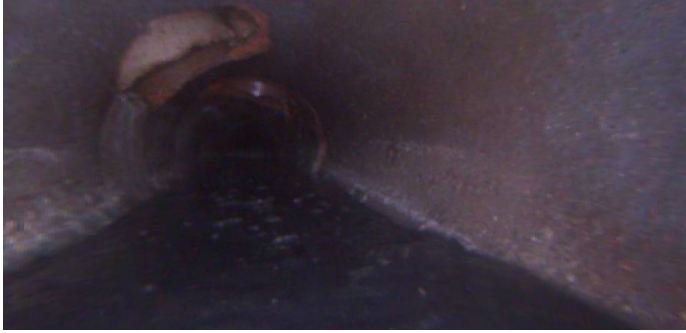
Code: **MSA**
Description: **Abandoned Survey**

Distance (ft): **5.4**
Structural Grade: **0**
O&M Grade: **0**
Clock Start/From:
Clock To:
1st Value:
2nd Value:
Value Percent:
Continuous Index:
Within 8" of Joint: **NO**
Remarks: **no blockage**

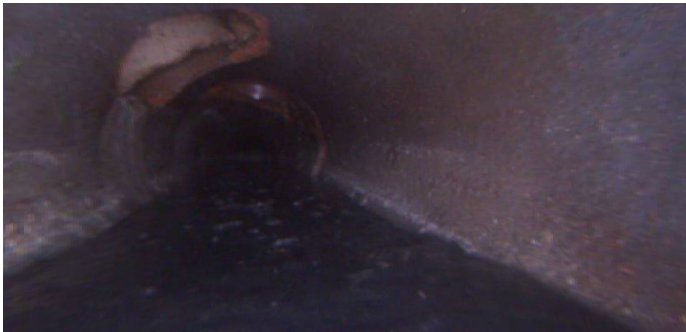
Code: **DSZ**
Description: **Deposits Settled Other**

Distance (ft): **5.4**
Structural Grade: **0**
O&M Grade: **2**
Clock Start/From: **6**
Clock To:
1st Value:
2nd Value:
Value Percent: **5.000**
Continuous Index: **F01**
Within 8" of Joint: **NO**
Remarks: **tissue**
